GEO-1 EROSION AND SEDIMENTATION TECHNICAL MEMORANDUM

**KERN RIVER No. 3 HYDROELECTRIC PROJECT
*FERC PROJECT No. 2290***

October 2023

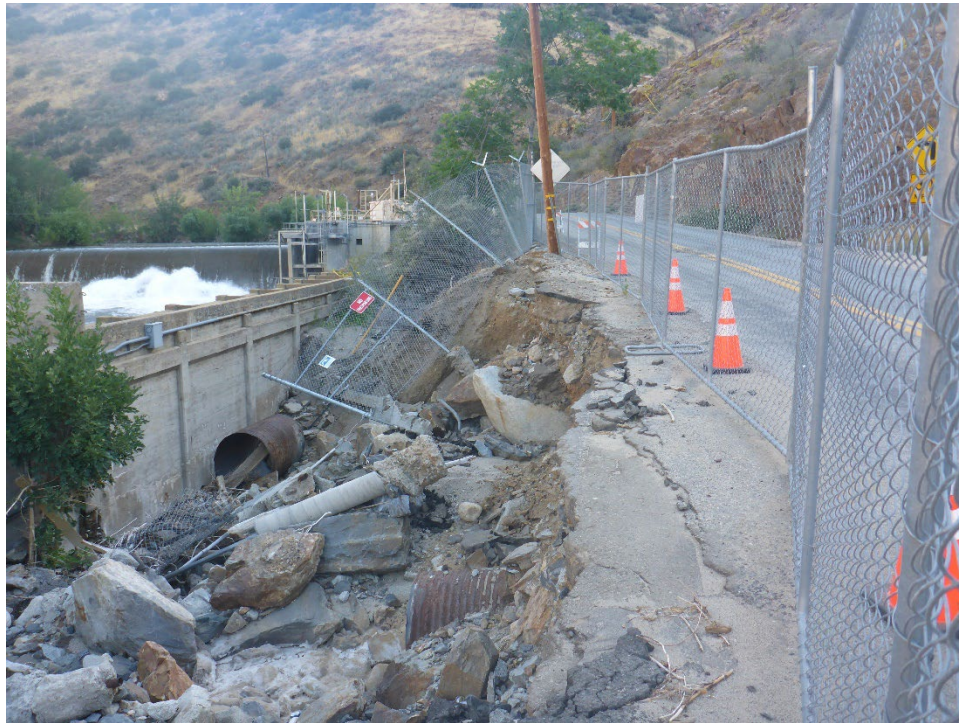
Site	Photographs (Appendix A)	Volume (CY)	% Delivery	Description
Fairview Dam Sandbox Facility ^a	A-1 to A-4	N/A	N/A	Significant erosion of (non-Project) Mountain Highway 99 road fill prism and basal area surrounding intake flume of the Fairview Dam Sandbox Facility occurred during significant March 2023 flood event as a result of failed culvert.
	A-5 to A-6	<1	100	Minor surface rilling and road fill prism failure at small access road leading to parking area located at the southwestern area of the Fairview Dam sandbox. See results from Appendix A, <i>Project and Shared Access Roads</i> , in the <i>LAND-1 Road Condition Assessment Interim Technical Memorandum</i> (Attachment R of this Initial Study Report).
Tunnel 6/7 Spoil Site	A-10 to A-13	3	60	Small failure located along the distal margin of the graded pad area of the Tunnel 6/7 Spoil Site caused by concentrated surface drainage (Figure A-13).

Figure A-1. Erosion of (non-Project) Mountain Highway 99 at Fairview Dam Sandbox Facility initiated by failed culvert crossing (view looking upstream).

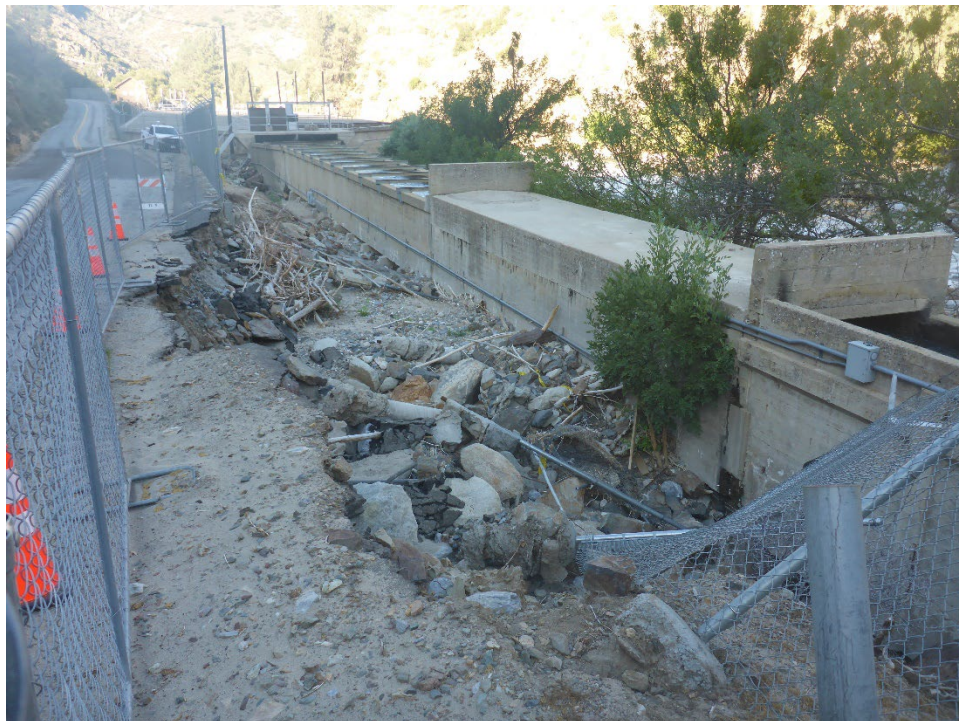
Figure A-2. Erosion of (non-Project) Mountain Highway 99 at Fairview Dam Sandbox Facility initiated by failed culvert crossing (view looking downstream).

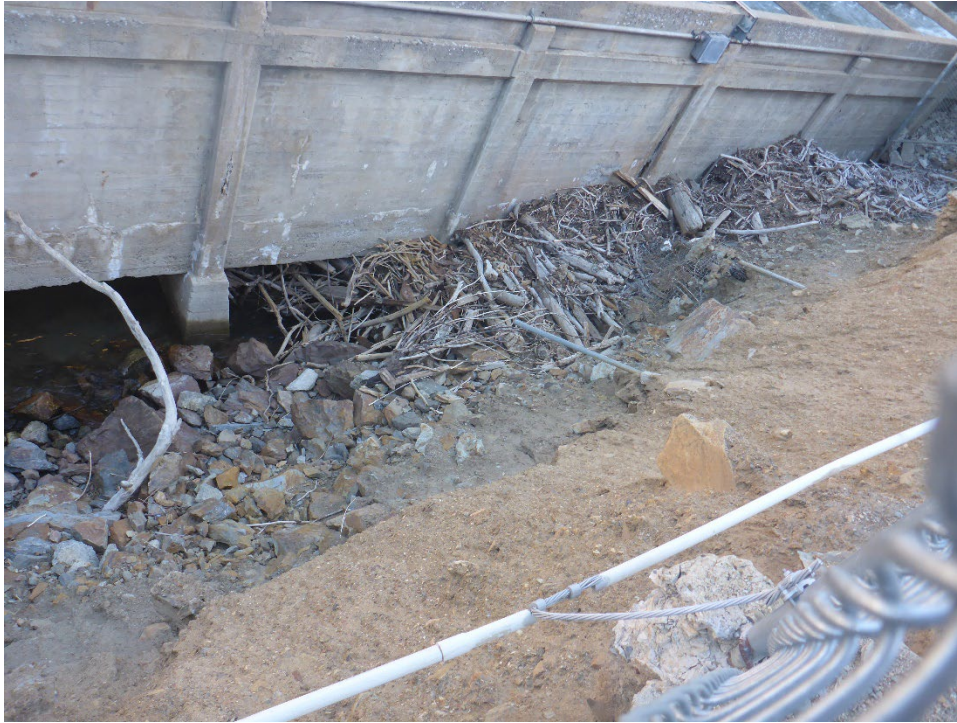
Figure A-3. Close-up view of erosion and debris along inboard edge of Fairview Dam Sandbox Facility near the failed (non-Project) Mountain Highway 99 culvert location.

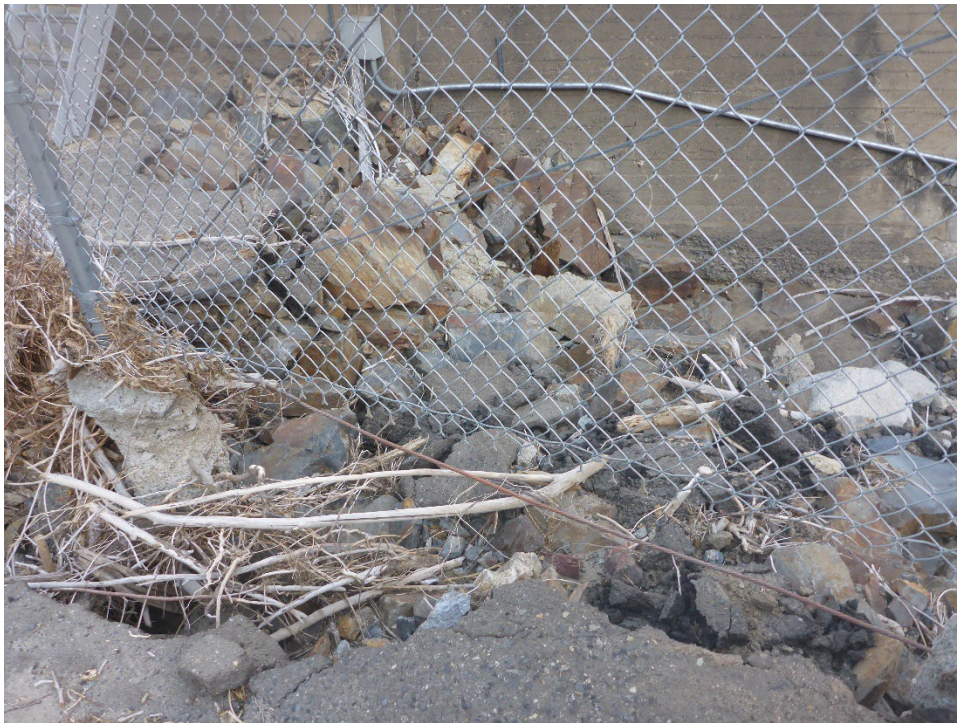
Figure A-4. Erosion and debris near access gate to Fairview Dam Sandbox Facility.

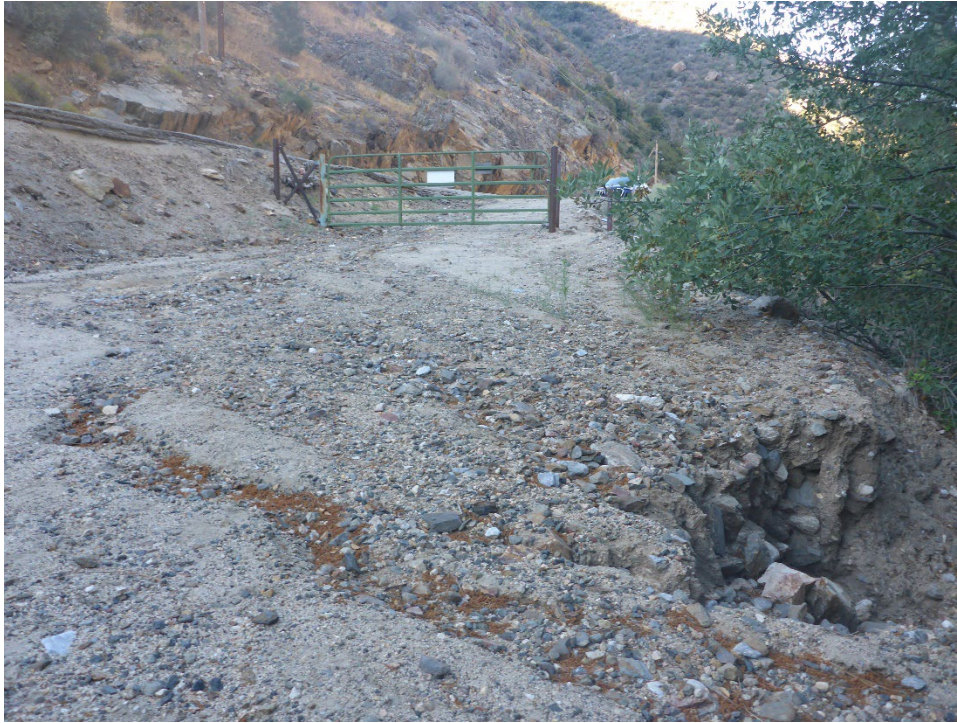
Figure A-5. Minor surface rilling and road fill prism failure cut into access road to Fairview Dam Sandbox Facility (view looking upslope).

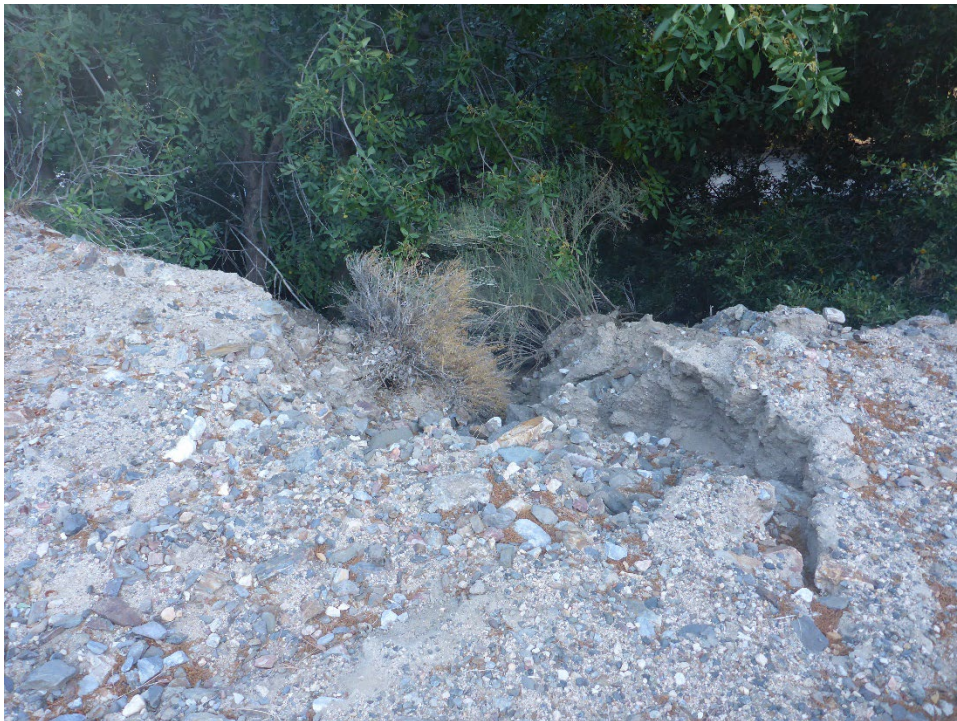
Figure A-6. Minor surface rilling and road fill prism failure cut into access road to Fairview Dam Sandbox Facility (view looking toward river channel, behind vegetation).

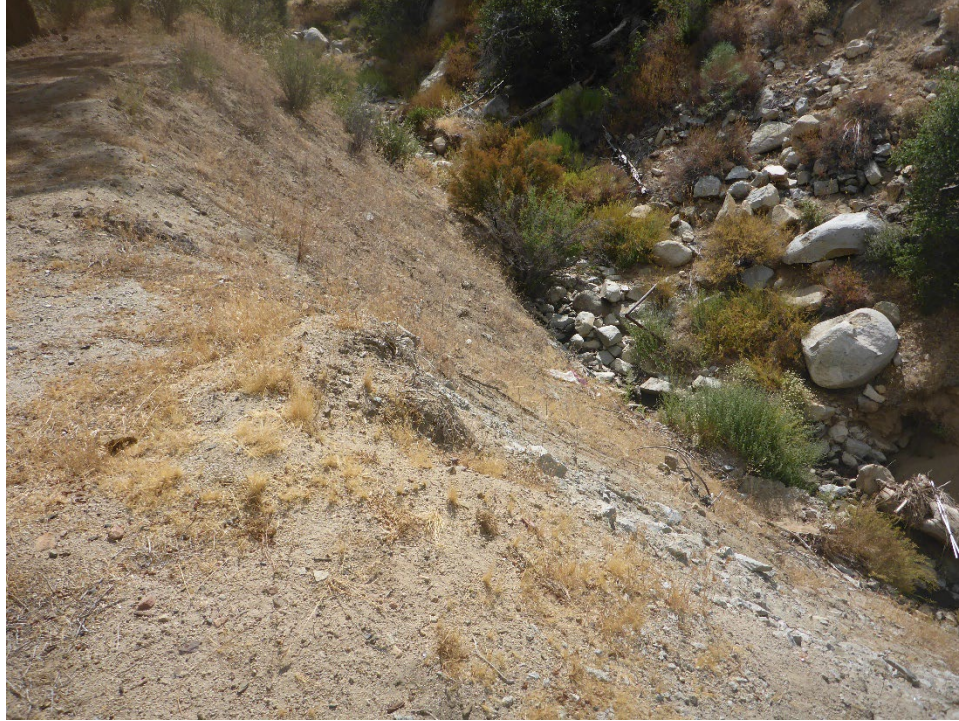
Figure A-7. Historical tunnel spoil material placed in drainage swale at Tunnel 4/5 Spoil Site (view looking into channel from downstream margin of spoil pile).

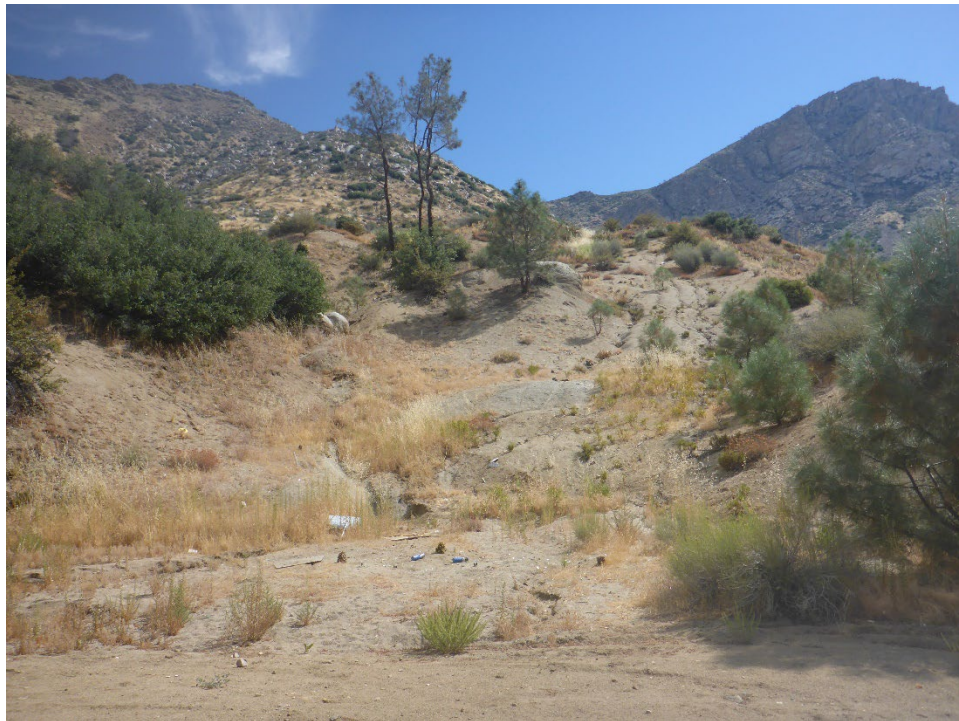
Figure A-8. Minor surface rilling cut into native decomposed granite hillslope at Tunnel 4/5 Spoil Site. Material potentially historical tunnel spoil material; sediment delivery captured by Tunnels 5-8A Access Road and spoil pile pad.

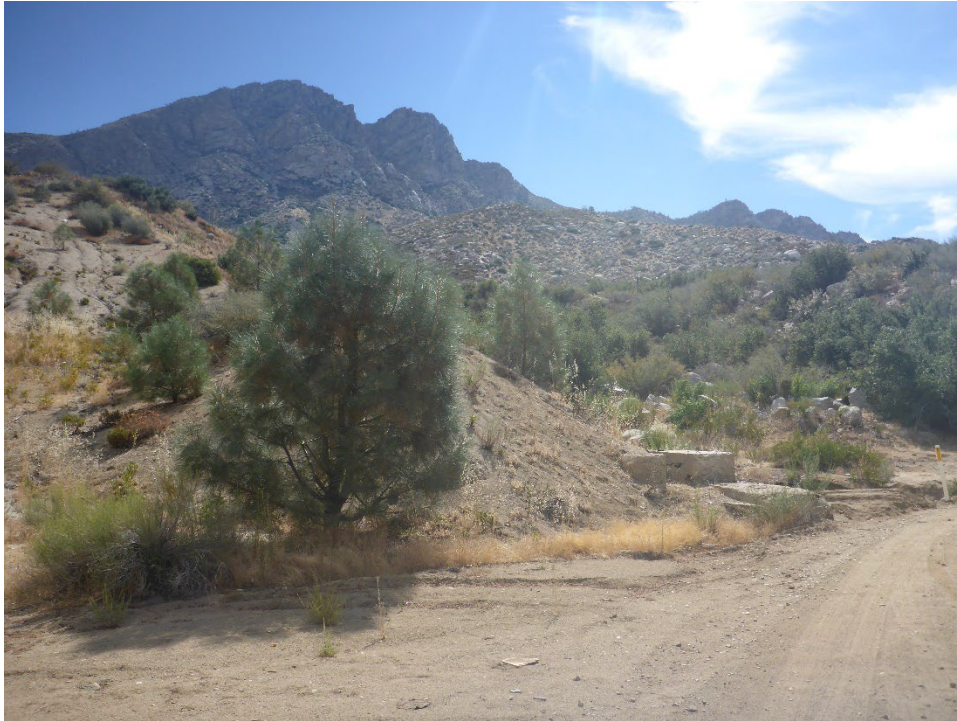
Figure A-9. Adjacent view to Figure A-8 image of minor surface rilling.

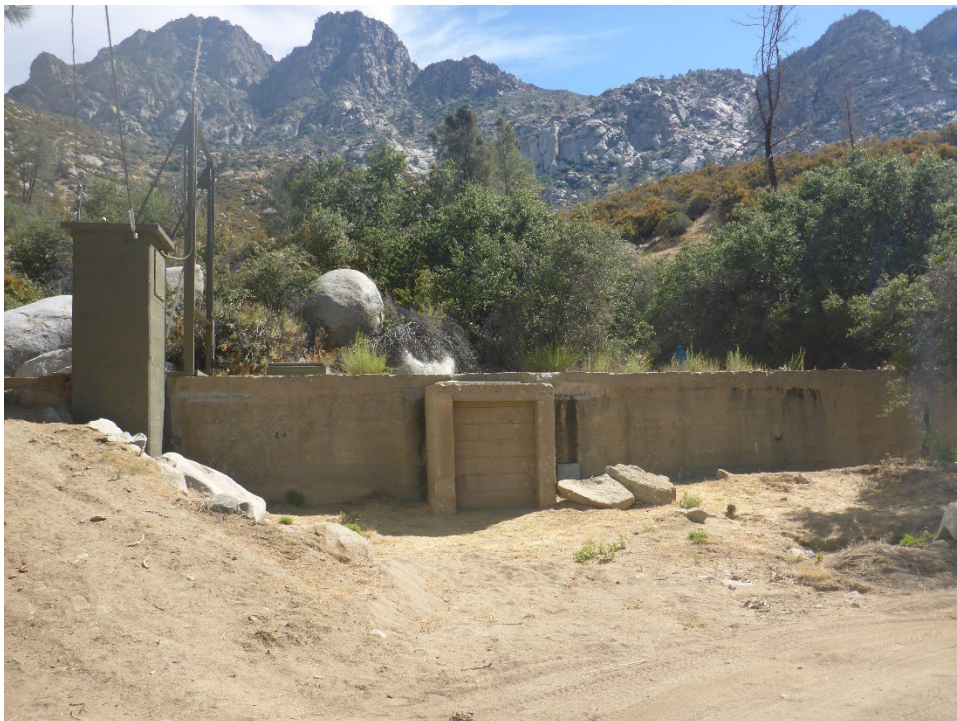
Figure A-10. Tunnel 6/7 Spoil Site showing exposed tunnel section built through drainage swale; upslope side filled to top of tunnel with sediment (view looking upslope from below tunnel).

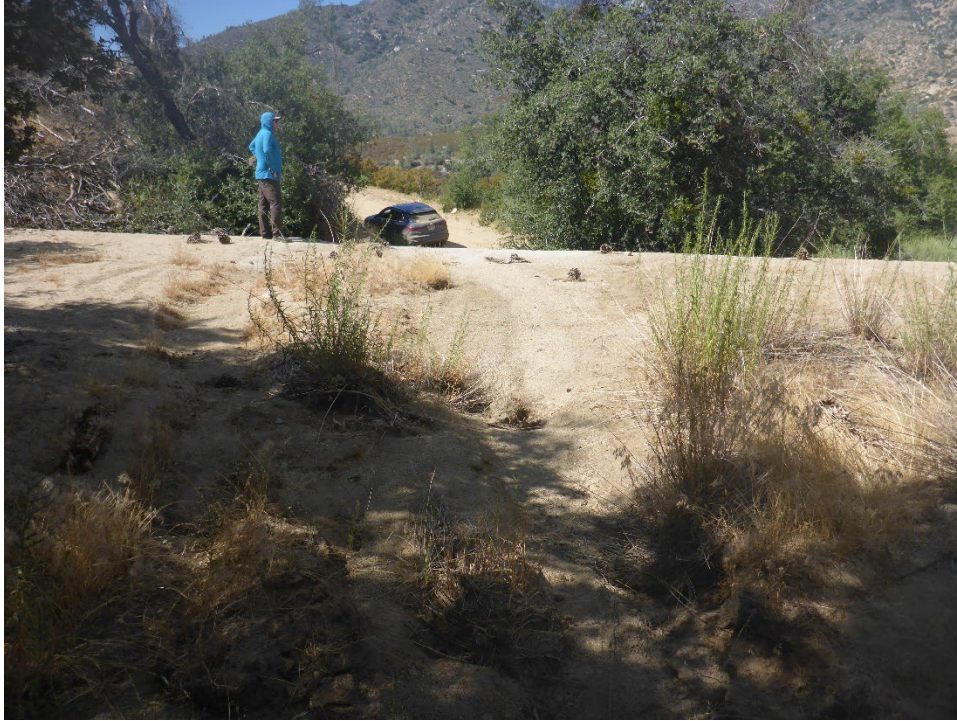
Figure A-11. Tunnel 6/7 Spoil Site showing exposed tunnel section built through drainage swale; upslope side filled to top of tunnel with sediment (view looking downslope from above tunnel).

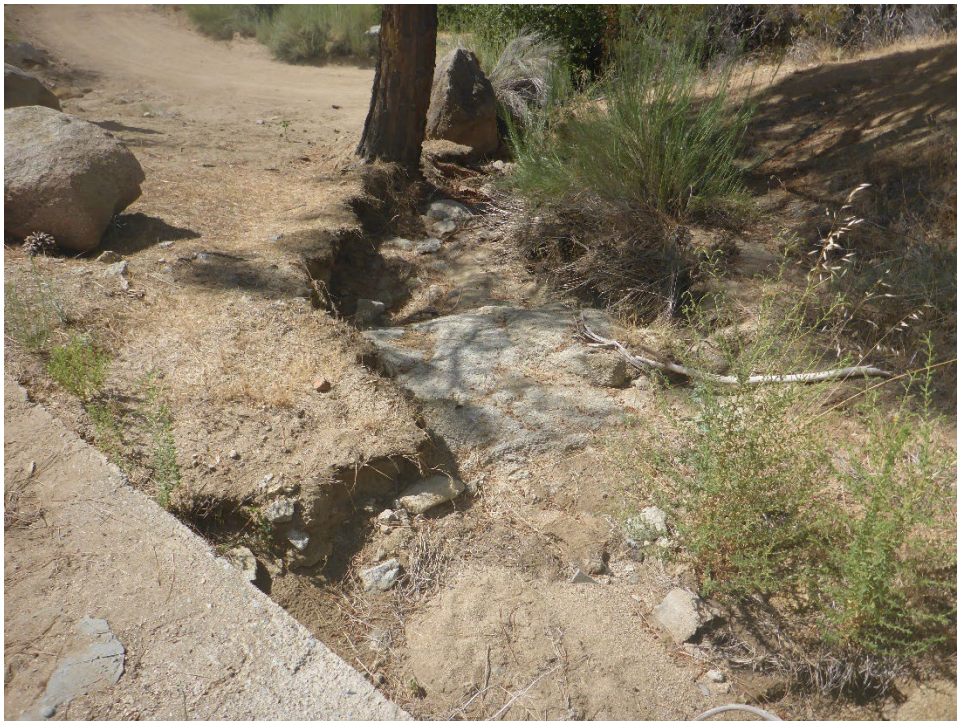
Figure A-12. Minor surface erosion at exposed tunnel section from disrupted drainage patterns.

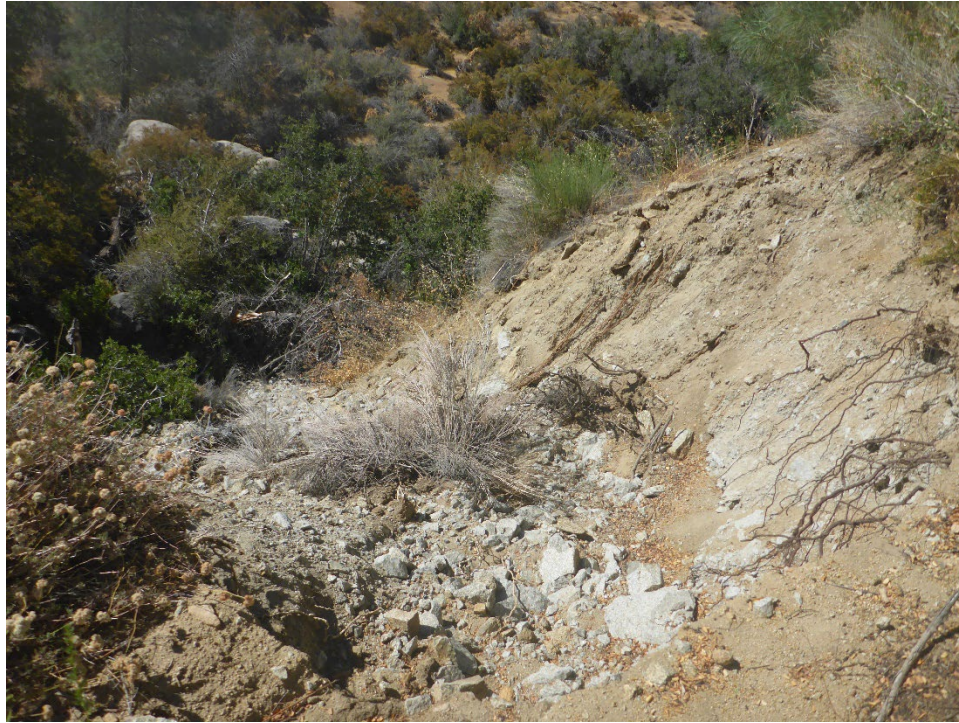
Figure A-13. Small failure in outboard edge of spoil pile fill pad at Tunnel 6/7 Spoil Pile Site; erosional feature located near the farthest downstream edge of spoil pile.

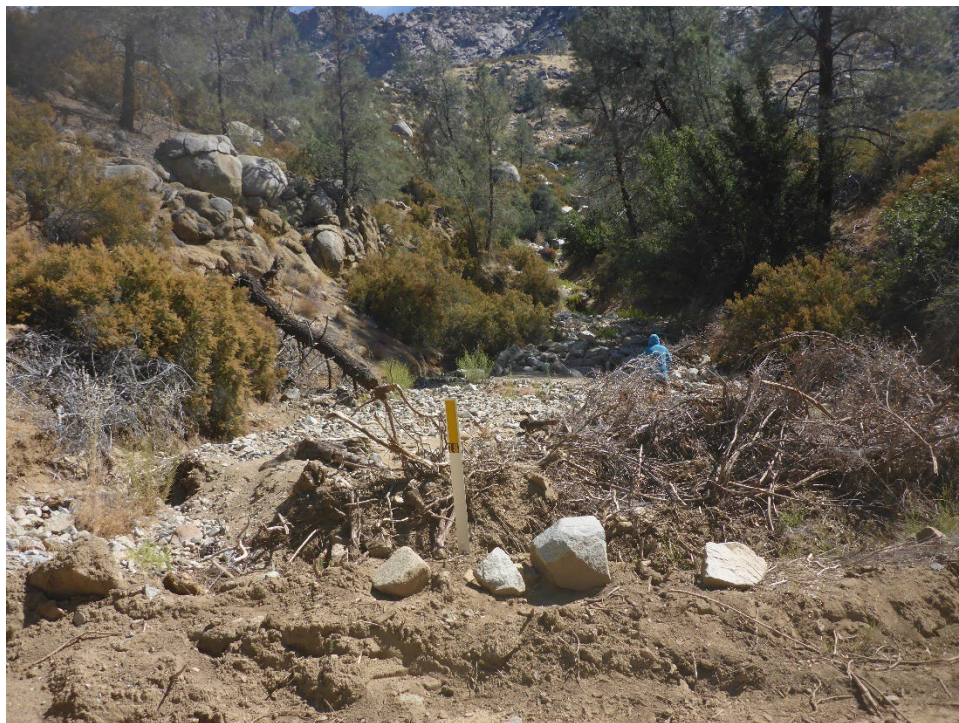
Figure A-14. Sediment and debris accumulation at Tunnel 8A Site (view looking up drainage channel from road crossing).

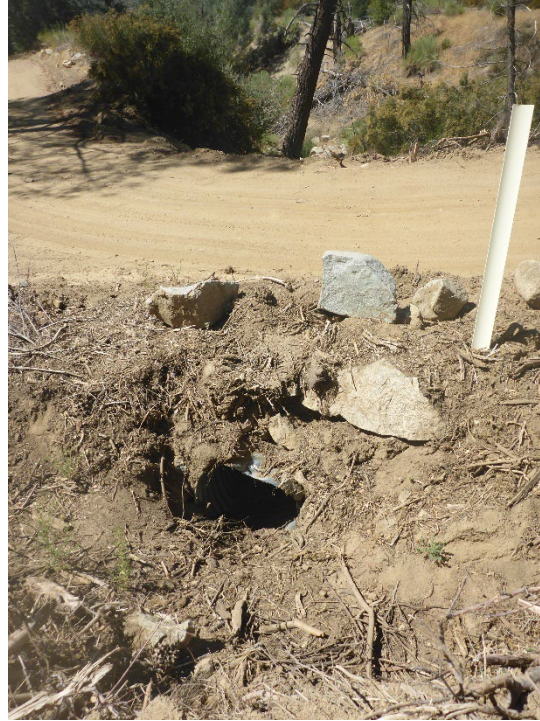
Figure A-15. Recently replaced culvert at Tunnel 8A Site (view looking downstream). Figure A-14 Image photographed from center of road (see witness post for reference).

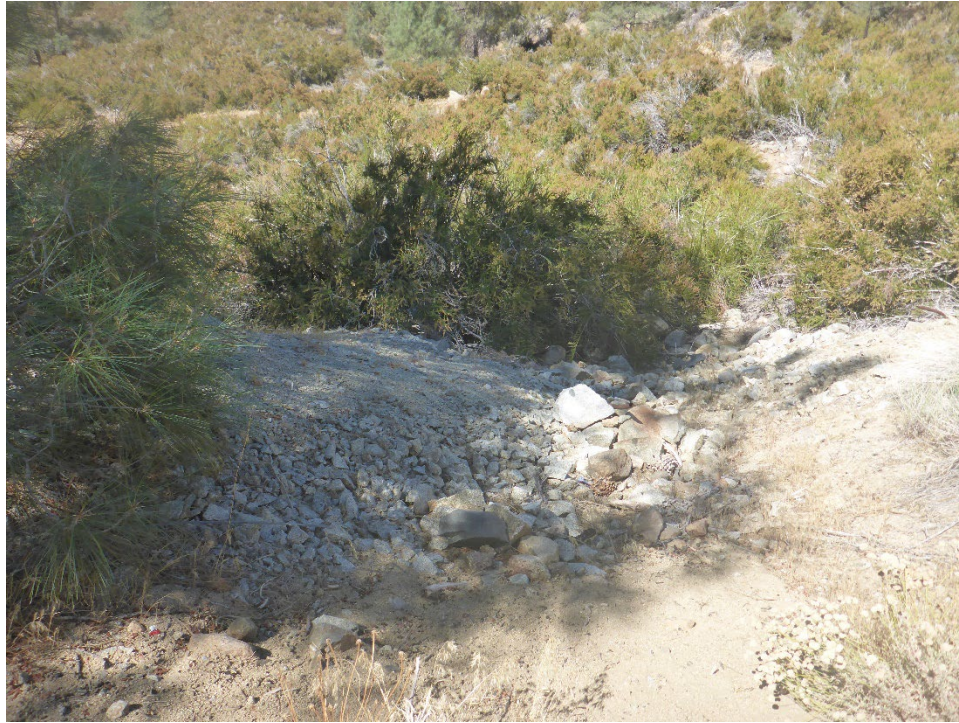
Figure A-17. Downslope margin of tunnel 8B spoil pile.

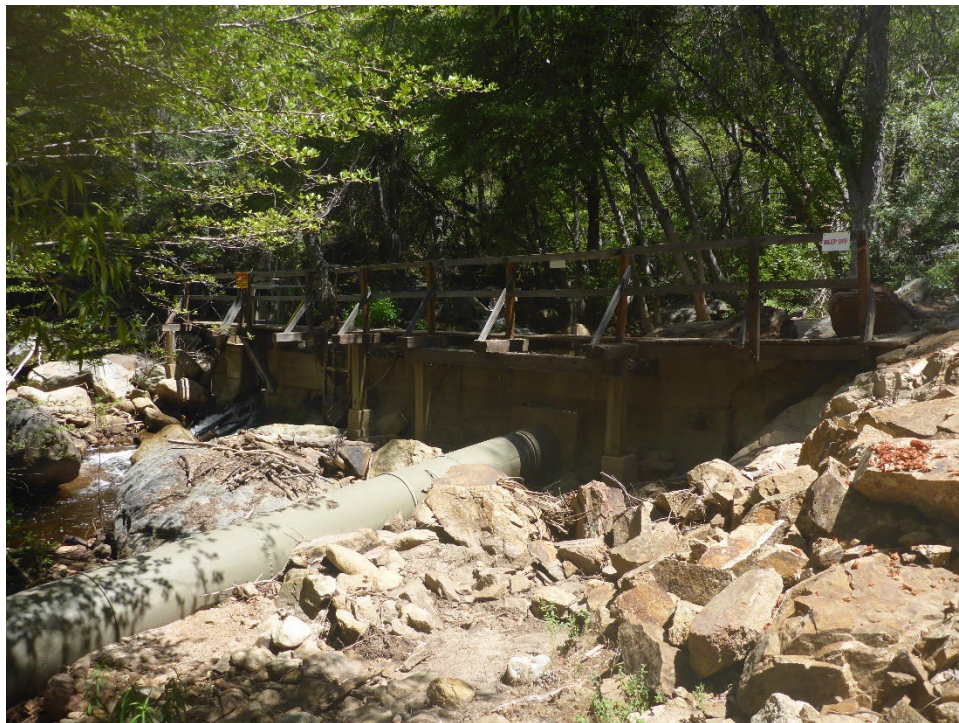
Figure A-18. Downstream side of Salmon Creek Diversion Dam with coarse colluvium from minor rockfall erosion along Left (south) channel margin (view looking upstream).

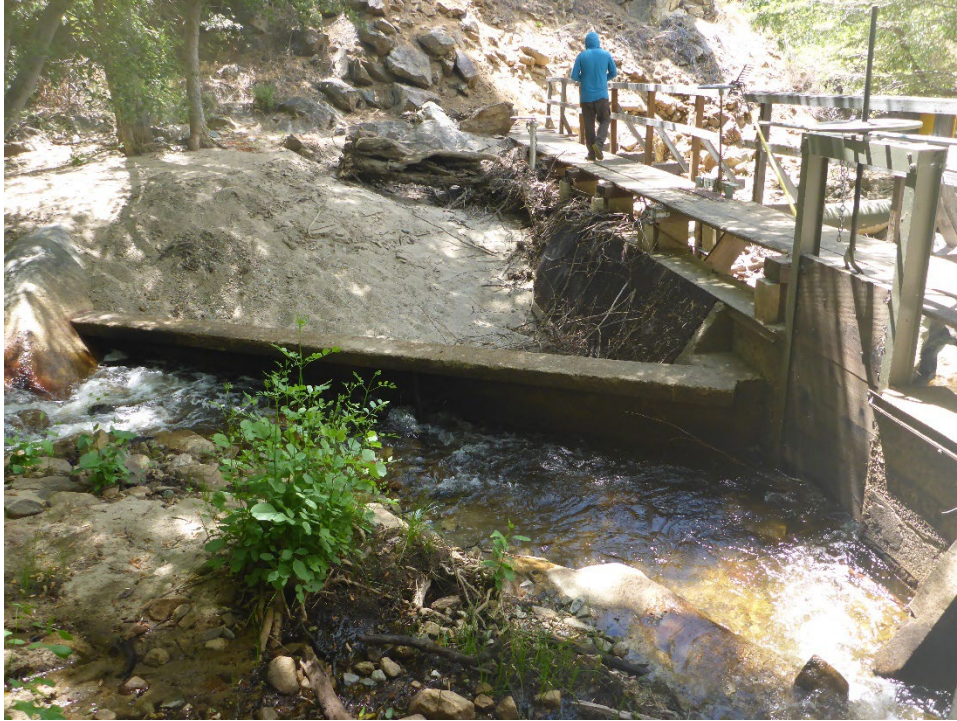
Figure A-19. Upstream side of Salmon Creek Diversion Dam with sand and debris accumulation above Diversion intake structure (view from right bank toward left bank, north to south).

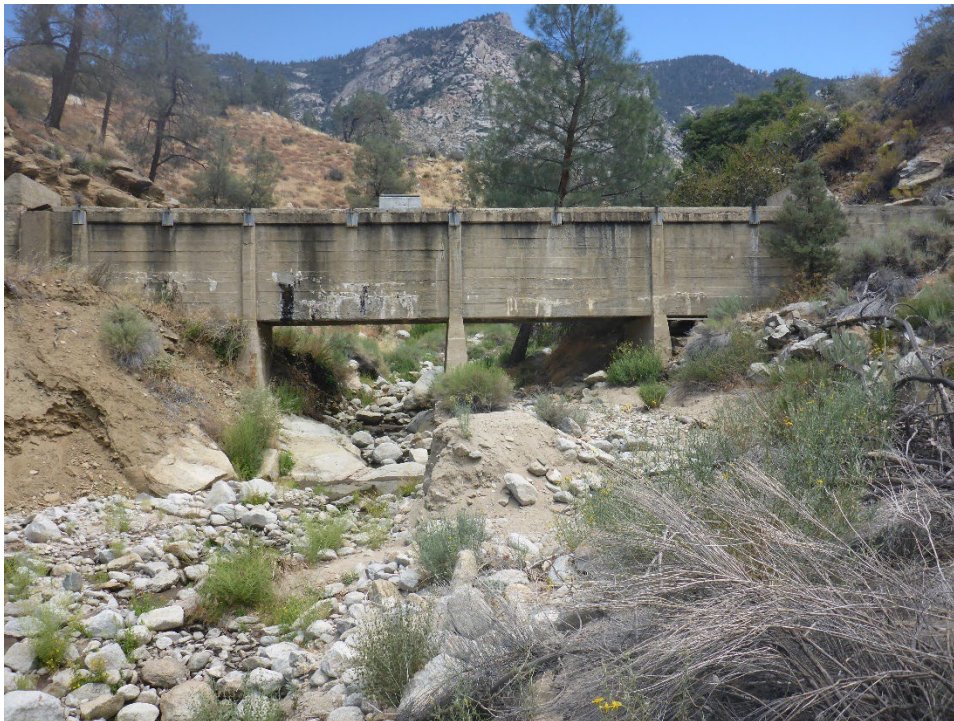
Tunnel 9B/10 Spoil Site	A-22 to A-25	N/A	N/A	Failed road crossing immediately downstream of an exposed section of Tunnel 9B/10 Spoil Site. Legacy material from tunnel excavation was likely placed directly in the watercourse and the road crossing was built with spoil material. Based on review of satellite imagery, the failure occurred sometime between April 2010 and April 2013. An unnamed tributary continues to erode the spoil material. See Section 5.5, Erosion Concerns and Impassable Road Sections, in the <i>LAND-1 Road Condition Assessment Interim Technical Memorandum</i> (Attachment R of this Initial Study Report).
Corral South Tunnel 18 Spoil Site	A-48 to A-49	1-2	100	Surface erosion and direct delivery of sediment to watercourse at Corral South Tunnel 18 Spoil Site. Legacy spoil pile placed directly within watercourse; subsequent channelization through legacy spoil pile develops steep banks and active erosion of the toe and spoil pile margins.

Figure A-22. Failed road crossing at Tunnel 9B/10 Spoil Site (view looking upstream from historical road–stream crossing location).

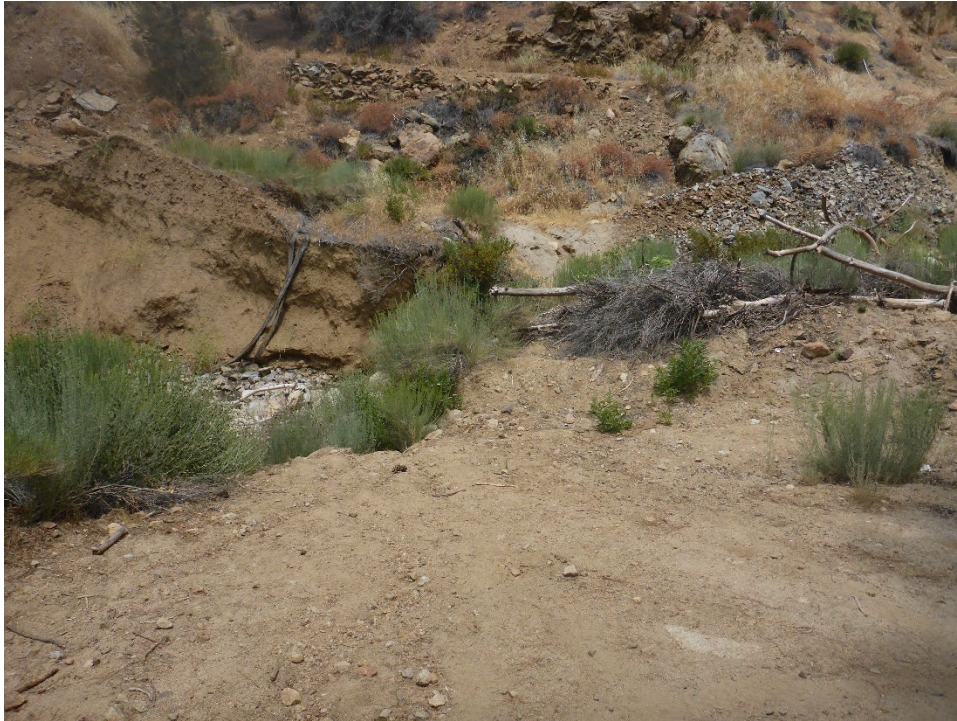
Figure A-23. Failed road crossing at Tunnel 9B/10 Spoil Site (view looking across channel at right bank [north side]).

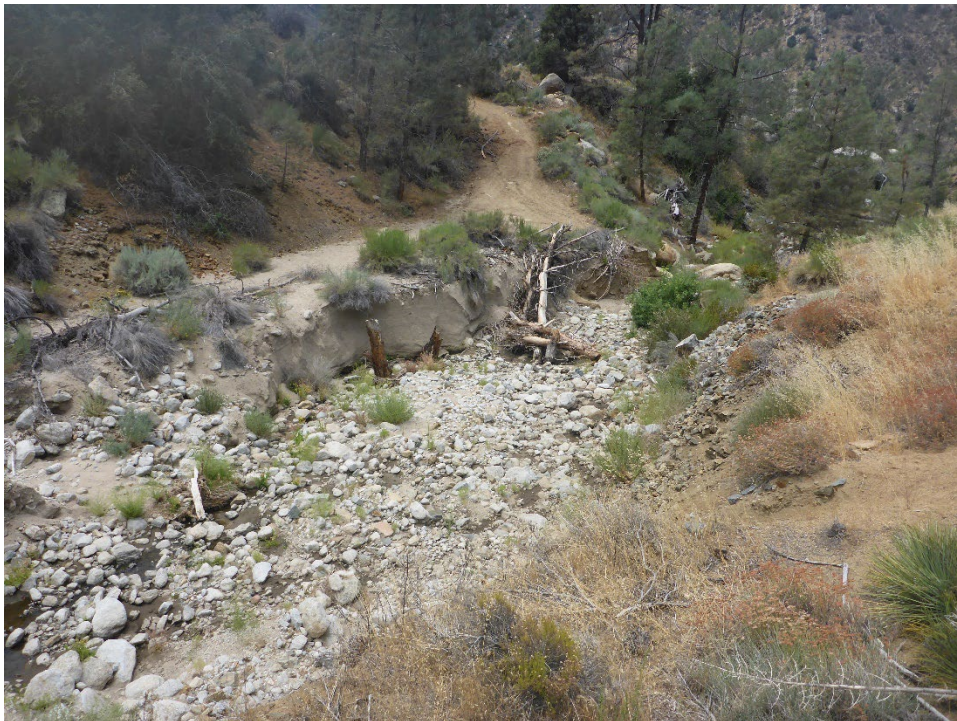
Figure A-24. Failed road crossing at Tunnel 9B/10 Spoil Site (view looking across channel at left bank [south side]).

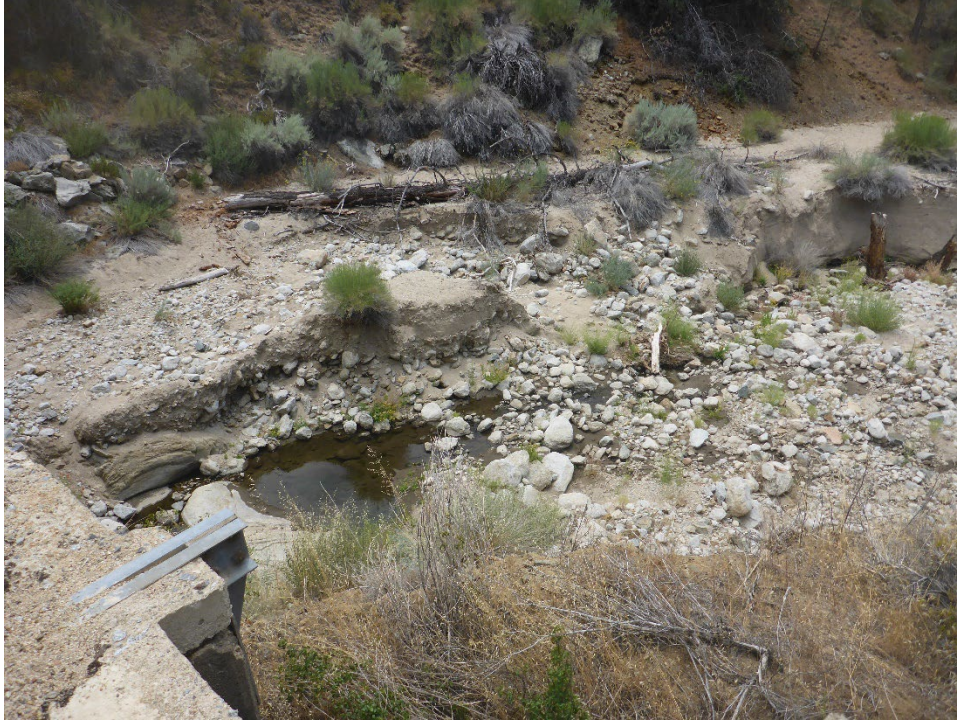
Figure A-25. Close-up view of failed road Crossing at Tunnel 9B/10 Spoil Site (view looking across channel at left bank [south side]).

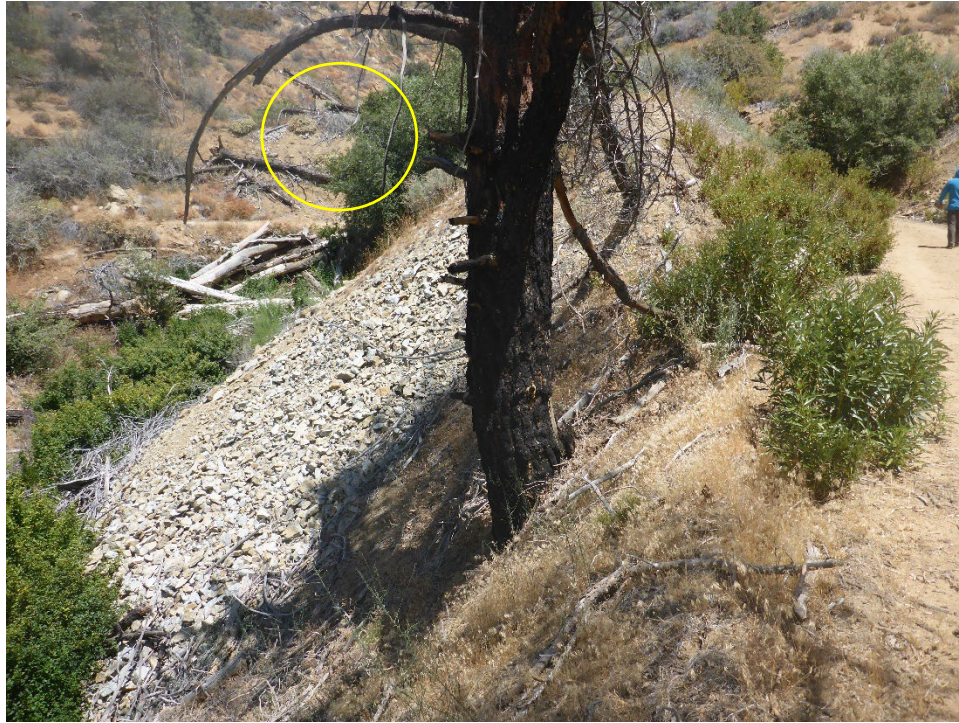
Figure A-27. Access road cut through historical coarse spoil pile material at Tunnel 10 Spoil Site (view looking upstream from left bank [south side]). Small section of exposed tunnel visible (circled in yellow), near location of Figure A-26 Image.

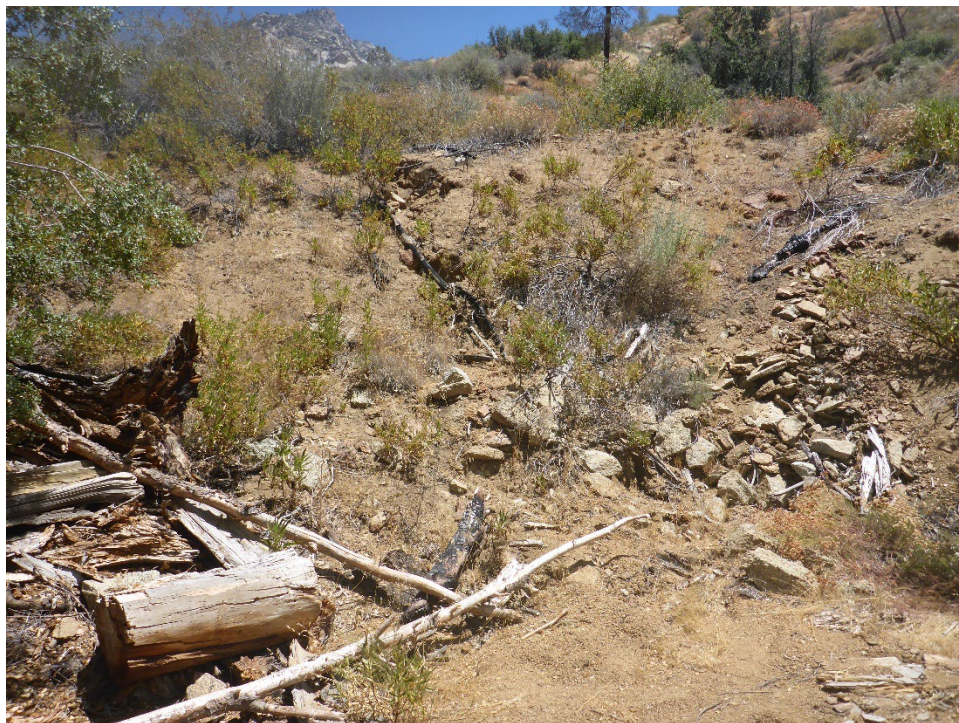
Figure A-28. Small gully formed in road-cut embankment in historical spoil pile at Tunnel 10 Spoil Site; sediment delivered to road surface.

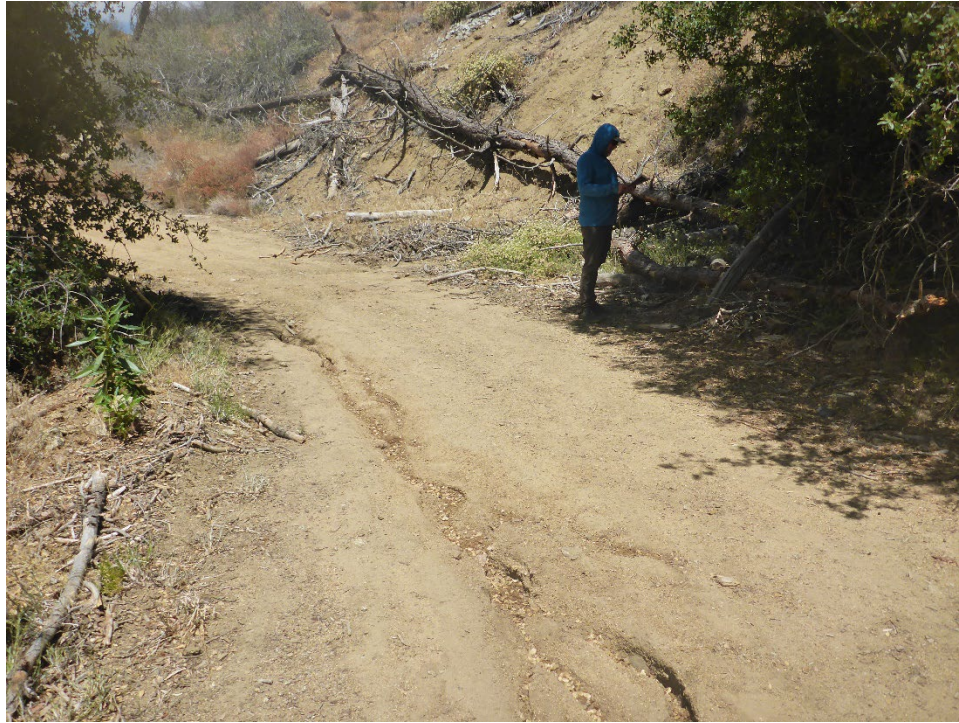
Figure A-29. Minor rilling cut into road surface at Tunnel 10 Spoil Site.

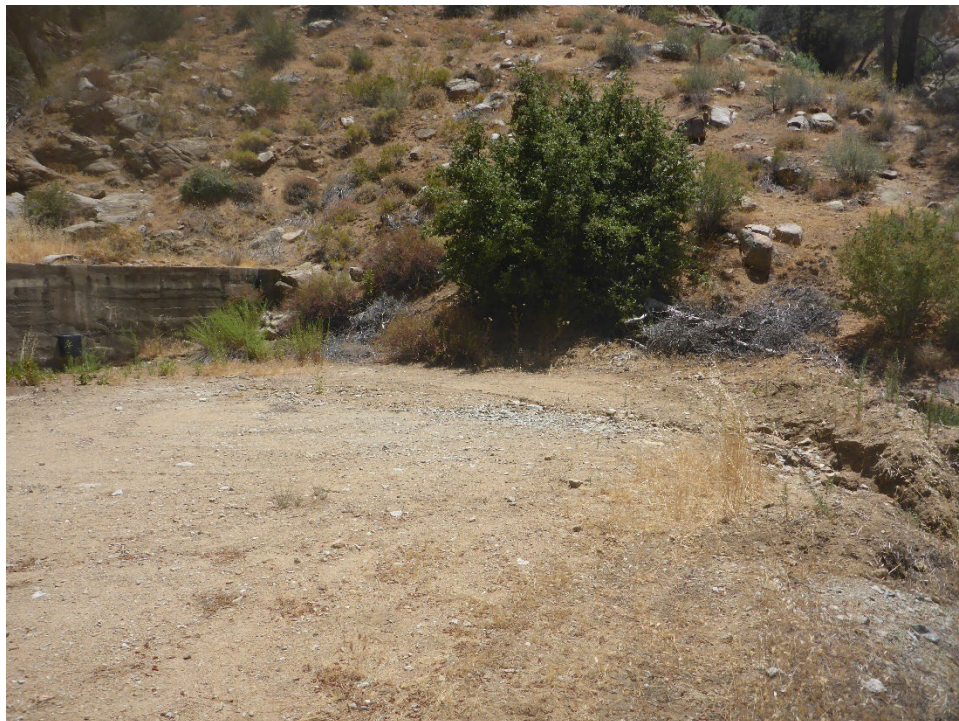
Figure A-30. Tunnel 11 Spoil Site with minor surface erosion along outboard edge of roadbed built on spoil pile pad (view looking upslope).

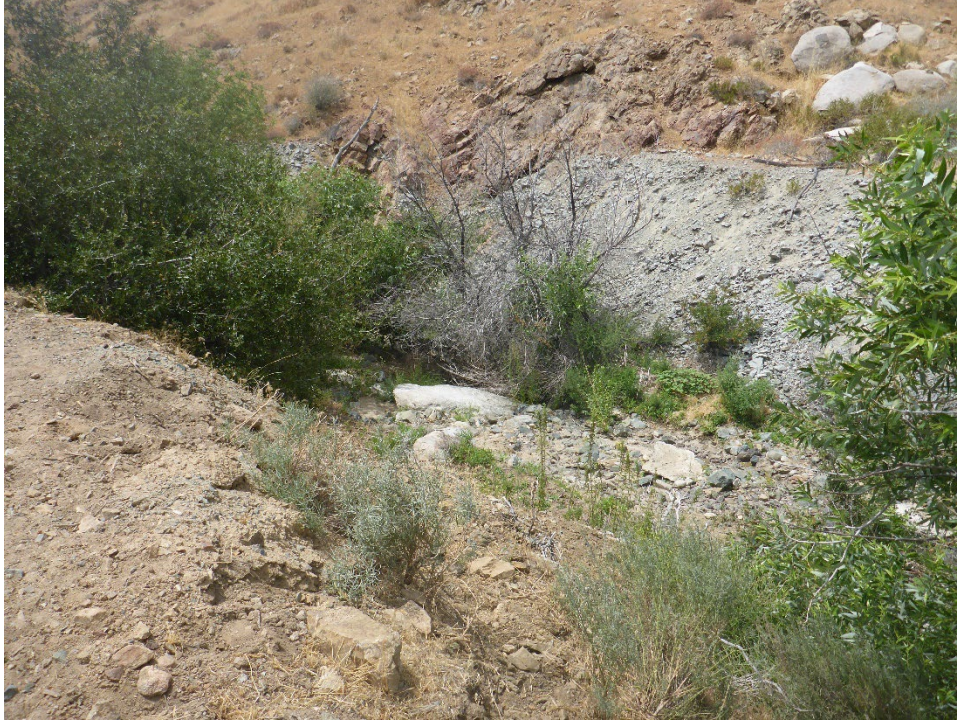
Figure A-35. Spoil Material Exposed along right bank (north side) of Gold Ledge Creek at Tunnel 13/14 Spoil Site; low-to-moderate erosion activity accelerated by cattle crossing trails down embankment (view looking across creek).

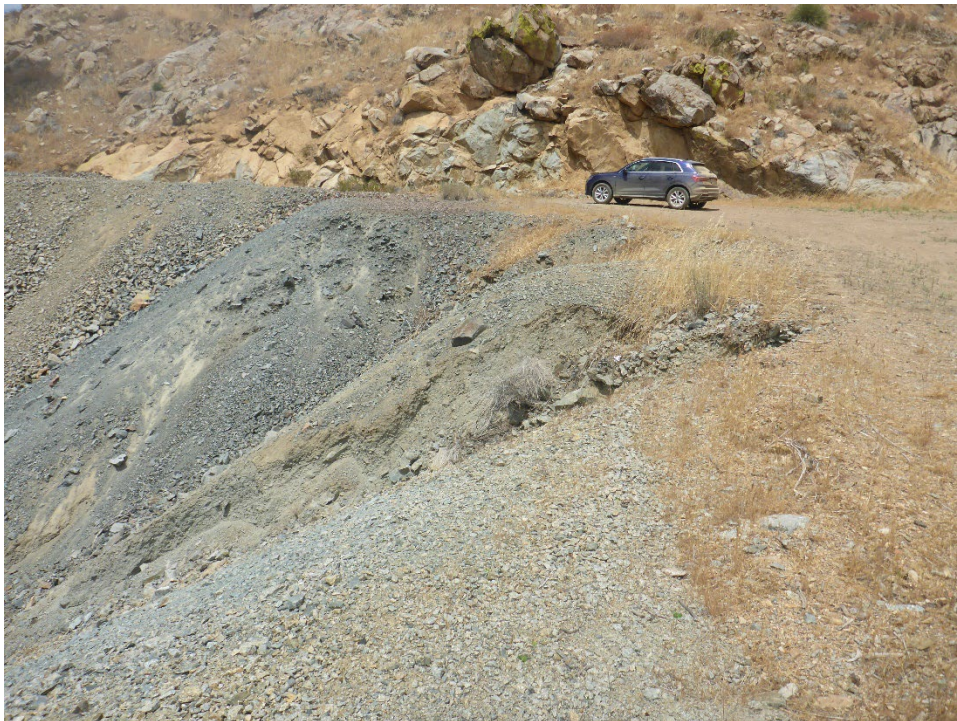
Figure A-36. Moderate erosion of coarse spoil material placed in steep drainage swale at Tunnel 14 Spoil Site; sediment delivered directly to watercourse.

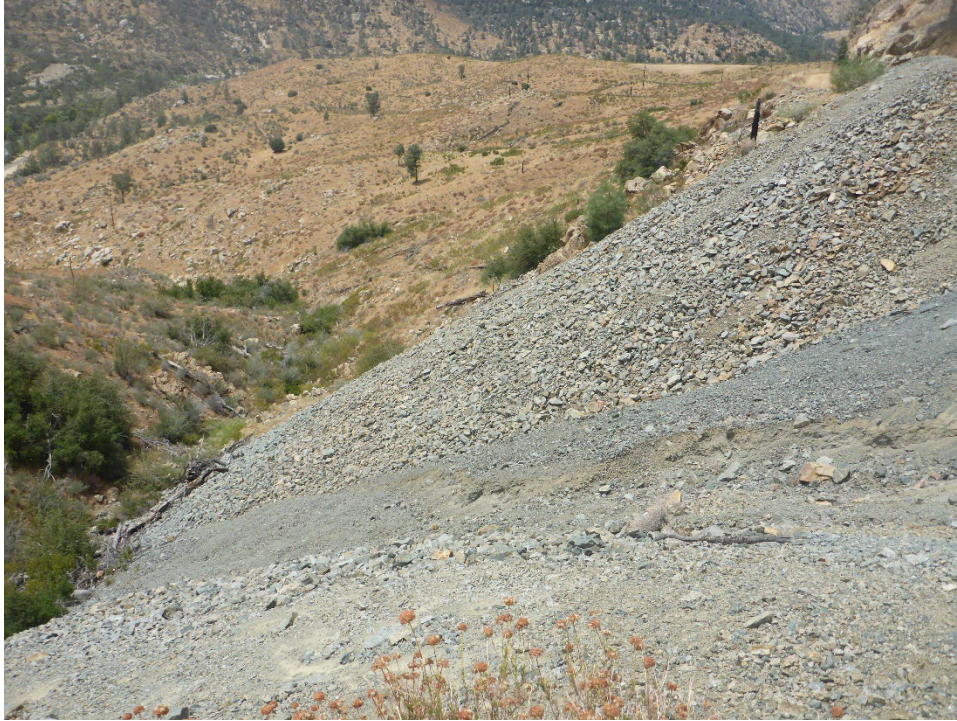
Figure A-37. Close-up view of erosion into Tunnel 14 spoil material.

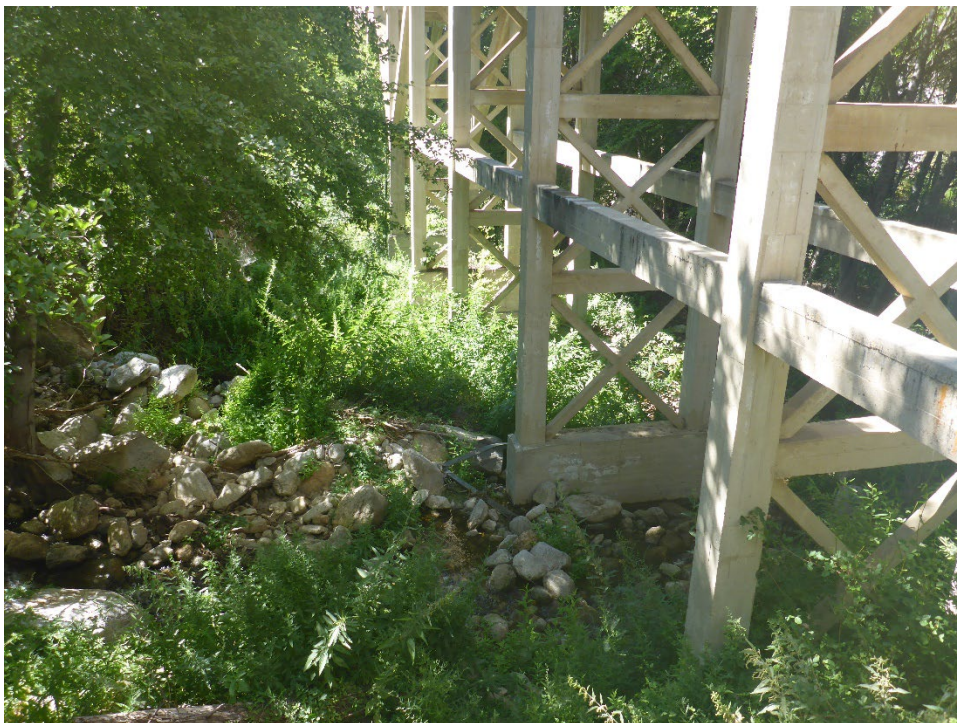
Figure A-44. Concrete footings of elevated flume with minor erosion and sedimentation at Corral Creek crossing.

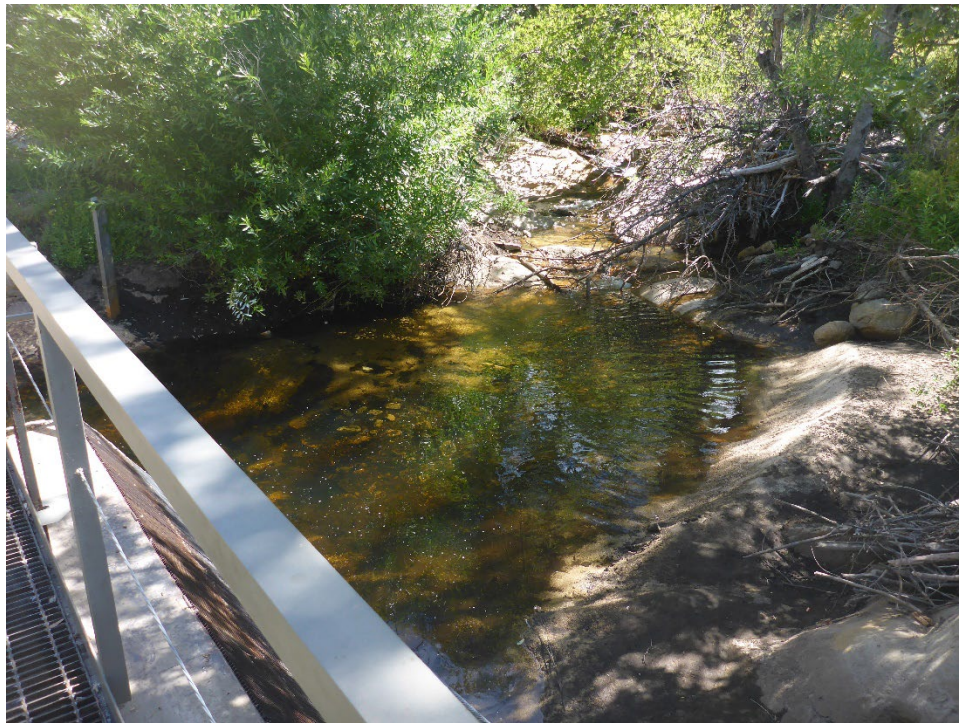
Figure A-46. Minor sand and debris accumulation on the upstream face of Corral Creek Diversion Dam.
