GEO-1 EROSION AND SEDIMENTATION TECHNICAL MEMORANDUM

**KERN RIVER No. 3 HYDROELECTRIC PROJECT
*FERC PROJECT No. 2290***

October 2023

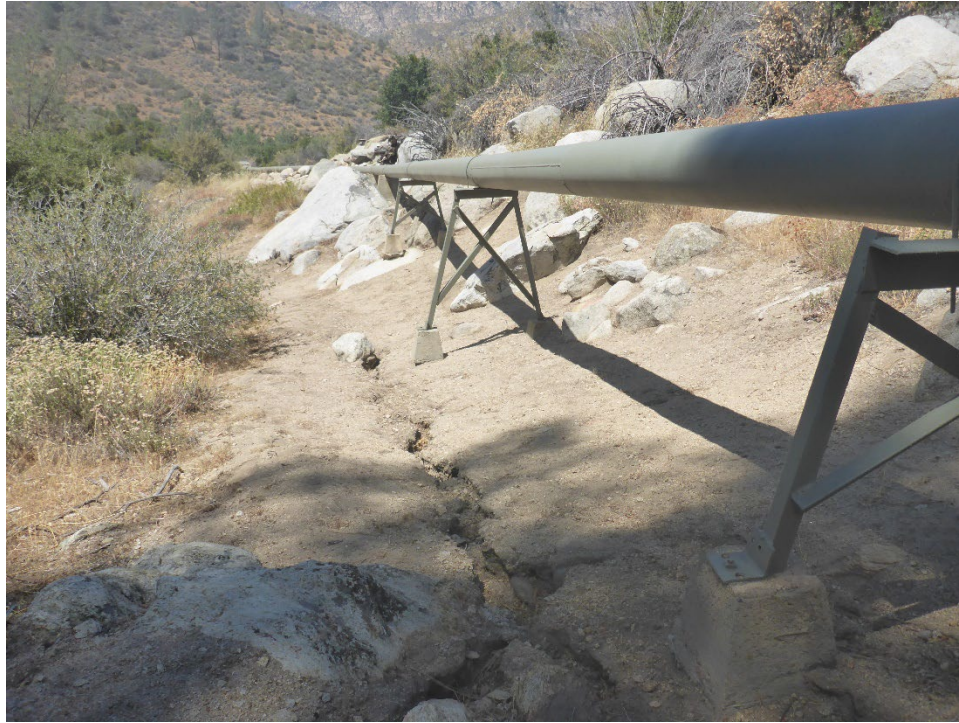
Figure A-47. Small gully erosion along Corral Creek Diversion Tunnel, approximately 300 feet upslope of point where diversion empties into exposed tunnel structure.

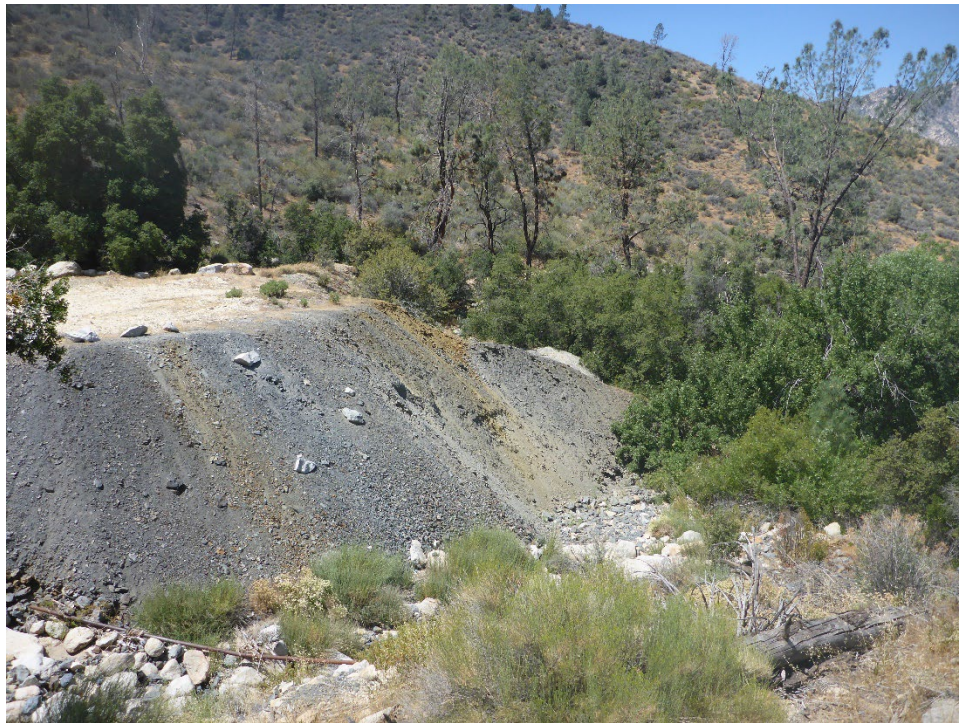
Figure A-48. Moderate erosion of left bank (south side) of Corral South Tunnel 18 Spoil Site; sediment delivered directly to the watercourse.

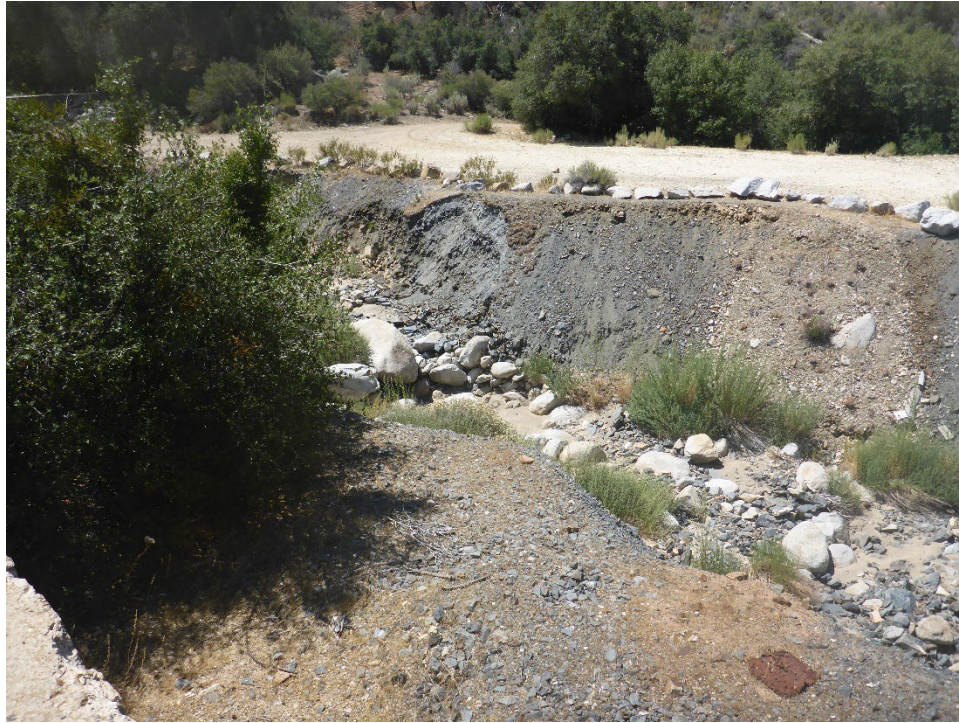
Figure A-49. Additional view of moderate erosion along left bank (south side) of Corral South Tunnel 18 Spoil Site (view immediately adjacent to left of Figure A-48 image).

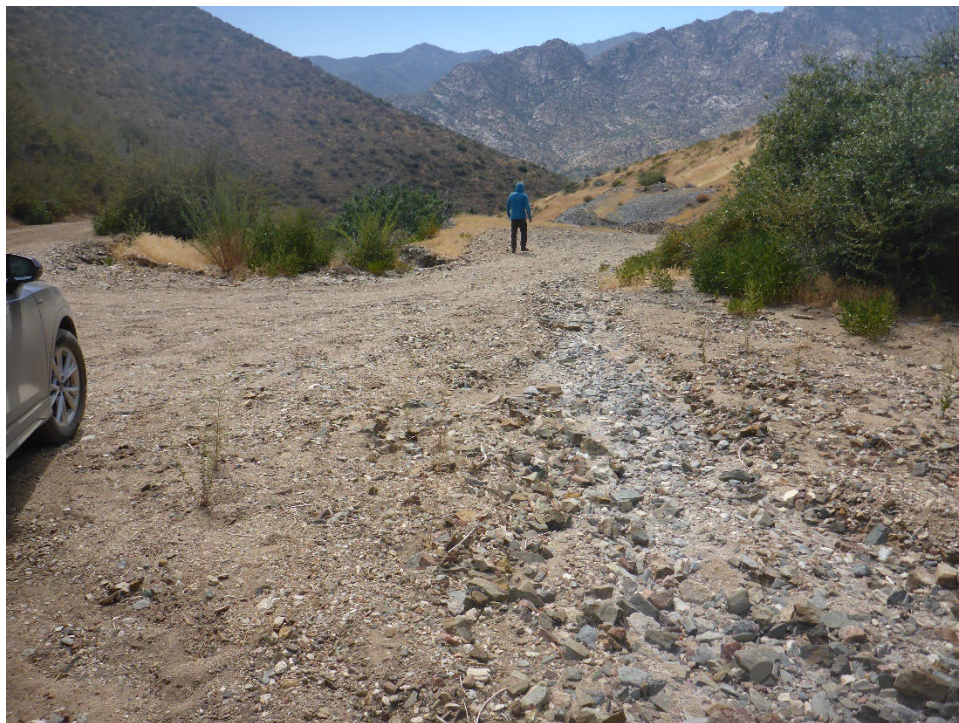
Figure A-50. Tunnel 18/19 Spoil Site with moderate surface erosion of spoil caused by disrupted surface drainage patterns from exposed tunnel section (view from downstream).

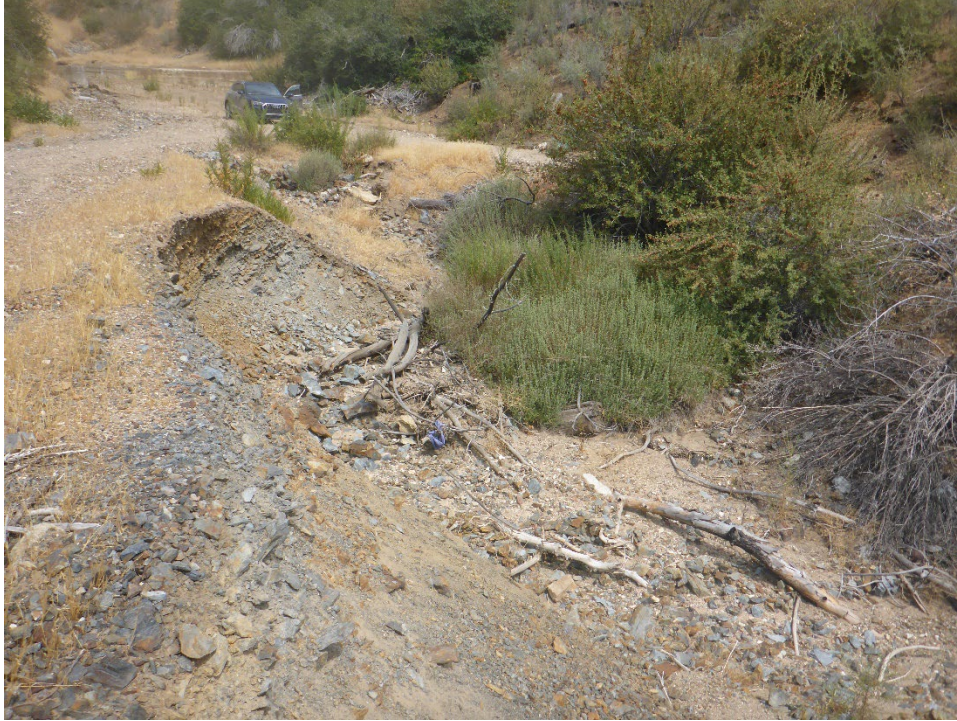
Figure A-51. Semi-active erosion of Tunnel 18/19 Spoil Site along watercourse margin; exposed tunnel section that disrupts surface drainage pattern visible in background behind vehicle (view upstream).

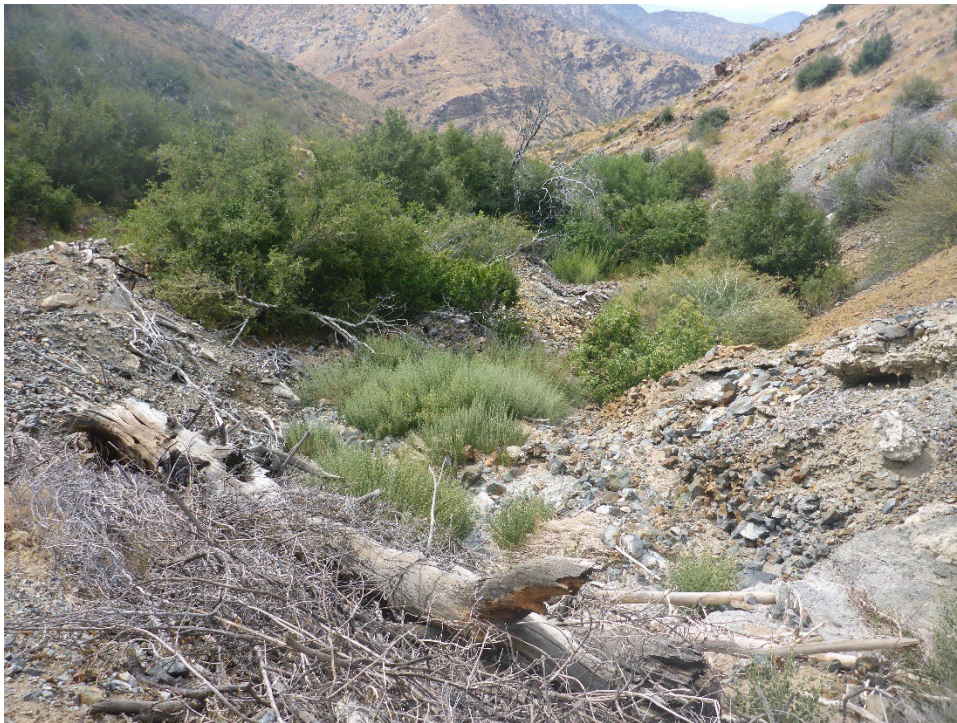
Tunnel 19/20 Spoil Site	A-52 to A-53	N/A	N/A	Legacy spoil material placed directly in watercourse where exposed tunnel section crosses unnamed drainage swale. Spoil material is actively being reworked and captured by run-off, and the disrupted surface drainage patterns are forcing run-off across road. A small gully is forming within the inboard ditch of the access road (Figure A-53). See results from Appendix A, <i>Project and Shared Access Roads</i> , in the <i>LAND-1 Interim Tech Memo</i> .
KR3 Spillway Channel	A-56 to A-63	N/A	N/A	Spillway channel formed in native hillslope colluvial mantle. Majority of erosion and sedimentation occurred shortly after operations began in 1921 according to historical records. Spillway channel banks continue to actively erode but at low rates. Numerous knickpoints were observed but are generally stable.

Figure A-52. Spoil material and debris at Tunnel 19/20 Spoil Site with moderate erosion of spoil material on both margins of watercourse.

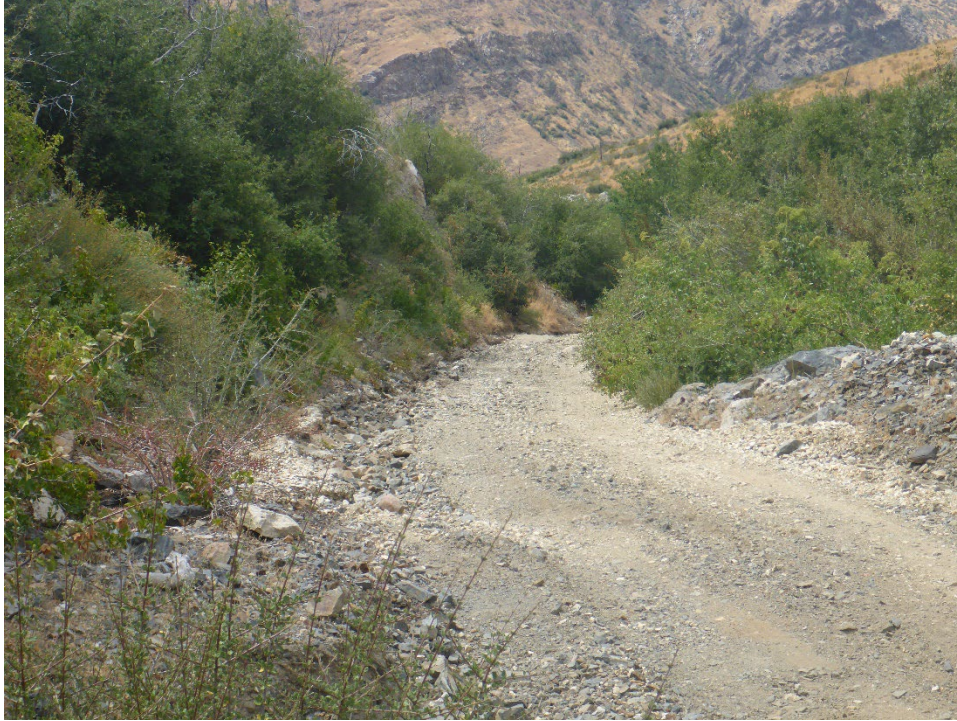
Figure A-53. Active erosion of inboard ditch along access road to Tunnel 19/20 Spoil Site.

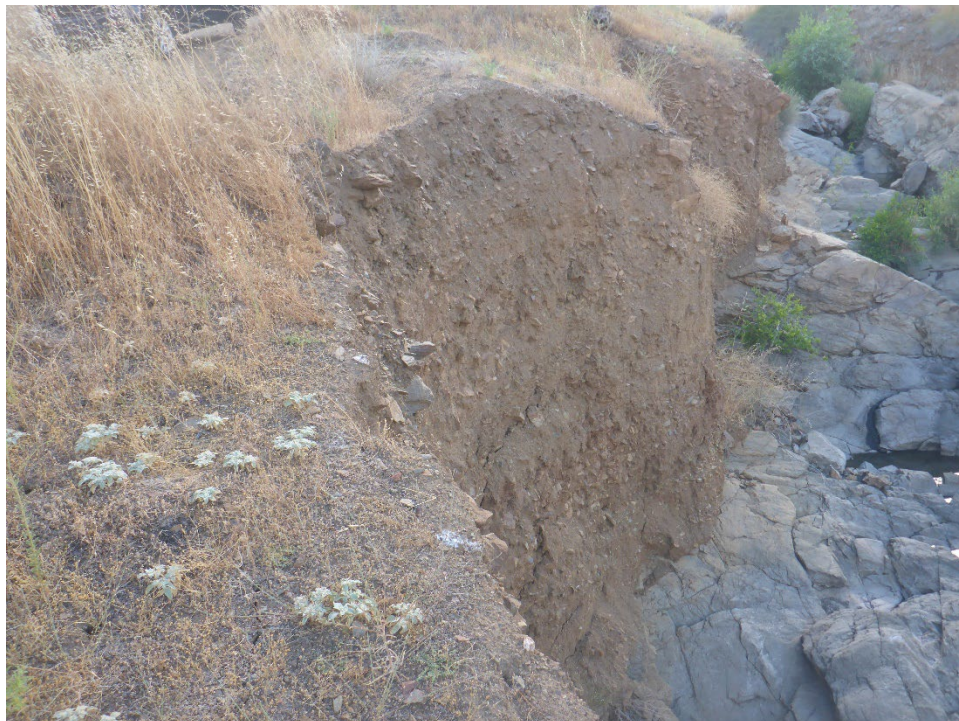
The KR3 Powerhouse Forebay Spillway channel was identified as an area of concern for potential active erosion and sedimentation based on communication with Stakeholders. The KR3 Powerhouse Forebay Spillway channel is formed in native hillslope soils and colluvium from direct surface discharge released at the end of the KR3 Conveyance Flowline immediately before the flowline enters the KR3 Powerhouse penstock (Figure 3-1). Over time, water released into the spillway has carved a distinct channel through the hillslope colluvial mantle down to underlying bedrock (Figures A-56 to A-63). The channel averages 40 to 50 feet wide and 10 to 15 feet deep over the entire length of the spillway channel, based on LiDAR measurements. KR3 Powerhouse Forebay Spillway channel enters the Kern River floodplain approximately 1,300 feet upstream of the KR3 Powerhouse. The channel planform pattern and degree of incision appears largely unchanged from 2005 to 2022, based on aerial imagery analysis.

Figure A-56. KR3 Powerhouse Forebay Spillway channel with incision in bedrock and vertical/overhanging banks.

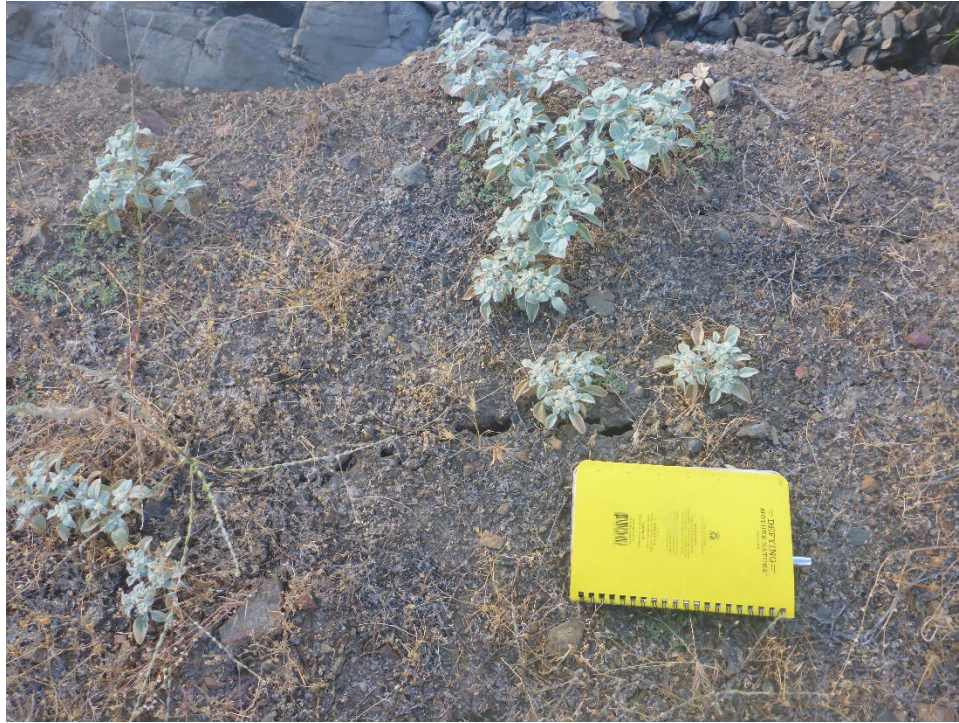
Figure A-57 Tension crack in vertical/overhanging bank of KR3 Powerhouse Forebay Spillway channel (tension crack located at the bottom edge of Figure A-57 image).

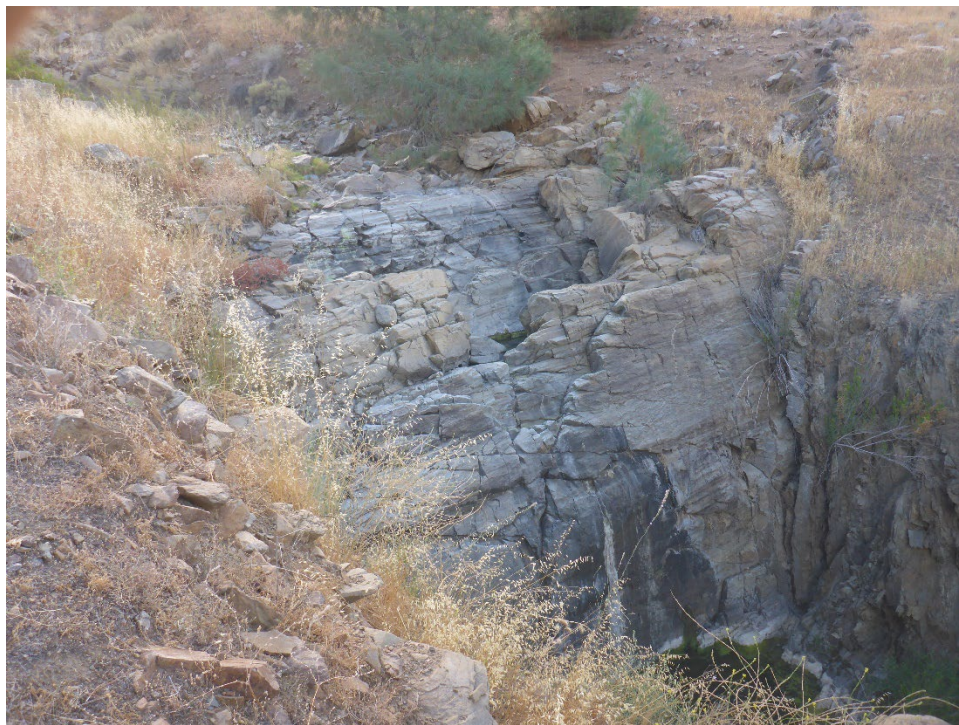
Figure A-58. Knickpoint in KR3 Powerhouse Forebay Spillway channel; few loose or separated blocks in knickpoint face indicate relatively stable feature.

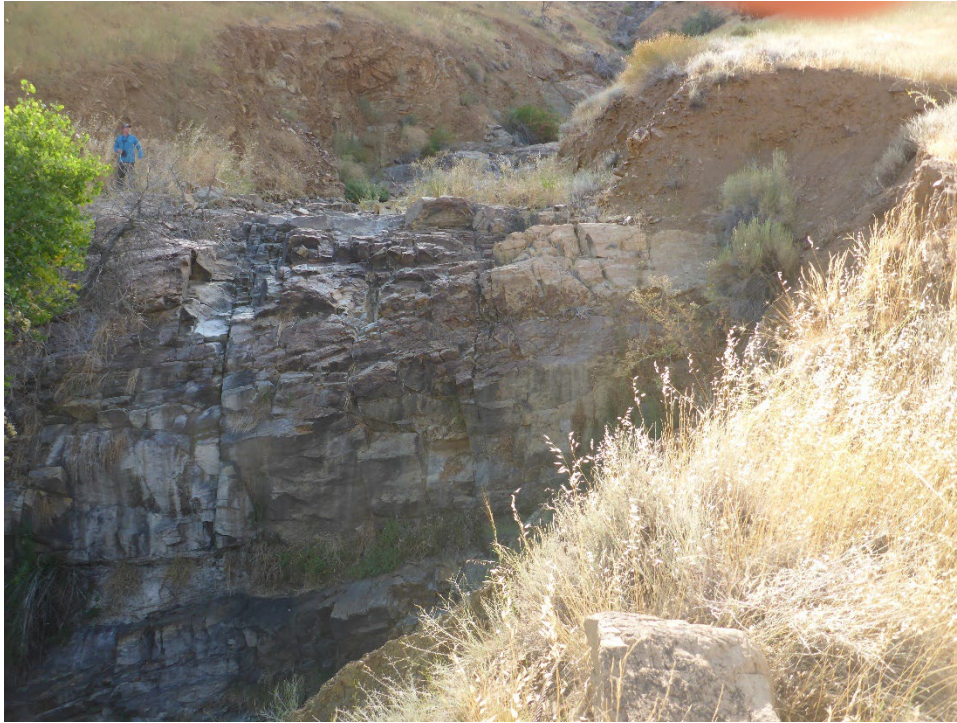
Figure A-59. Second knickpoint in KR3 Powerhouse Forebay Spillway channel.

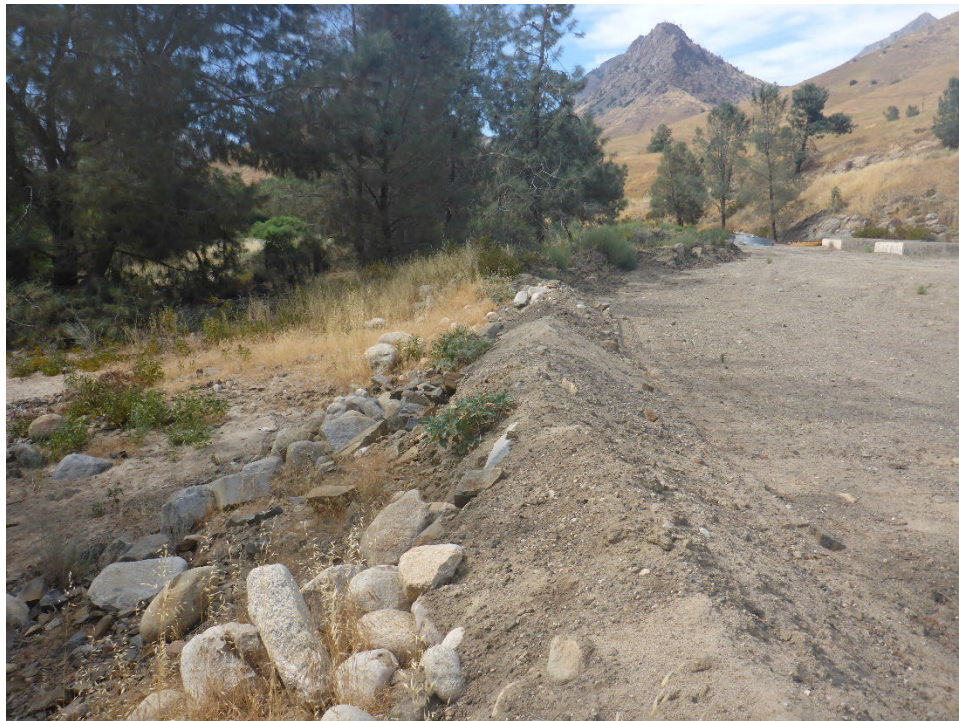
Site	Photographs (Appendix A)	Volume (CY)	% Delivery	Description
KR3 Powerhouse	A-64 to A-68	1-2	100	Scour and bank erosion along KR3 Powerhouse retaining wall and access road. Large volumes of sediment and debris from March 2023 flood accumulated within Kern River floodplain and powerhouse maintenance storage yard.

Figure A-64. Small berm constructed of sediment and debris from the March 2023 flood event deposited at the KR3 Powerhouse maintenance yard.

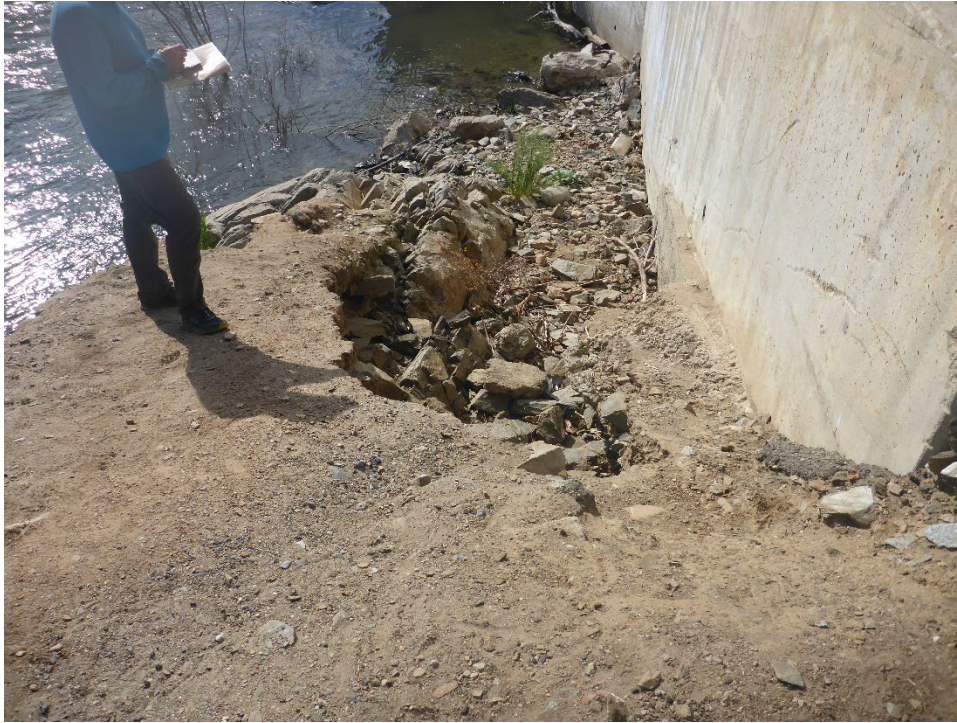
Figure A-65. Scour along base of retaining wall at KR3 Powerhouse access gate.

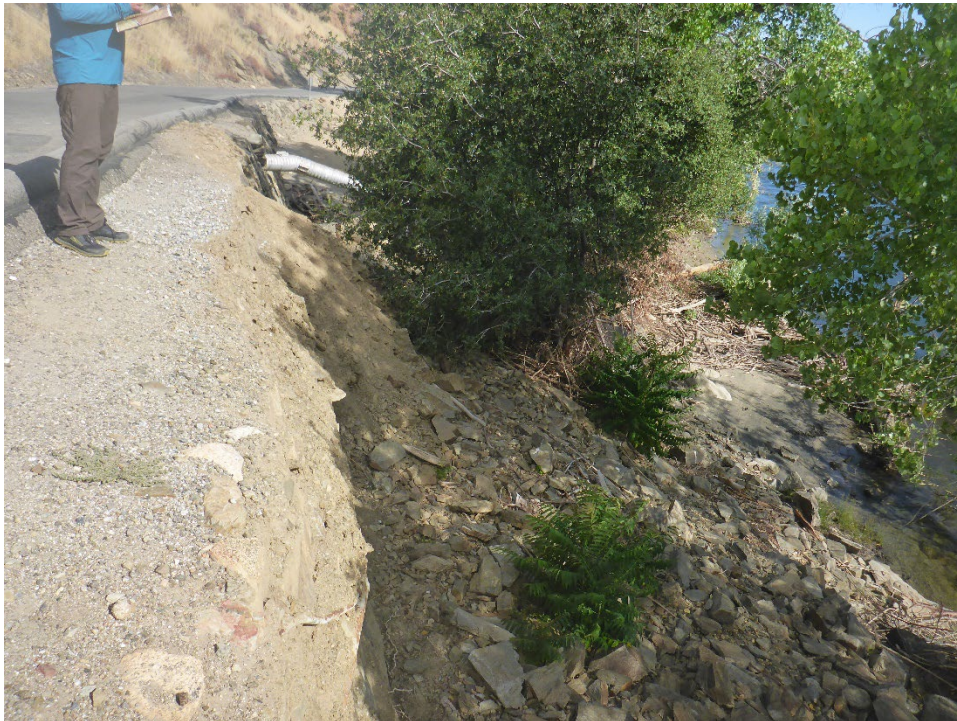
Figure A-66. Potential erosion of road prism fill near KR3 Powerhouse access road and gate.
