LAND 1 – ROAD AND TRAIL CONDITION ASSESSMENT TECHNICAL MEMORANDUM

**KERN RIVER No. 1 HYDROELECTRIC PROJECT
*FERC PROJECT No. 1930***

May 2026

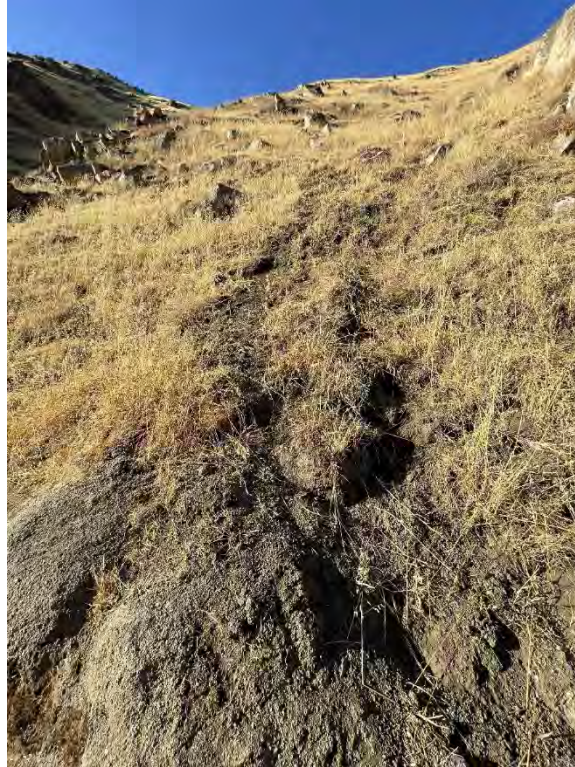
Photo D-1. August 27, 2024. Adit 17 & 18 Trail. Example of hillslope erosion present within steep, grassy trails.

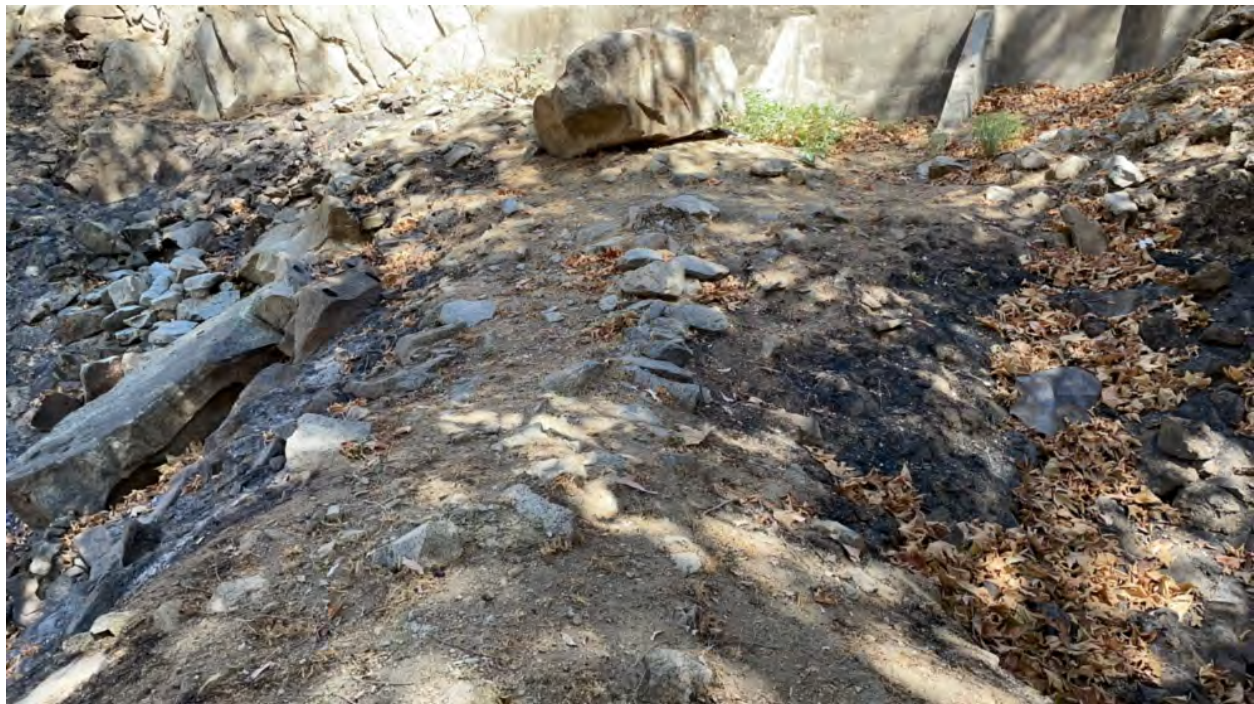
Photo D-2. August 25, 2024. Conduit No. 3 Trail. Burned soil following the July 2024 Borel Fire.

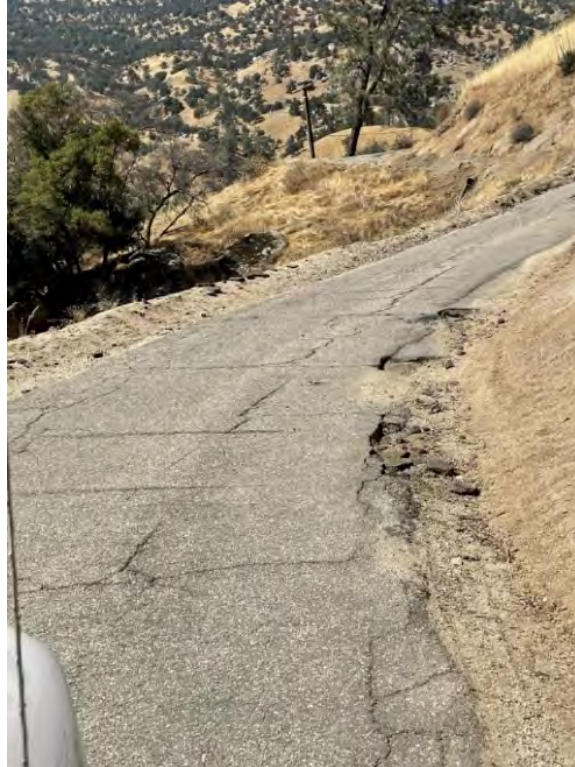
Photo D-3. August 26, 2024. Democrat Dam Road. Example of road surface erosion present throughout this road.

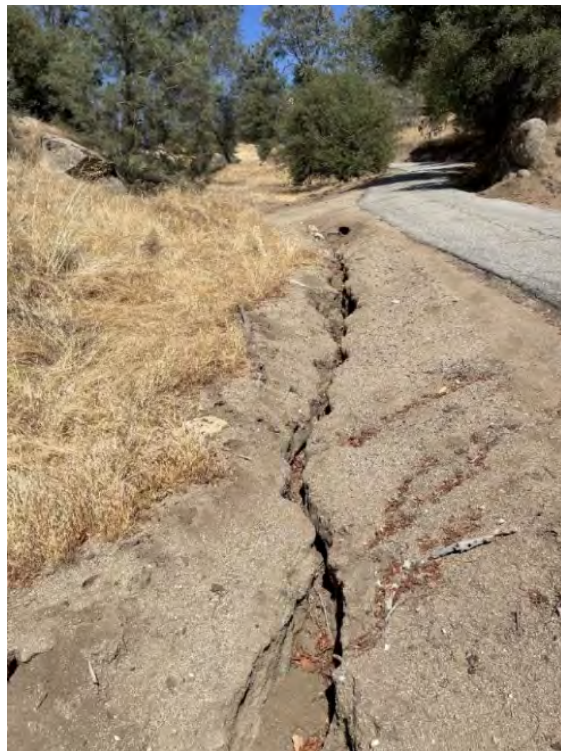
Photo D-4. August 26, 2024. Democrat Dam Road. Gullying present along several hundred feet of roadway below culvert.

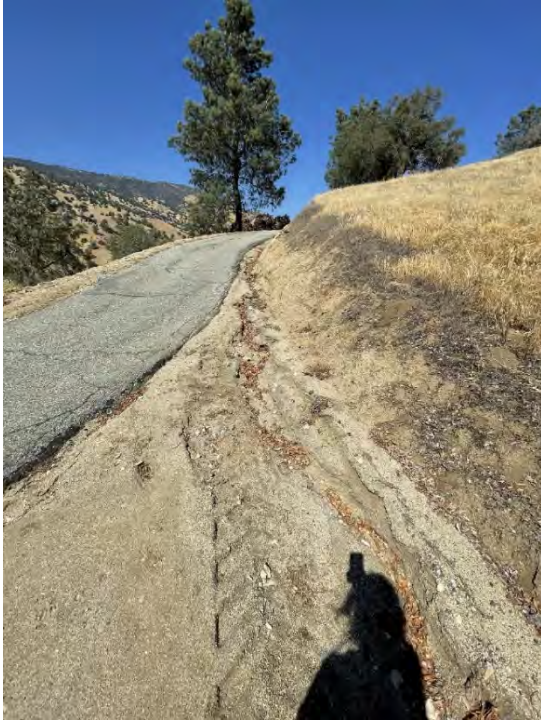
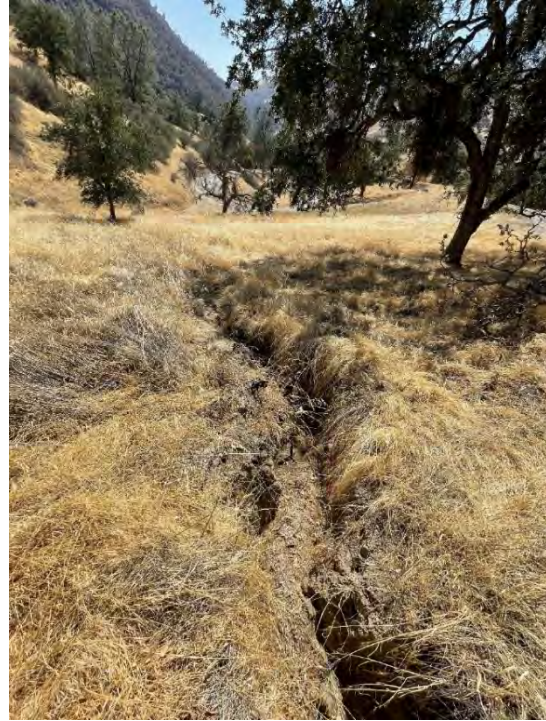
Photo D-5. August 26, 2024. Democrat Dam Road. Gully along shoulder extending into vegetated hillside.

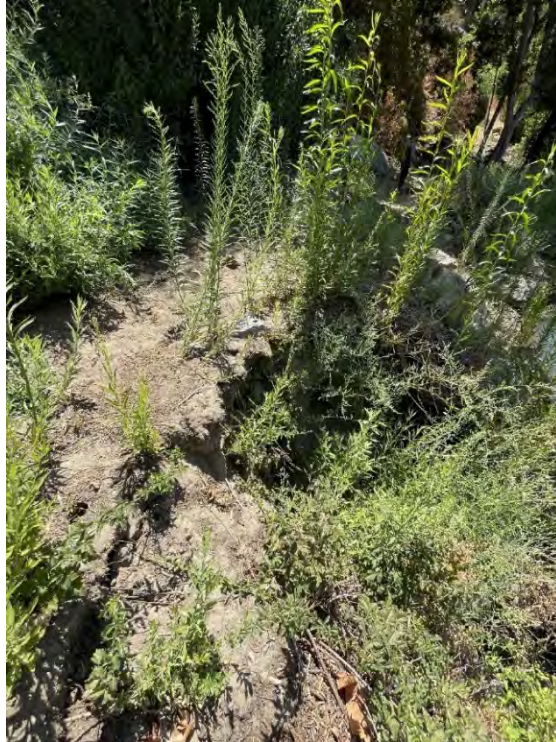
Photo D-6. August 26, 2024. Democrat Gage Trail. Bank failure along trail and overgrown vegetation.

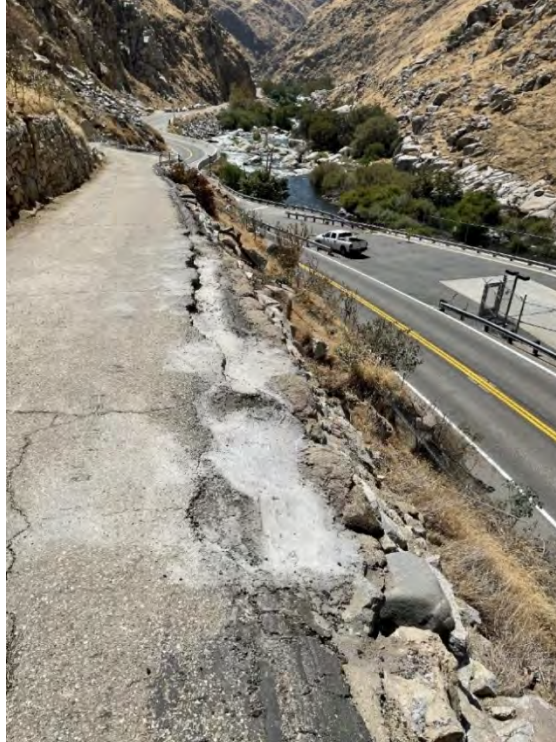
Photo D-7. August 27, 2024. Forebay Operations Area Road. Gap in curb along approximately 20-25 feet of roadway.

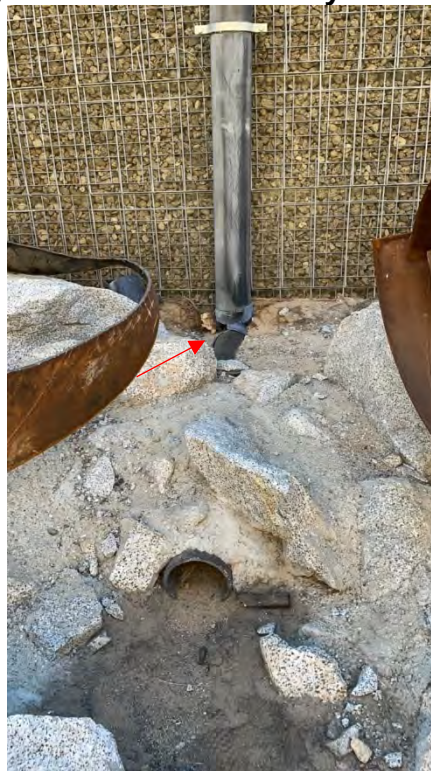
Photo D-8. August 26, 2024. Lower Powerhouse Road. Broken drainpipe (elbow; see red arrow).

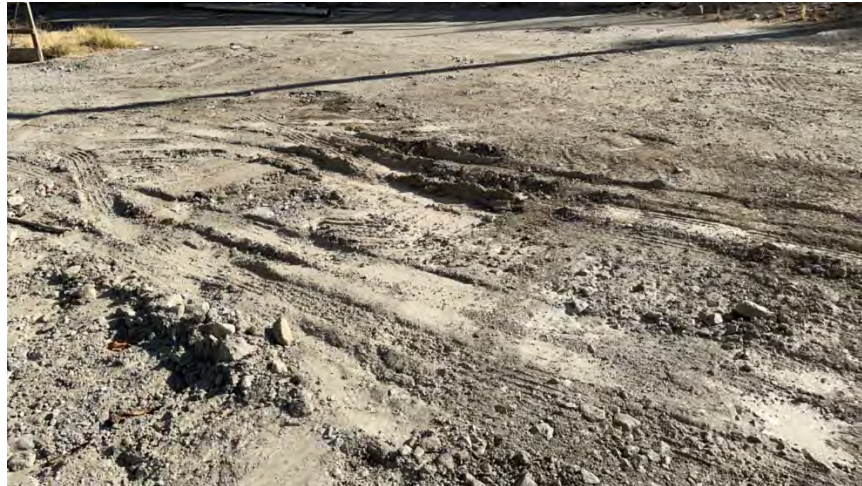
Photo D-9. August 26, 2024. Lower Powerhouse Road. Tire ruts within the lower turnout area.

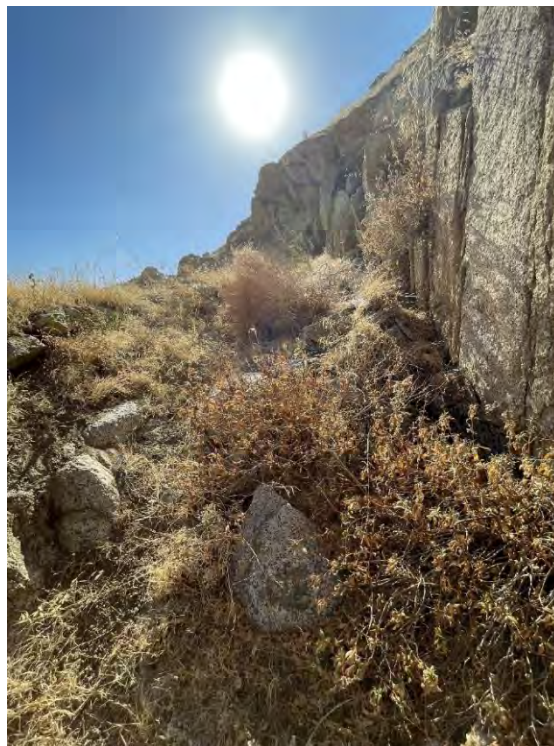
Photo D-10. August 27, 2024. Overflow Spillway Trail. Example of overgrown vegetation that is typical of this trail.

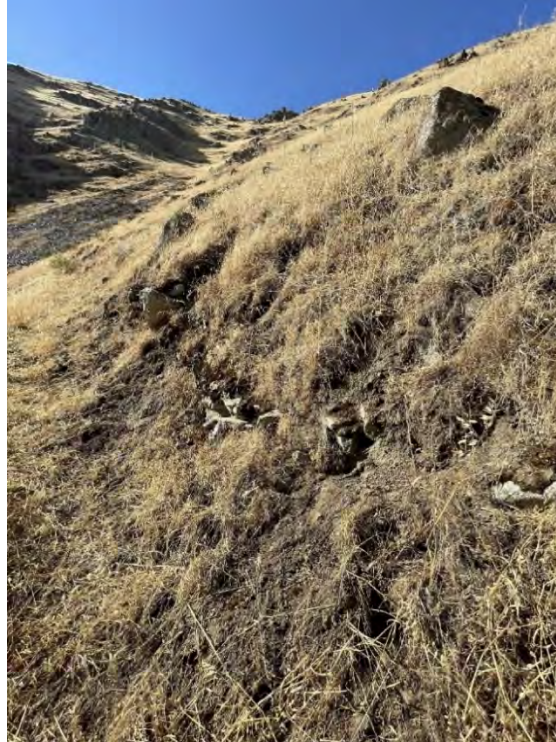
Photo D-11. August 27, 2024. Overflow Spillway Trail. Trail is poorly defined and unmaintained.

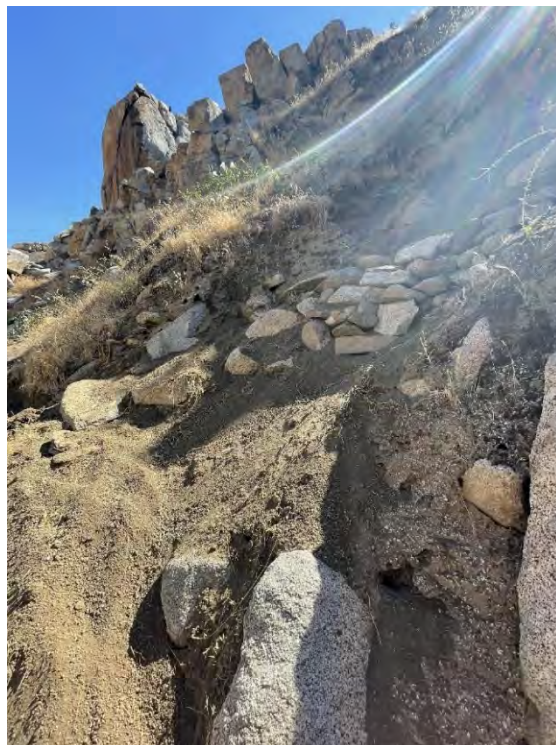
Photo D-12. August 27, 2024. Skip Hoist/Forebay Trail. Example of soil erosion characteristic of this trail.

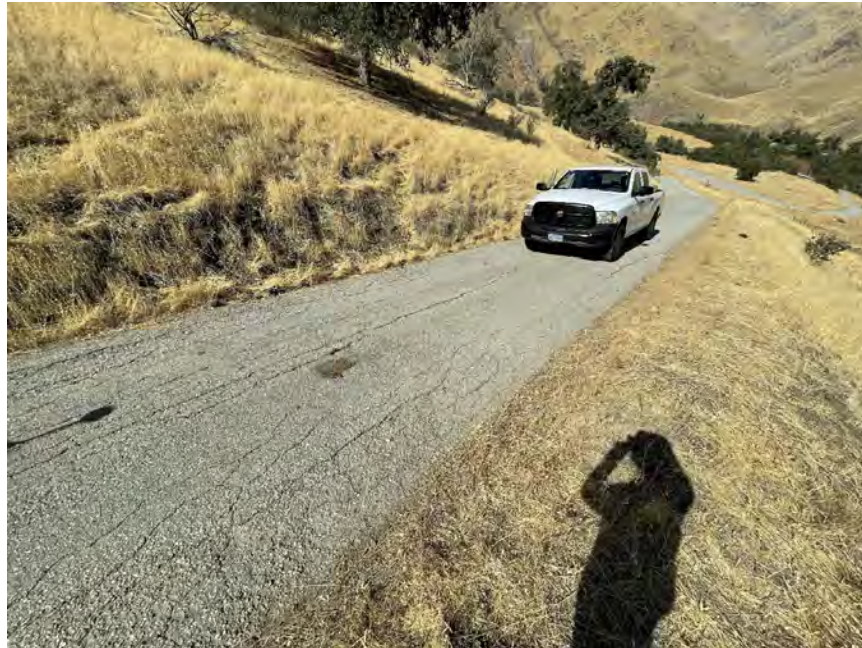
Photo D-13. August 26, 2024. Stark Creek Road. Low to moderate cracking along approximately 150 feet of roadway.

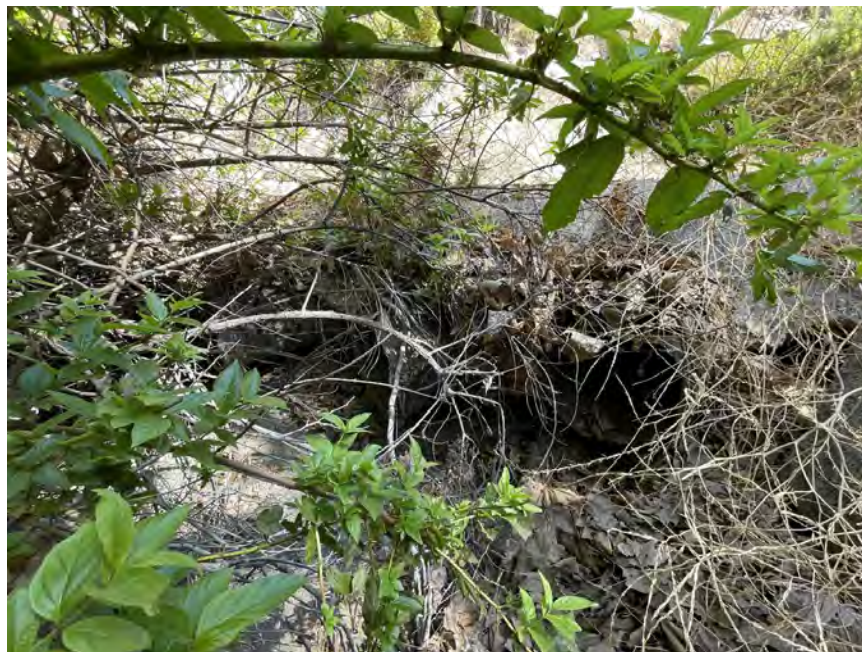
Photo D-14. August 26, 2024. Stark Creek Road. Upstream side of low-water crossing along Stark Creek. Accumulated vegetative debris obscured the CMP underneath the cement slab, but the easternmost CMP appeared to be crushed.

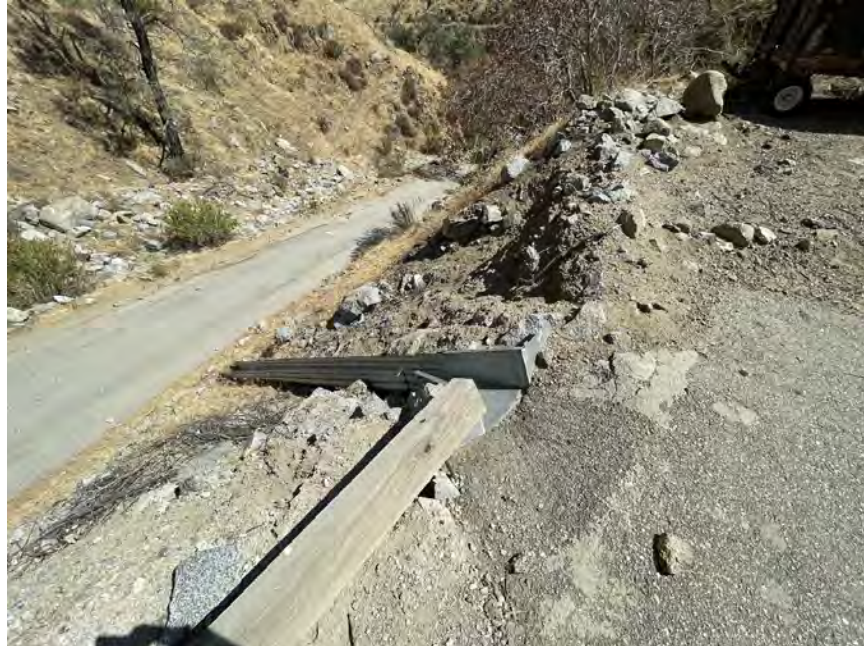
Photo D-15. August 26, 2024. Stark Creek Road. Example of steel slope drain in good condition, which are present throughout Stark Creek Road.
