# **LAND 2 – EROSION AND SEDIMENTATION TECHNICAL MEMORANDUM**

**KERN RIVER No. 1 HYDROELECTRIC PROJECT**  
***FERC PROJECT No. 1930***

**May 2026**

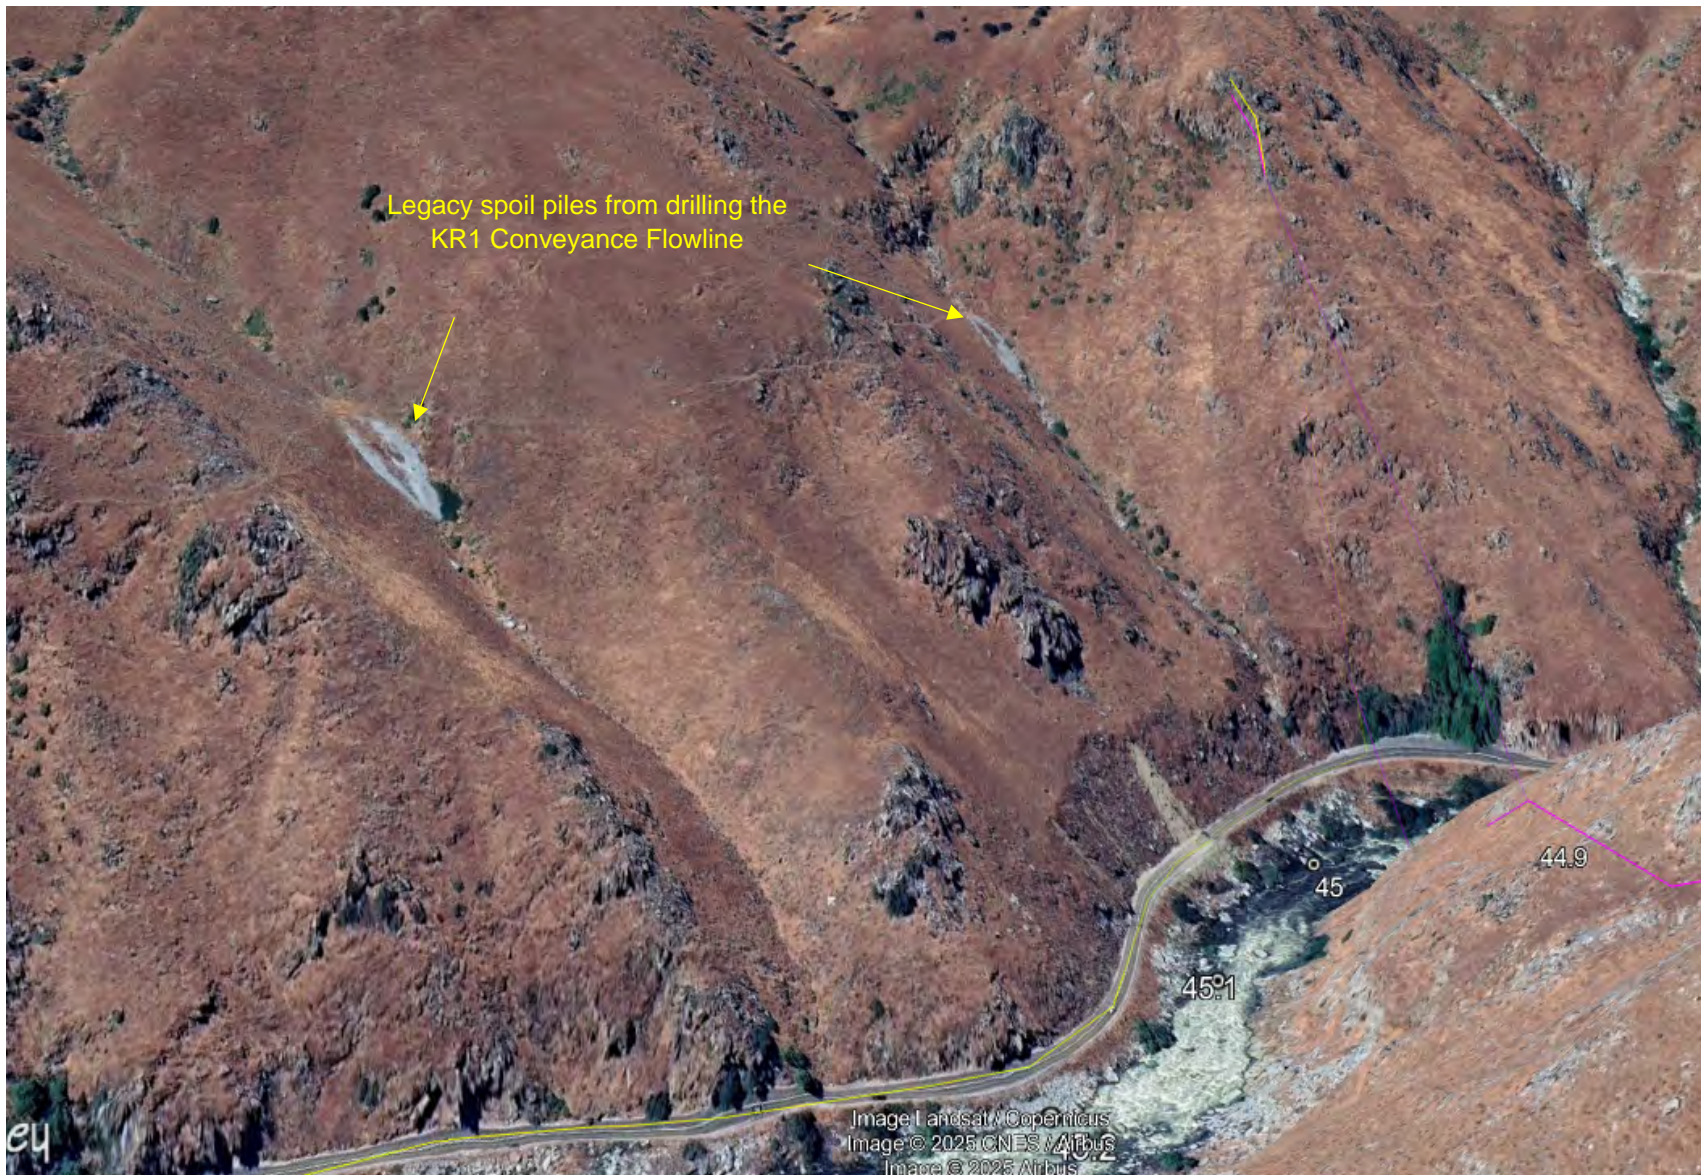
**Figure 5-1. Example of Legacy Spoil Piles from Drilling the KR1 Conveyance Flowline.**

A review of historical aerial imagery and field observations indicated that potential erosion and sedimentation related to Project features was small scale and remained stable from 2002 to 2023 (availability of imagery). The only Project-related features that were identified as locations of potential ongoing erosion and sedimentation were the legacy spoil piles from drilling the KR1 Conveyance Flowline. These spoil piles were visible in all

photo sets and appear largely unchanged between 2002 and 2023. An aerial image of a few of the spoil piles is provided in Figure 5-1 (January 2025).

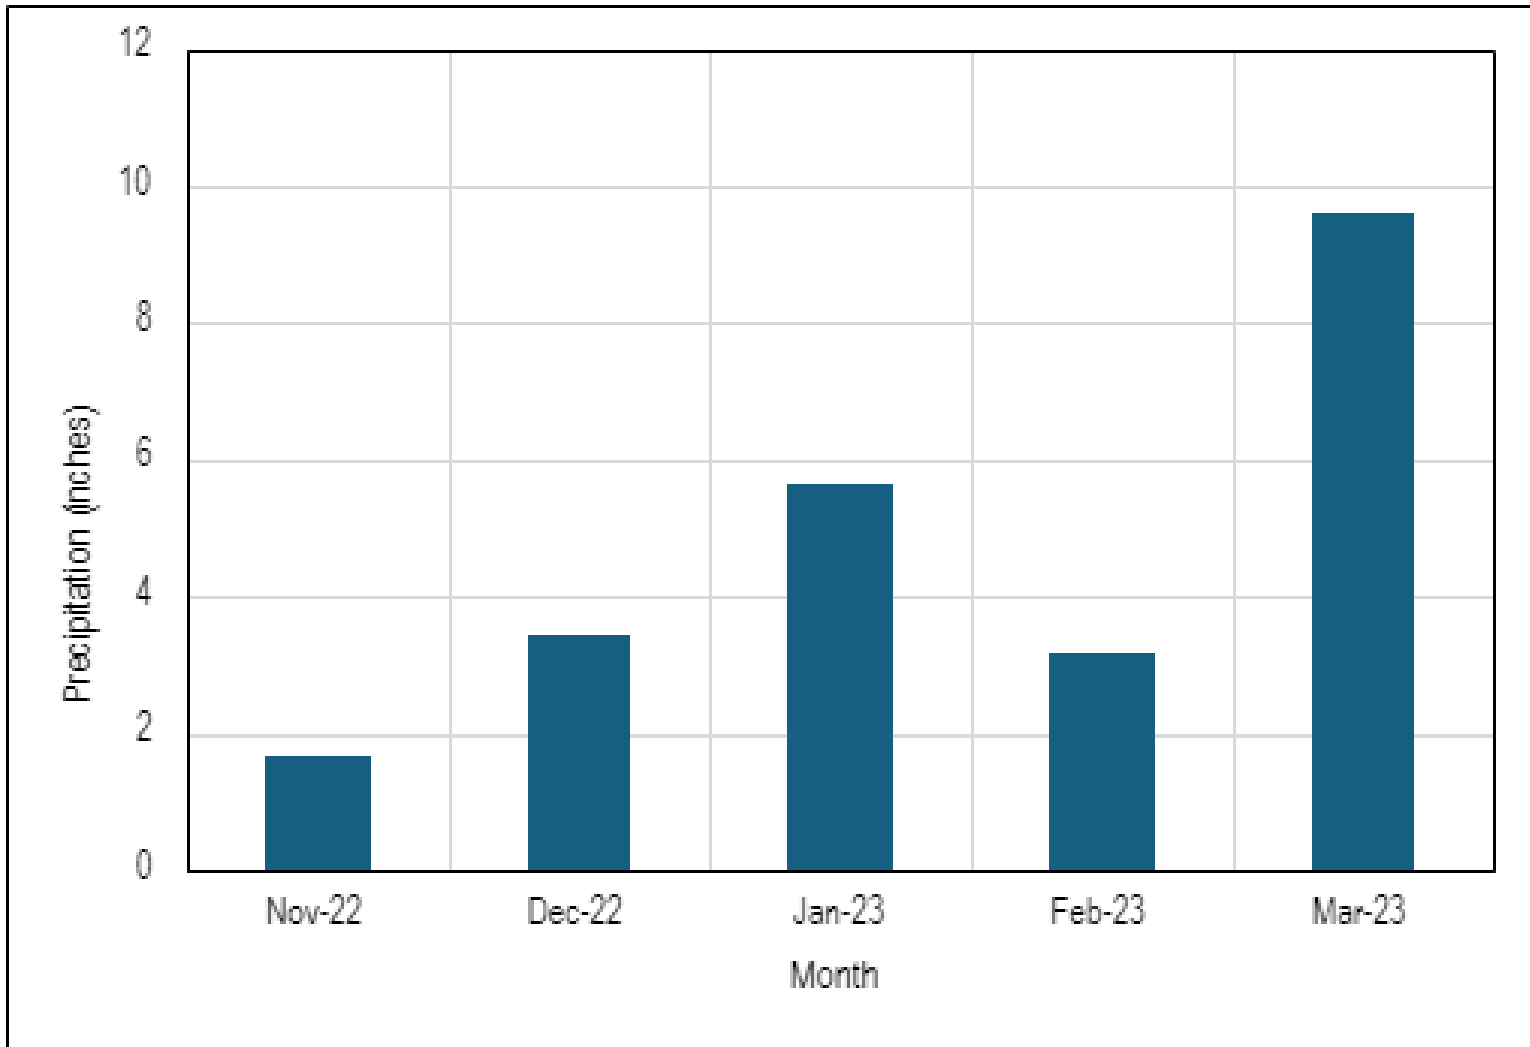
**Figure 5-2. Monthly Peak Precipitation at Lake Isabella from November 2022–March 2023**

Peak monthly rainfall of approximately 5.62 inches in January 2023, and 9.61 inches in March 2023 was measured at Lake Isabella (California Nevada River Forecast Center [CNRFC] 2024) (Figure 5-2). On March 10, 2023, flows in the Kern River at Kernville peaked at 15,700 cubic feet per second (cfs) (U.S. Geological Survey [USGS] 2024) (Figure 5-3). This was the second highest peak flow recorded at Kernville for the period of record spanning from 1961–2023, with the peak flow of 33,600 cfs occurring on December 6, 1966 (USGS 2024).

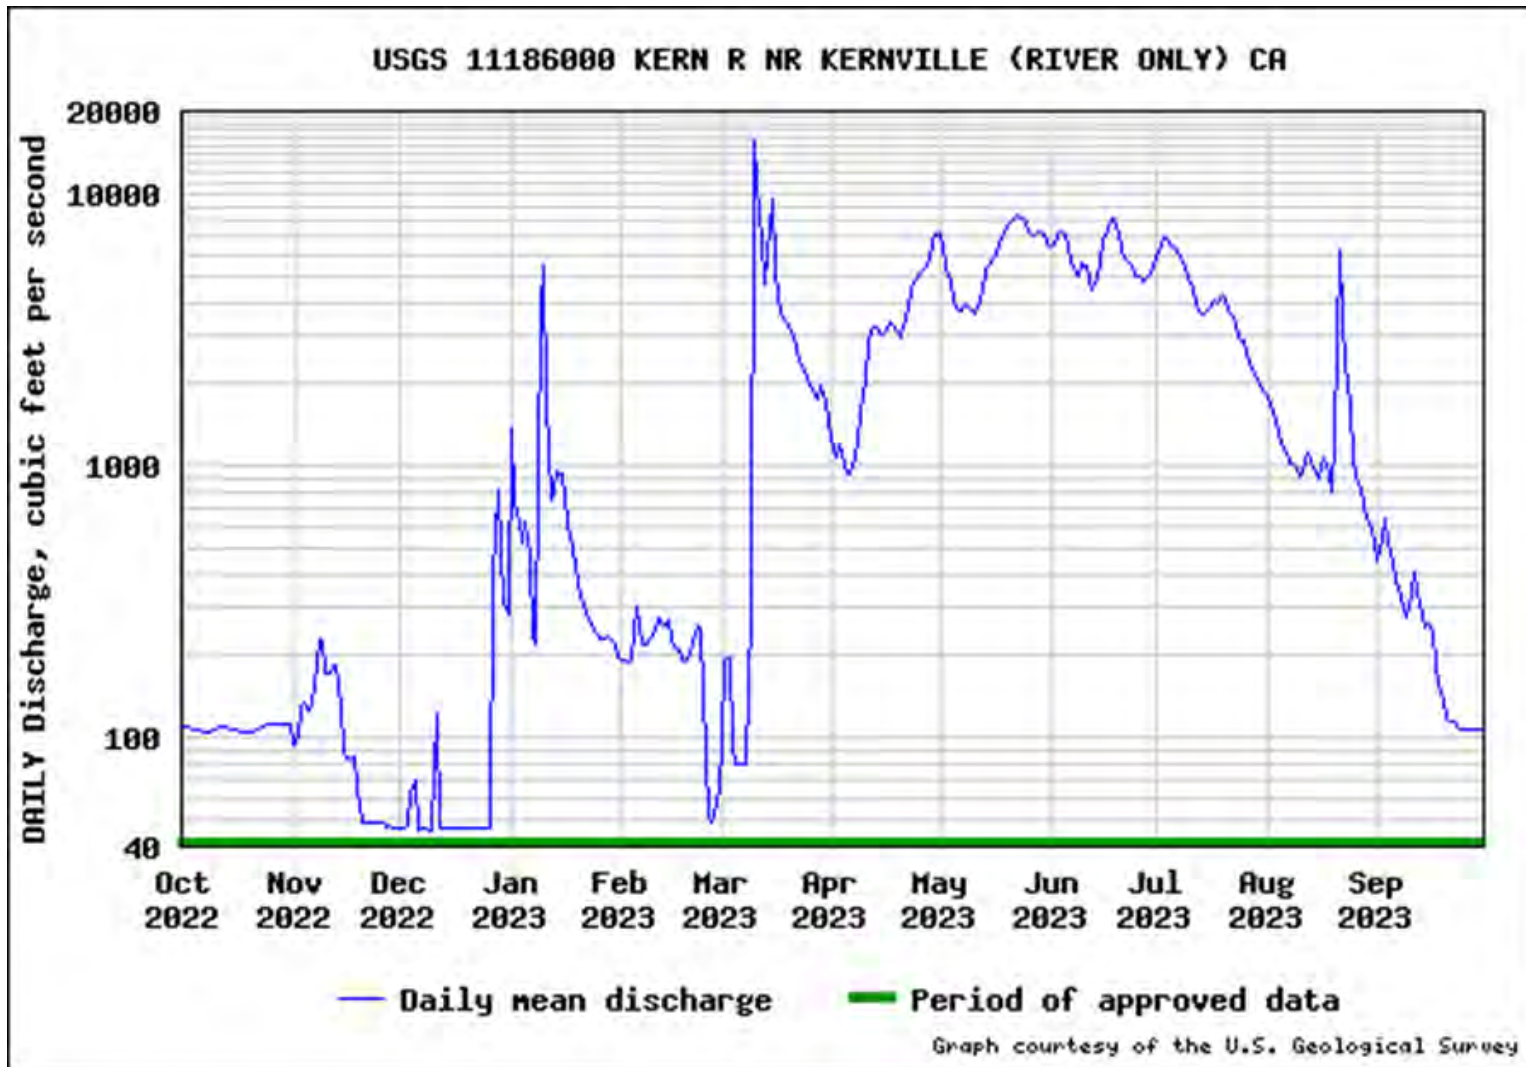
Figure 5-3. USGS Water Year Summary for Site USGS 11186000 at Lake Isabella Dam

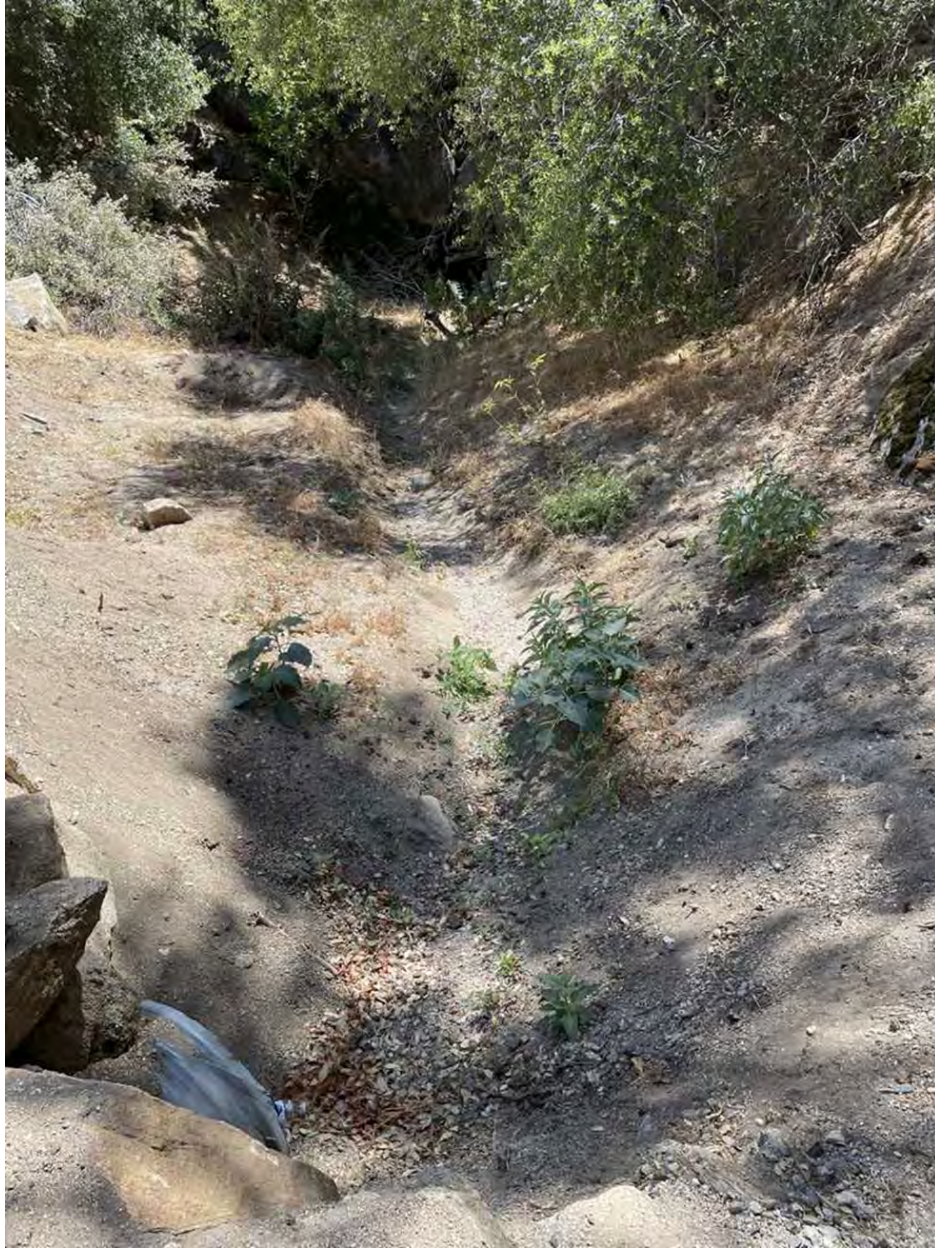
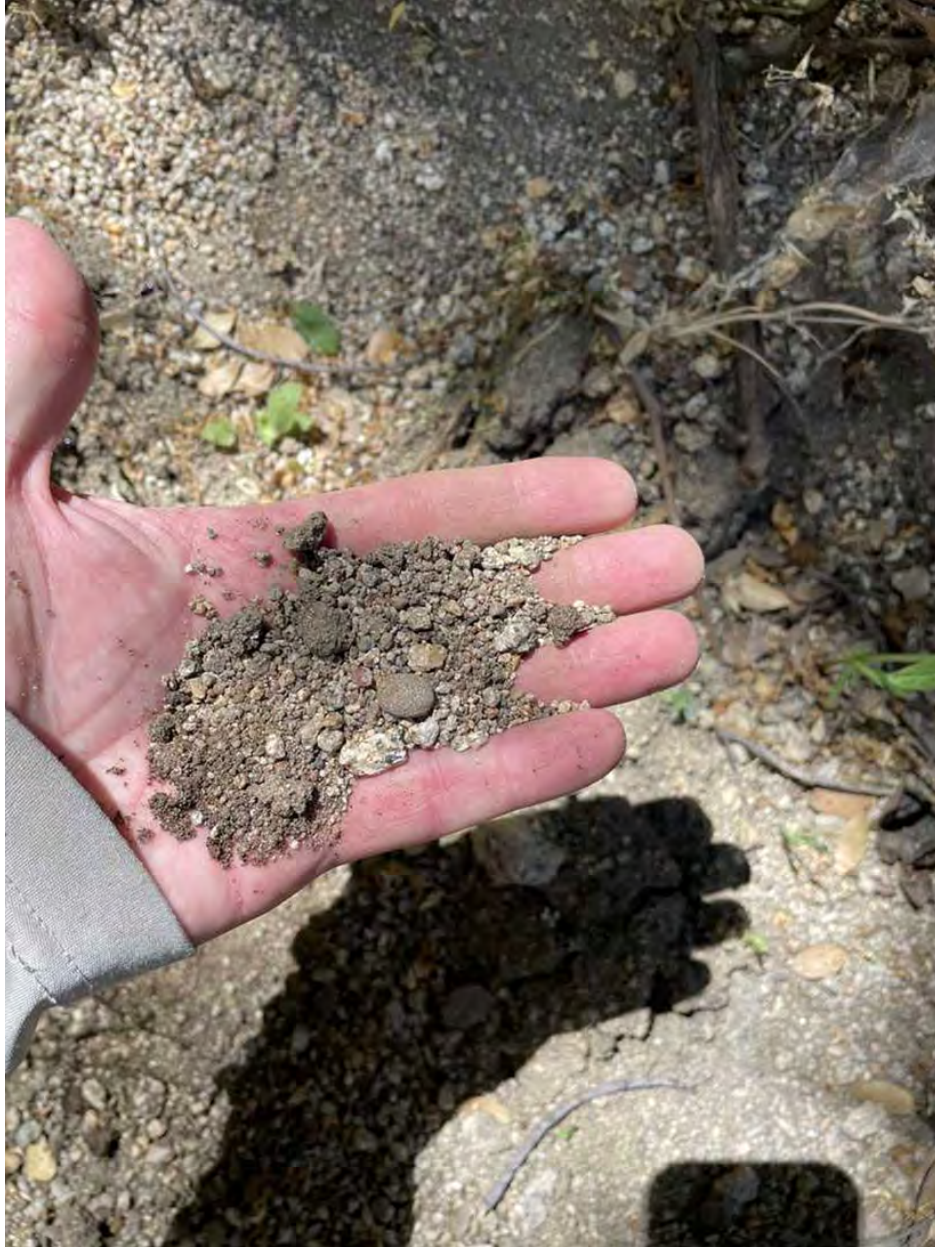
**Photo A-1. Unnamed tributary on Democrat Dam Flowline Access Road**

**Photo A-2. Unnamed tributary on Democrat Dam Flowline Access Road**

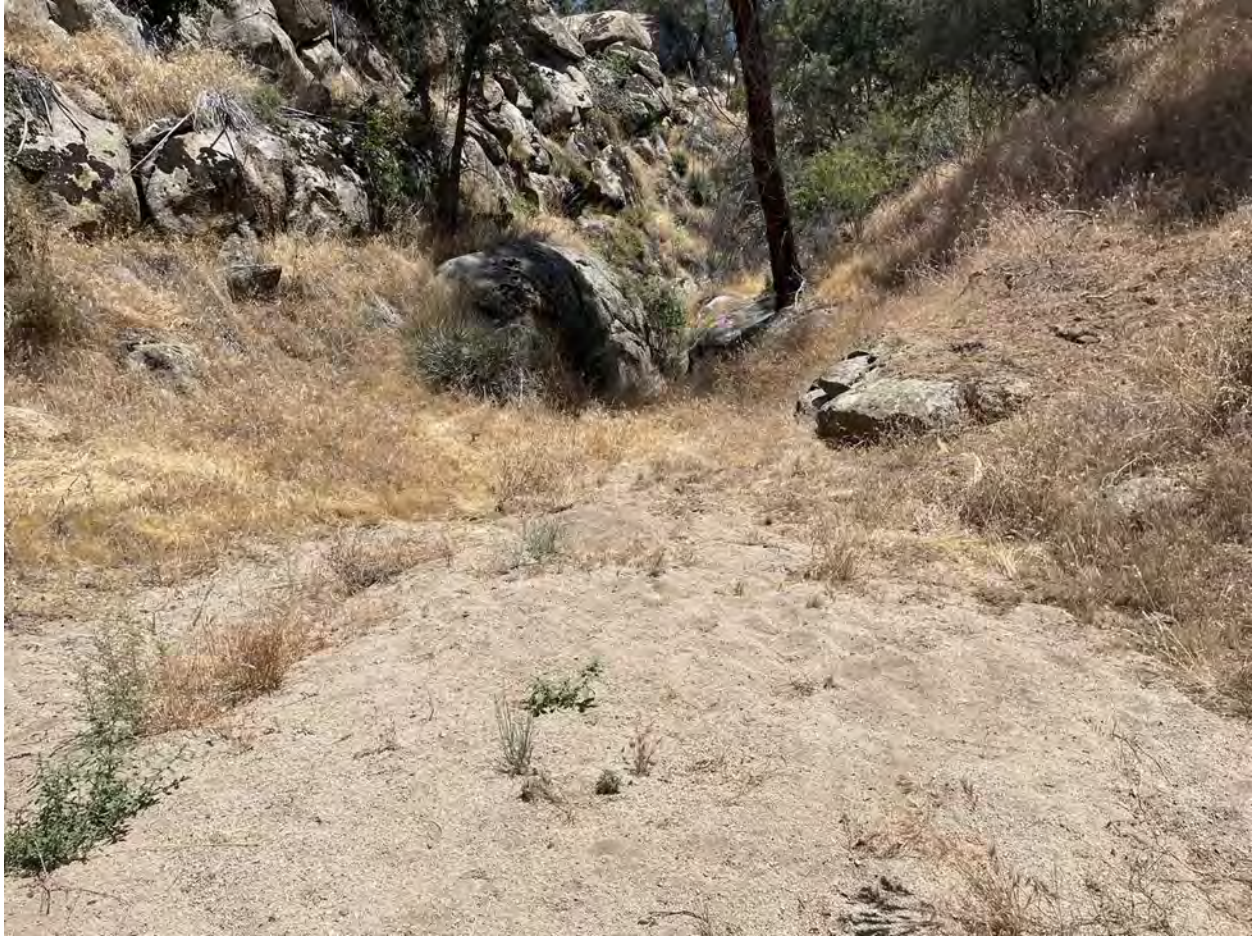
**Photo A-3. Unnamed tributary at water crossing on Cow Flat Road**

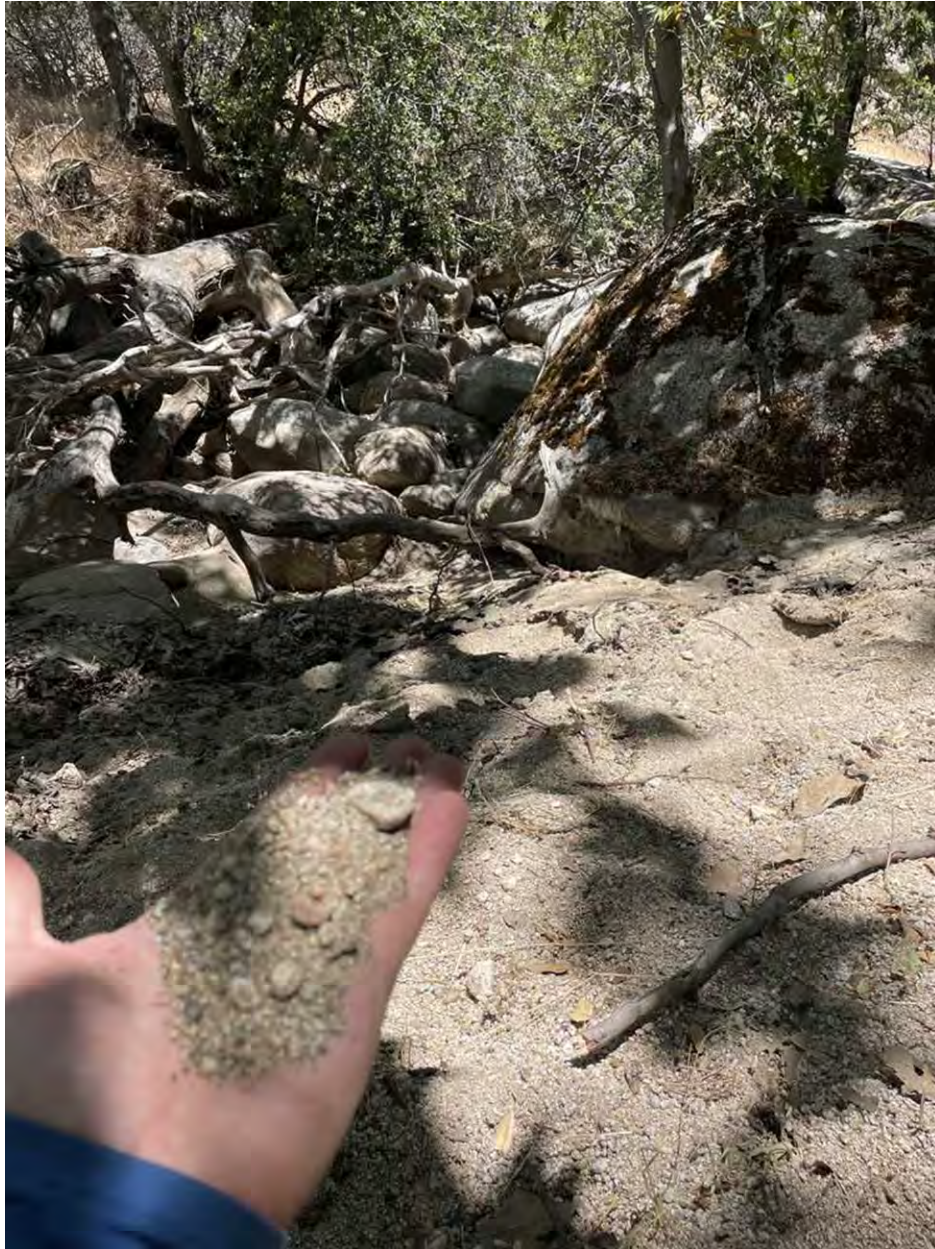
**Photo A-4. Upper Cow Flat Creek**

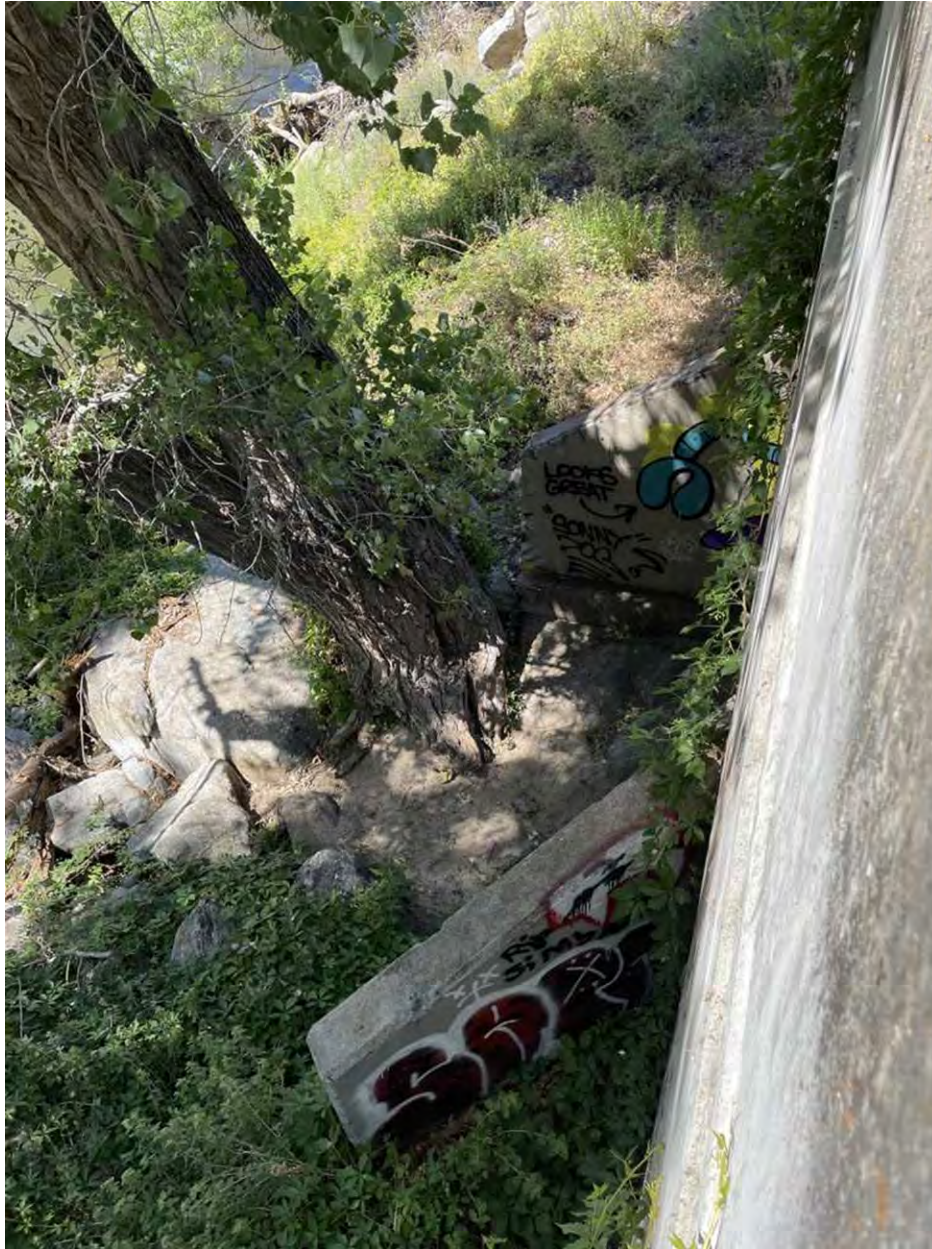
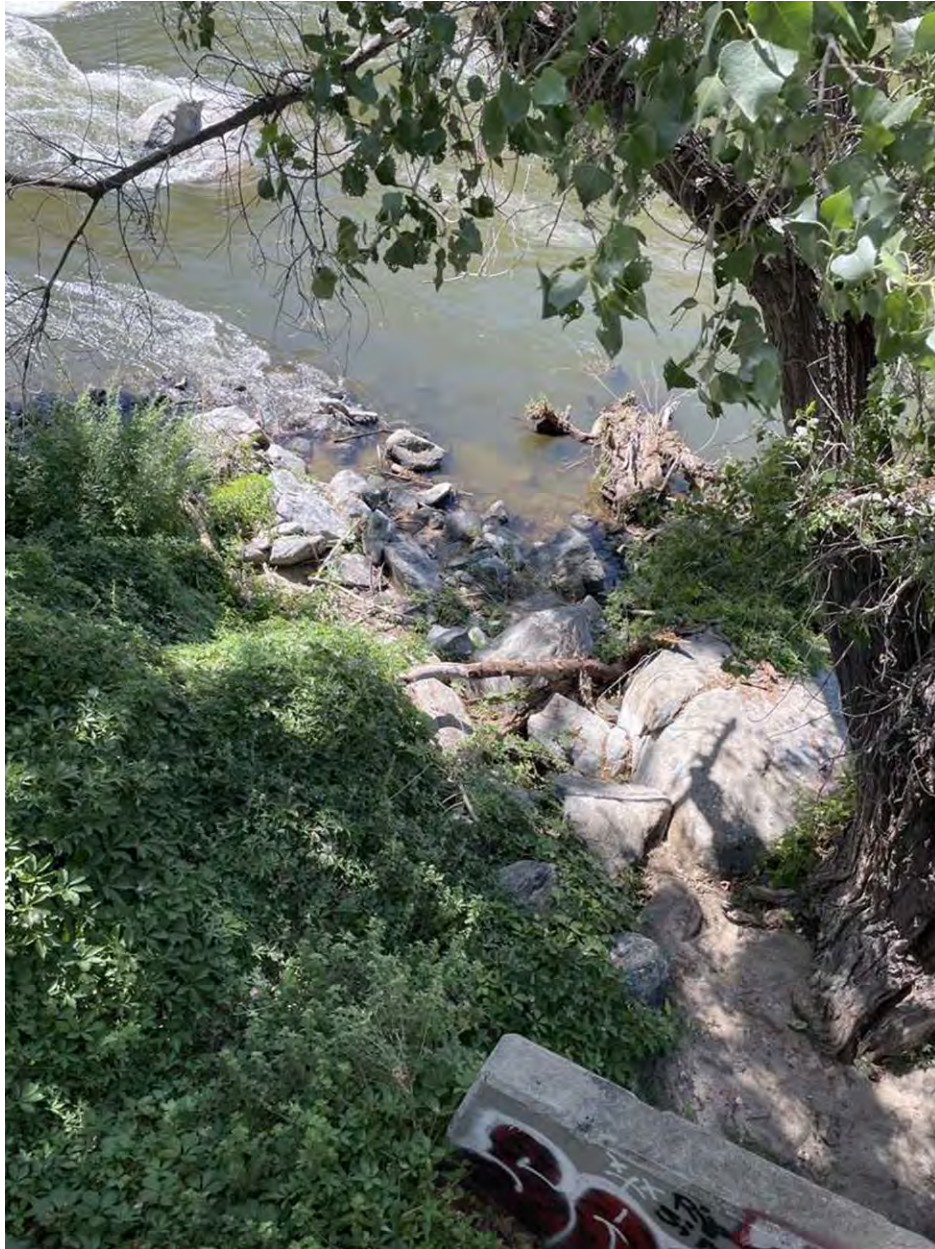
**Photo A-5. Cow Flat Creek at SR-178 and confluence with mainstem channel**

**Photo A-6. Cow Flat Creek at SR-178 and confluence with mainstem channel**

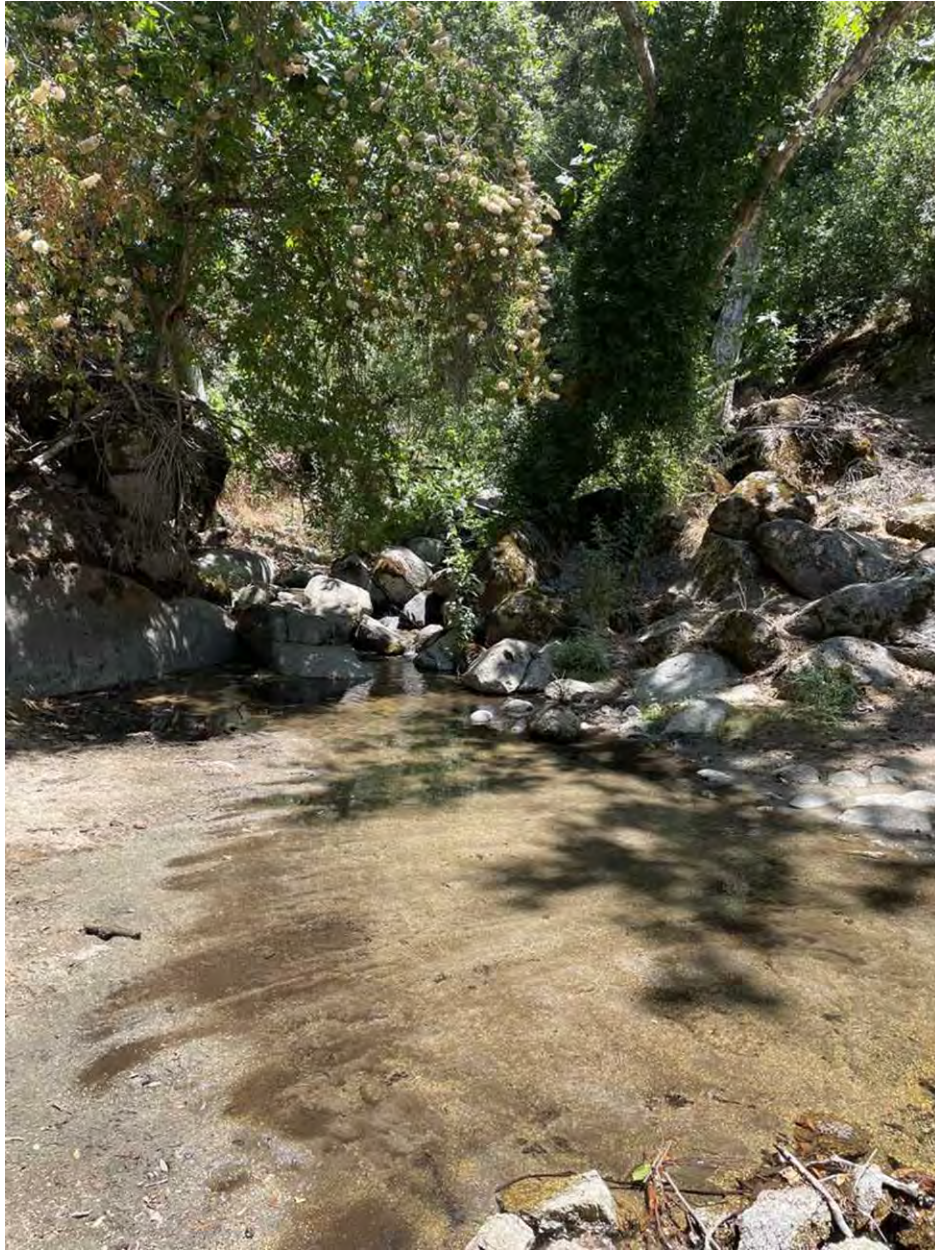
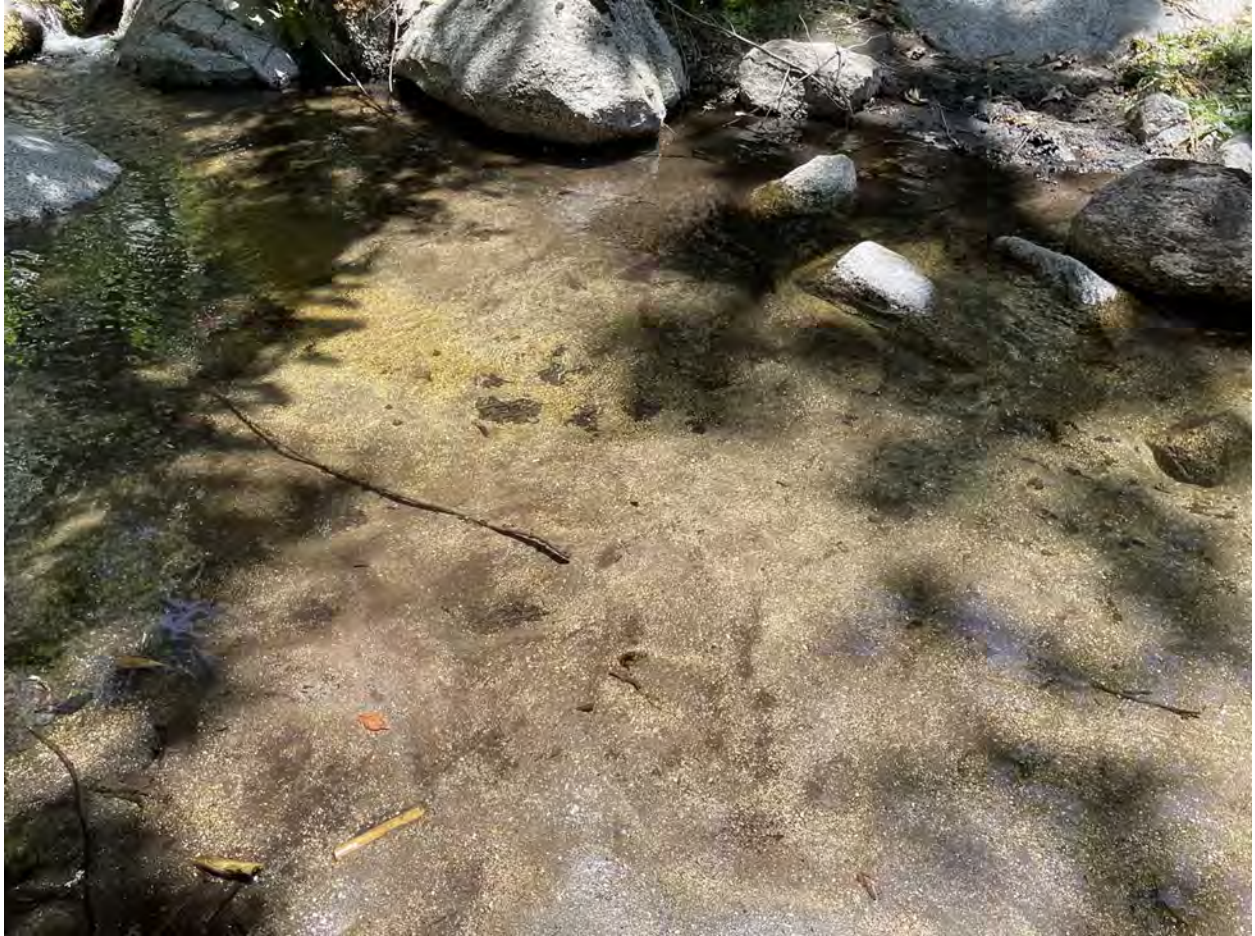
**Photo A-7. Upper Lucas Creek at water crossing on Cow Flat Road**

**Photo A-8. Upper Lucas Creek at water crossing on Cow Flat Road**

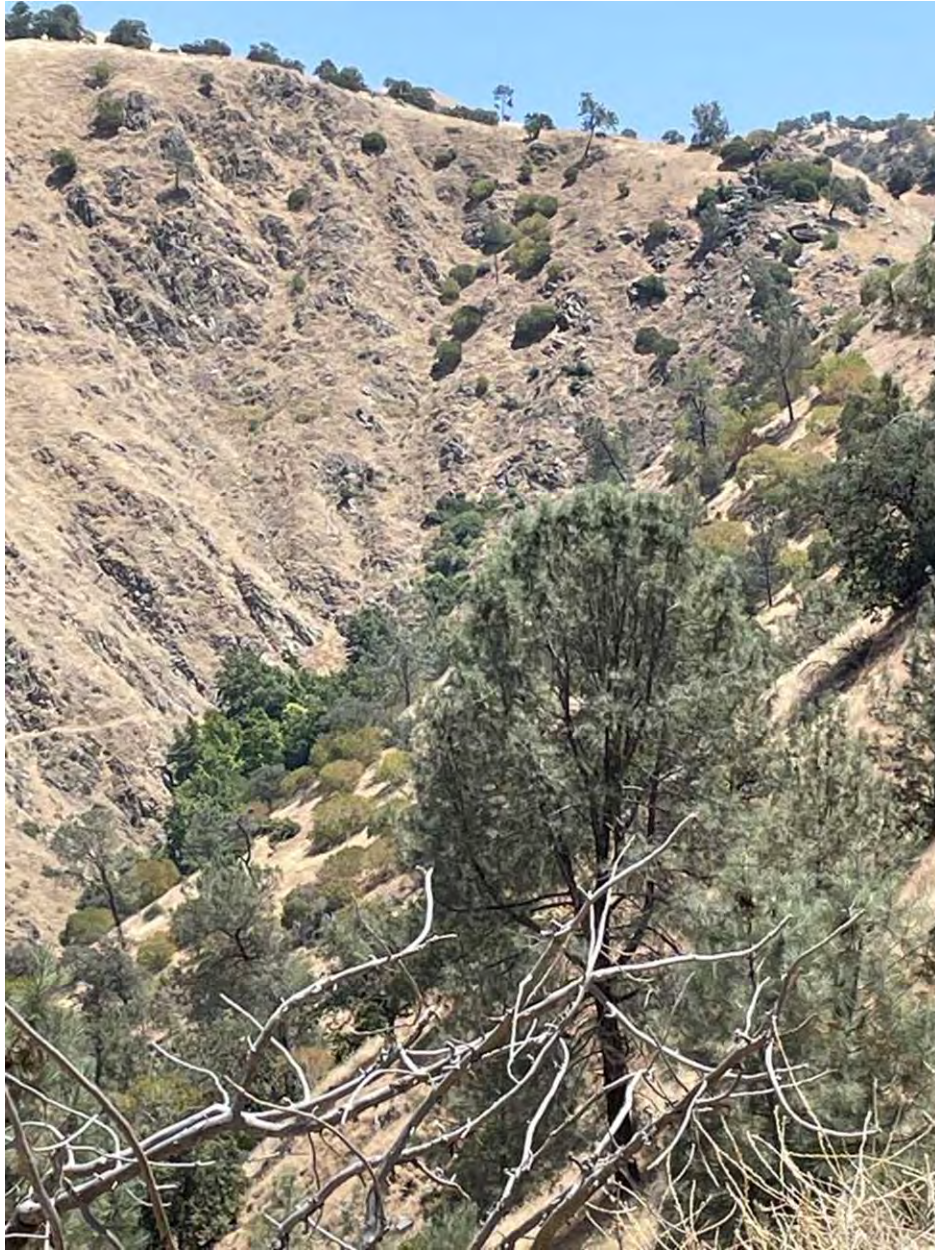
**Photo A-9. Dougherty Creek drainage above SR-178**

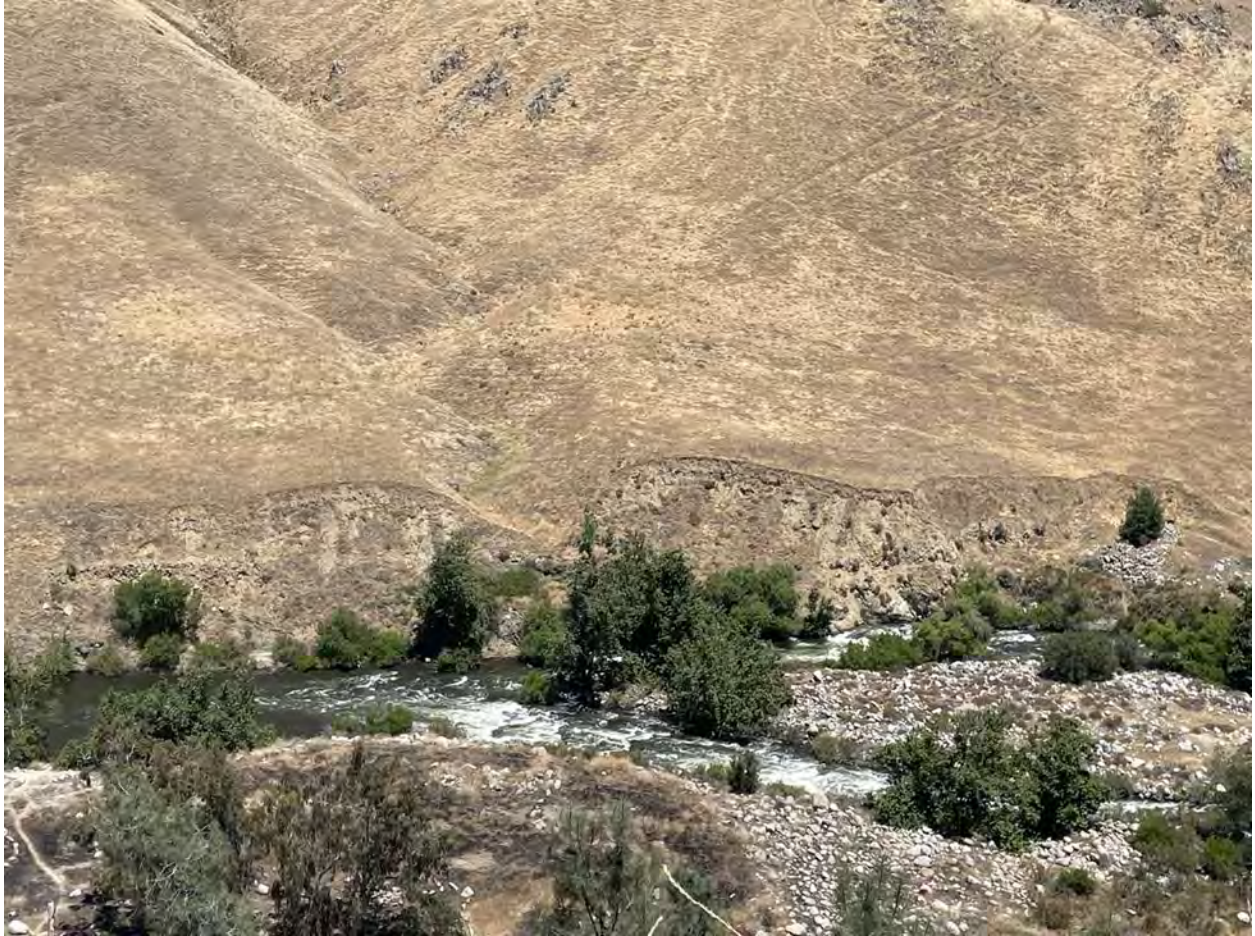
**Photo A-10. Bank Erosion RB\_1**

Based on field observation, few of the sites were actively eroding, with the only exceptions being two sites where active bank erosion was observed (Bank Erosion RB\_1, and Bank Erosion RB\_2 in Table 5-1). The few drainages that had flowing water (low flows) were not actively contributing sediment to the stream channel. The sites presented in Table 5-1 were classified as having high sediment delivery potential during high flow / heavy precipitation events. Hazards related to debris flows, landslides, and rock falls during heavy precipitation are a distinct possibility throughout the canyon. Project-Related Sediment Sources

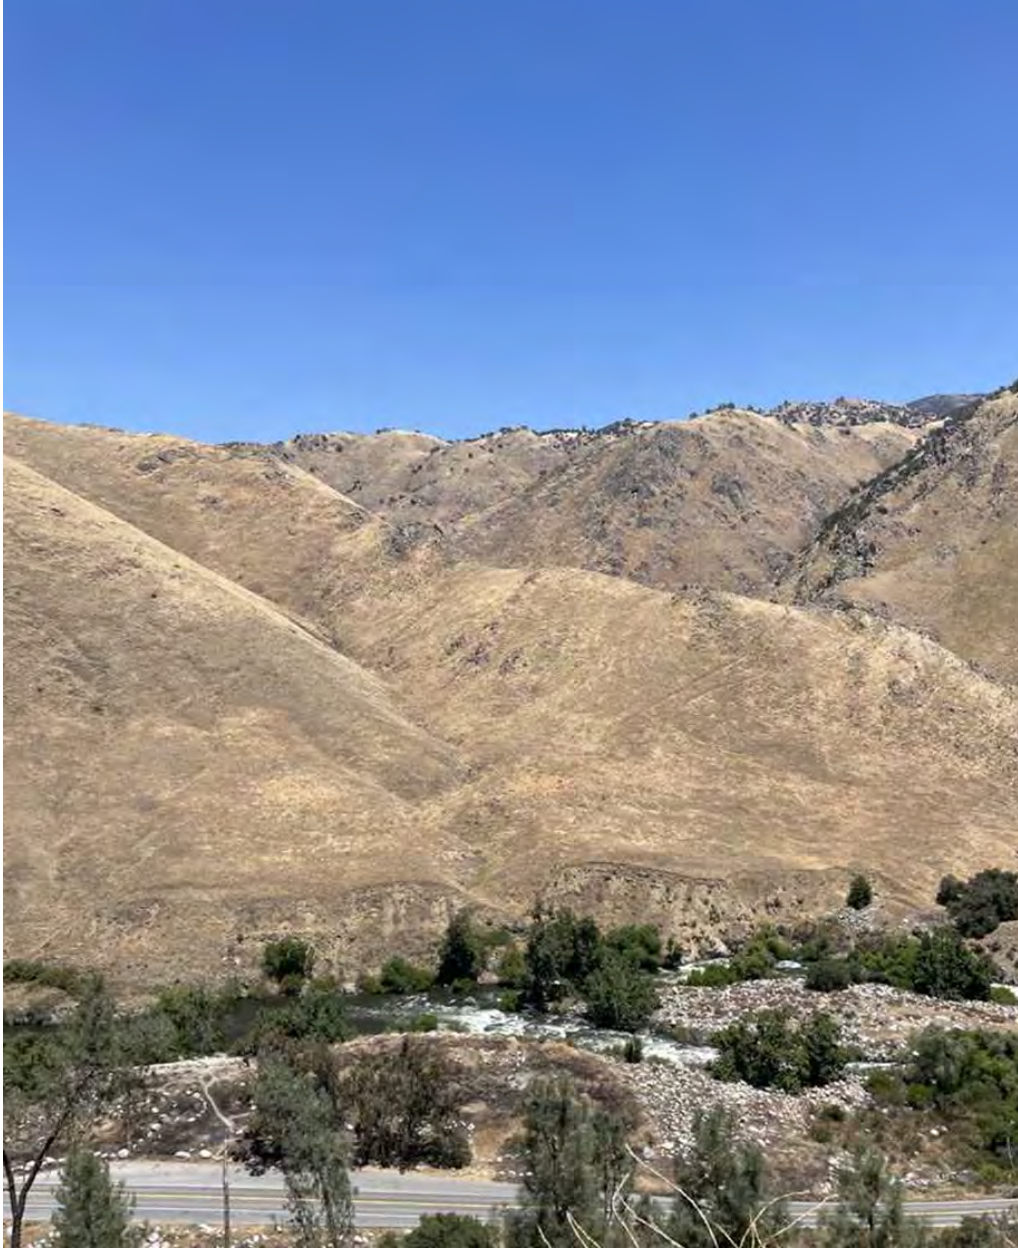
**Photo A-11. Bank Erosion RB\_1**

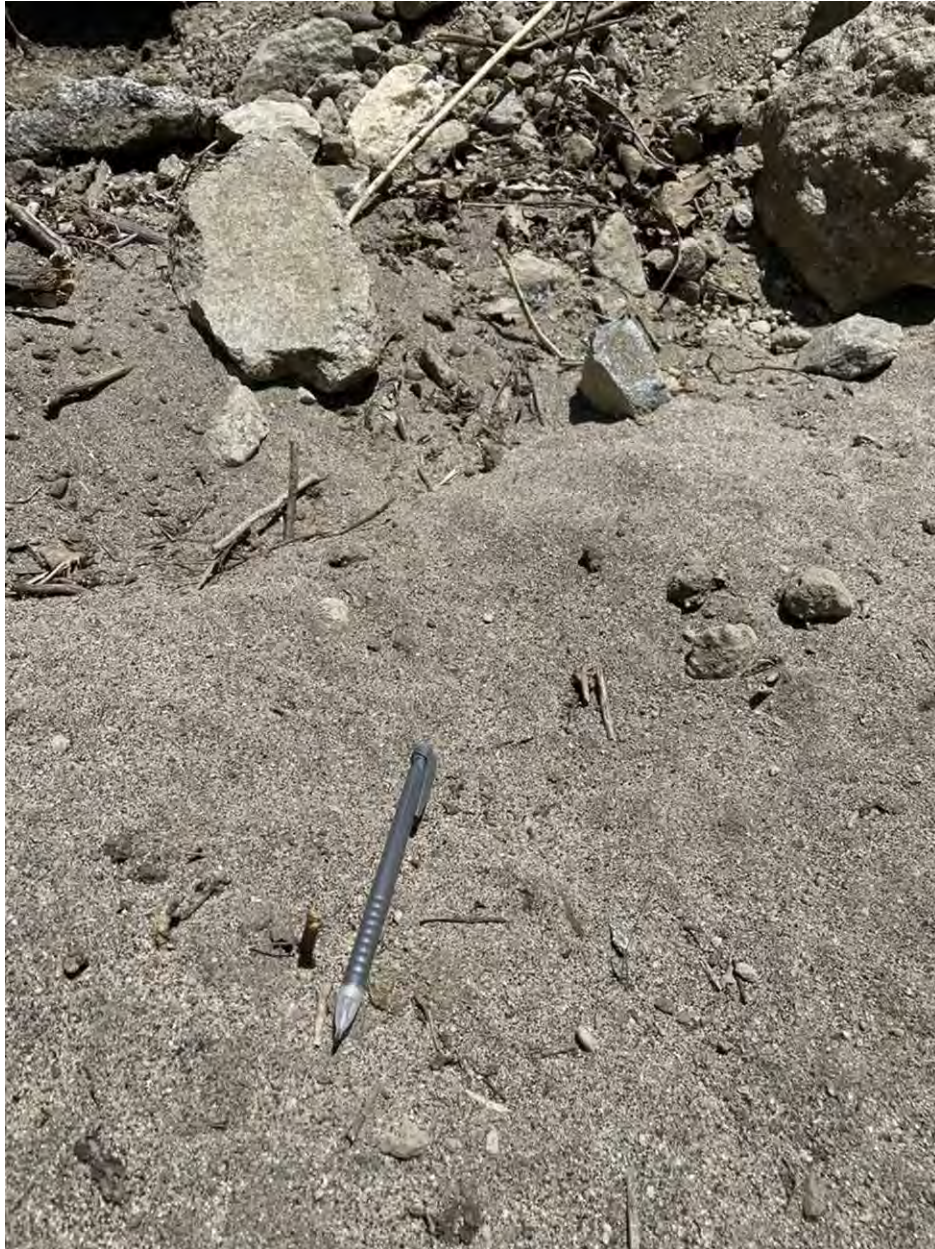
**Photo A-12. Fine sediment in Stark Creek at end of flowline access road**

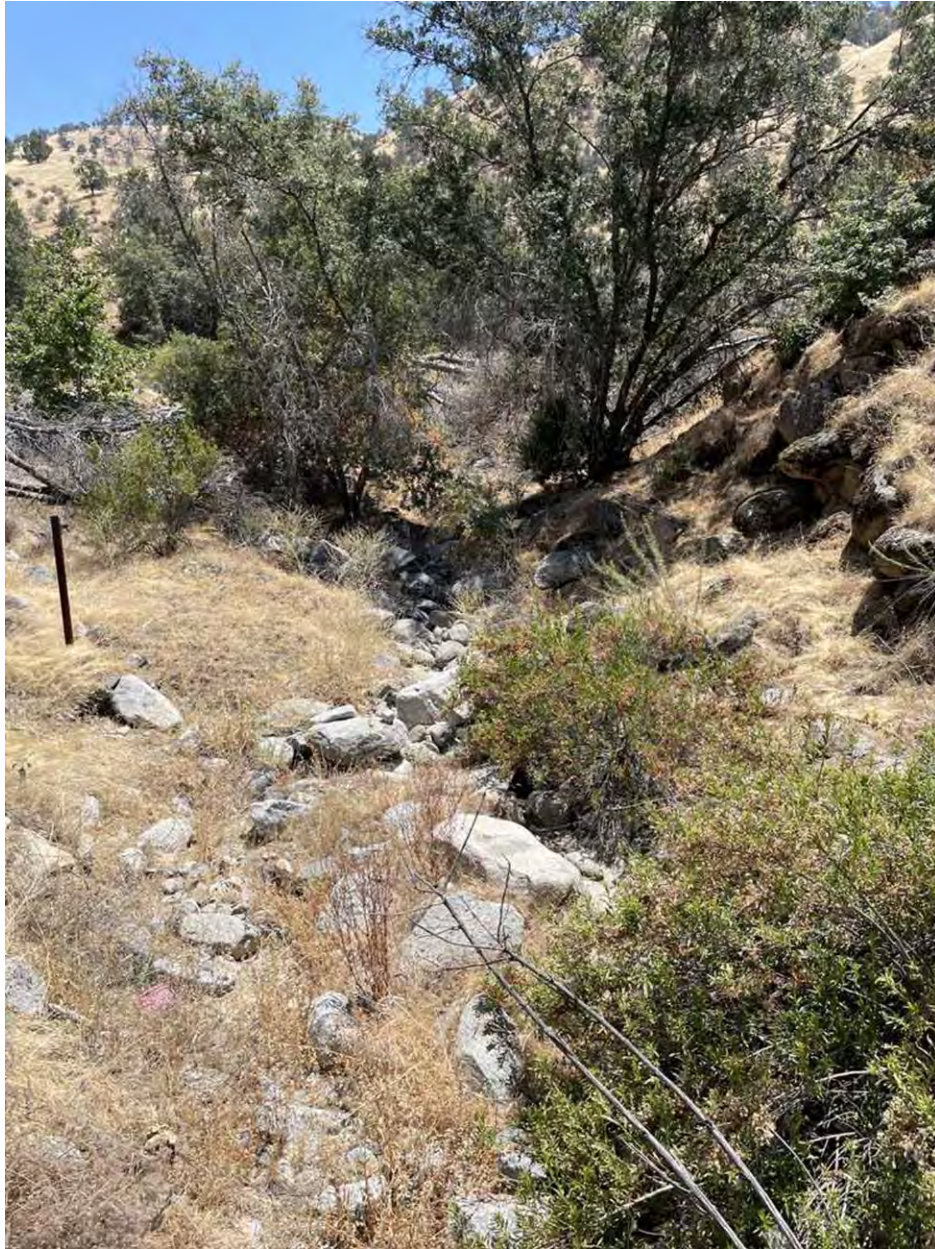
**Photo A-13. Stark Creek at SR-178**

A-13	N/A	Dry	No	Yes	Stark Creek at SR-178. Boulder and cobble bed with some sand and gravel. Observations of the upper drainage and channel geometry suggest the potential for episodic debris flows and sediment transport that could impact travel on SR-178. Confluence with mainstem channel not accessible for visual observation or photos.
Rilling/Landslide_RB1	A-14 to A-15	N/A	N/A	No	Yes	Landslide scar with rilling on RB across from Lower Richbar Day Use Area. Potential for episodic erosion and sediment delivery directly into mainstem channel.
Bank Erosion_RB2	A-16	N/A	N/A	No	Yes	Steep eroding cut bank on RB. Composed of boulders and cobbles supported by sand and gravel matrix.
Peachacho Creek	N/A	N/A	Dry	No	Yes	Peachacho Creek at SR-178. Steep, deeply incised drainage. Considered to be a potentially significant source of sediment during high flows based on observations of other creeks in the canyon and aerial imagery. Not accessible for visual observation or photos.

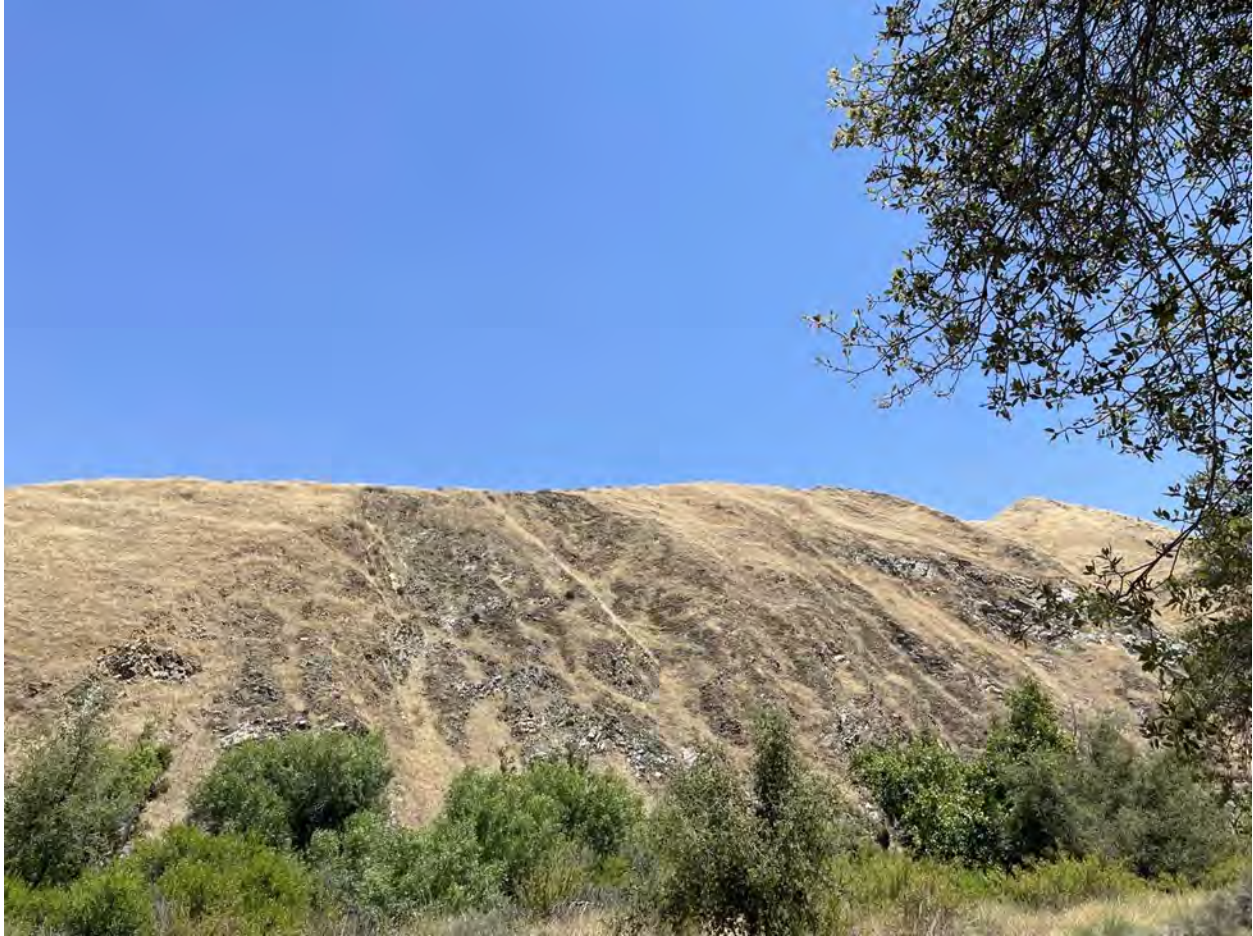
**Photo A-14. Rilling/Landslide RB-1**
