# **LAND 2 – EROSION AND SEDIMENTATION TECHNICAL MEMORANDUM**

**KERN RIVER No. 1 HYDROELECTRIC PROJECT**  
***FERC PROJECT No. 1930***

**May 2026**

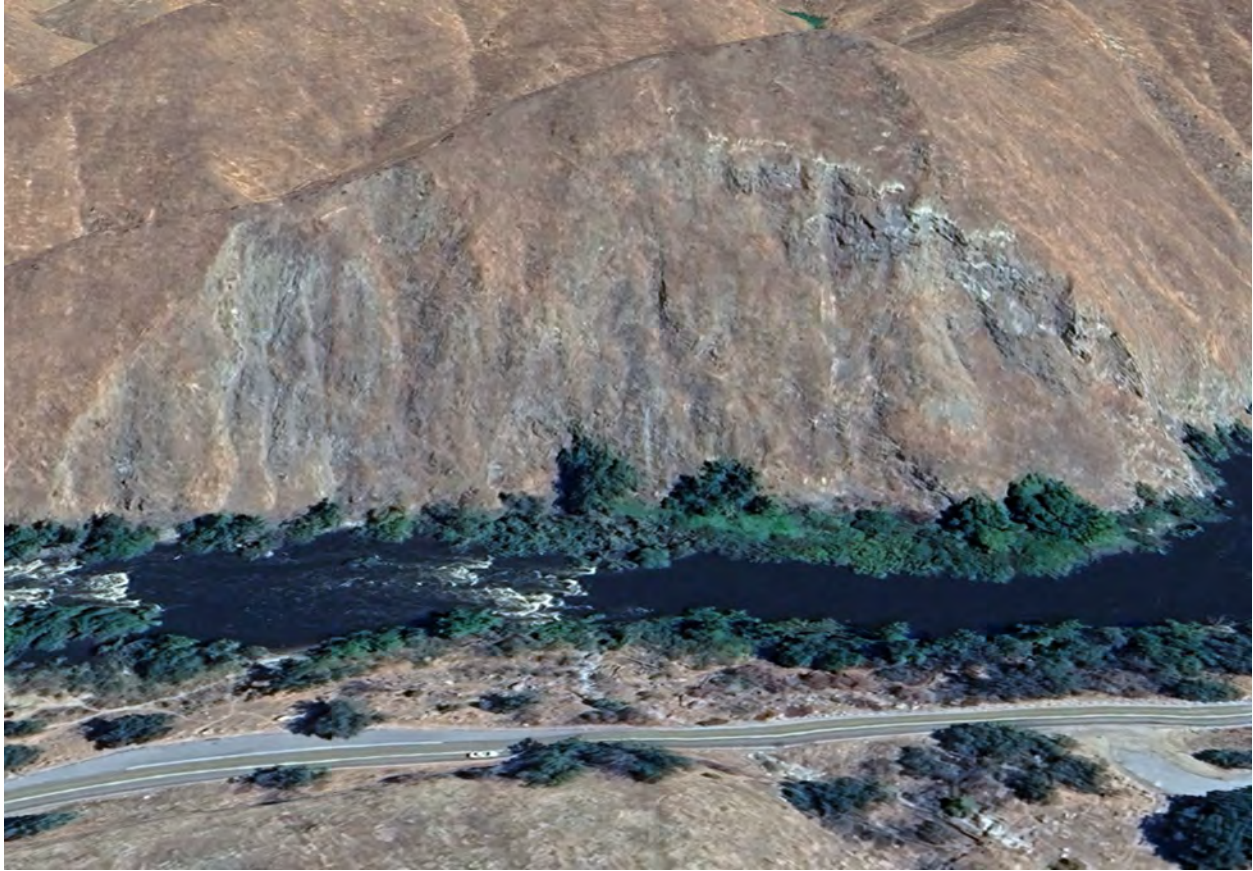
**Photo A-15. Rilling/Landslide RB-1 (Google Earth Image, Date: 8/24/23)**

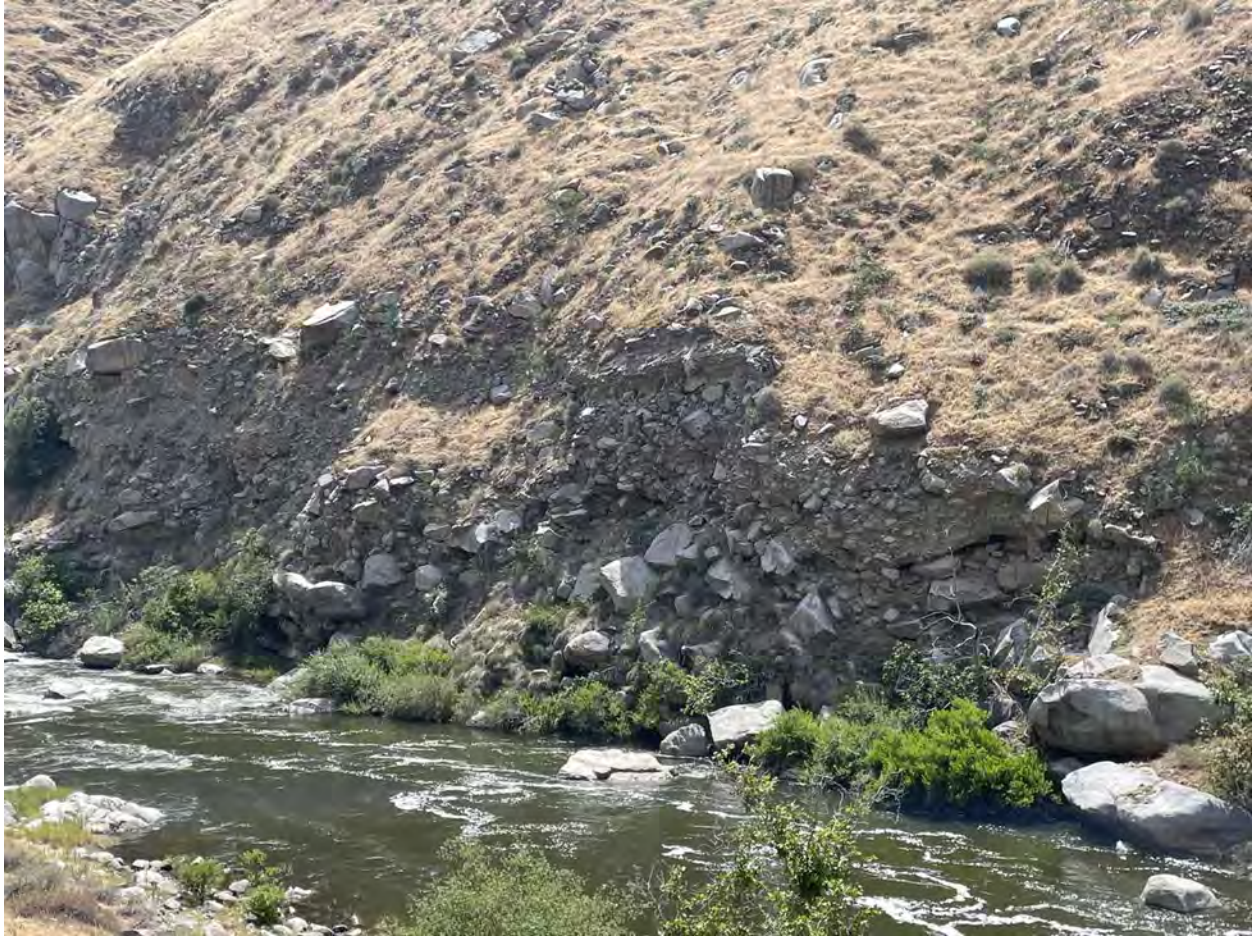
**Photo A-16. Bank Erosion RB-2**

Based on field observation, few of the sites were actively eroding, with the only exceptions being two sites where active bank erosion was observed (Bank Erosion RB\_1, and Bank Erosion RB\_2 in Table 5-1). The few drainages that had flowing water (low flows) were not actively contributing sediment to the stream channel. The sites presented in Table 5-1 were classified as having high sediment delivery potential during high flow / heavy precipitation events. Hazards related to debris flows, landslides, and rock falls during heavy precipitation are a distinct possibility throughout the canyon. Project-Related Sediment Sources

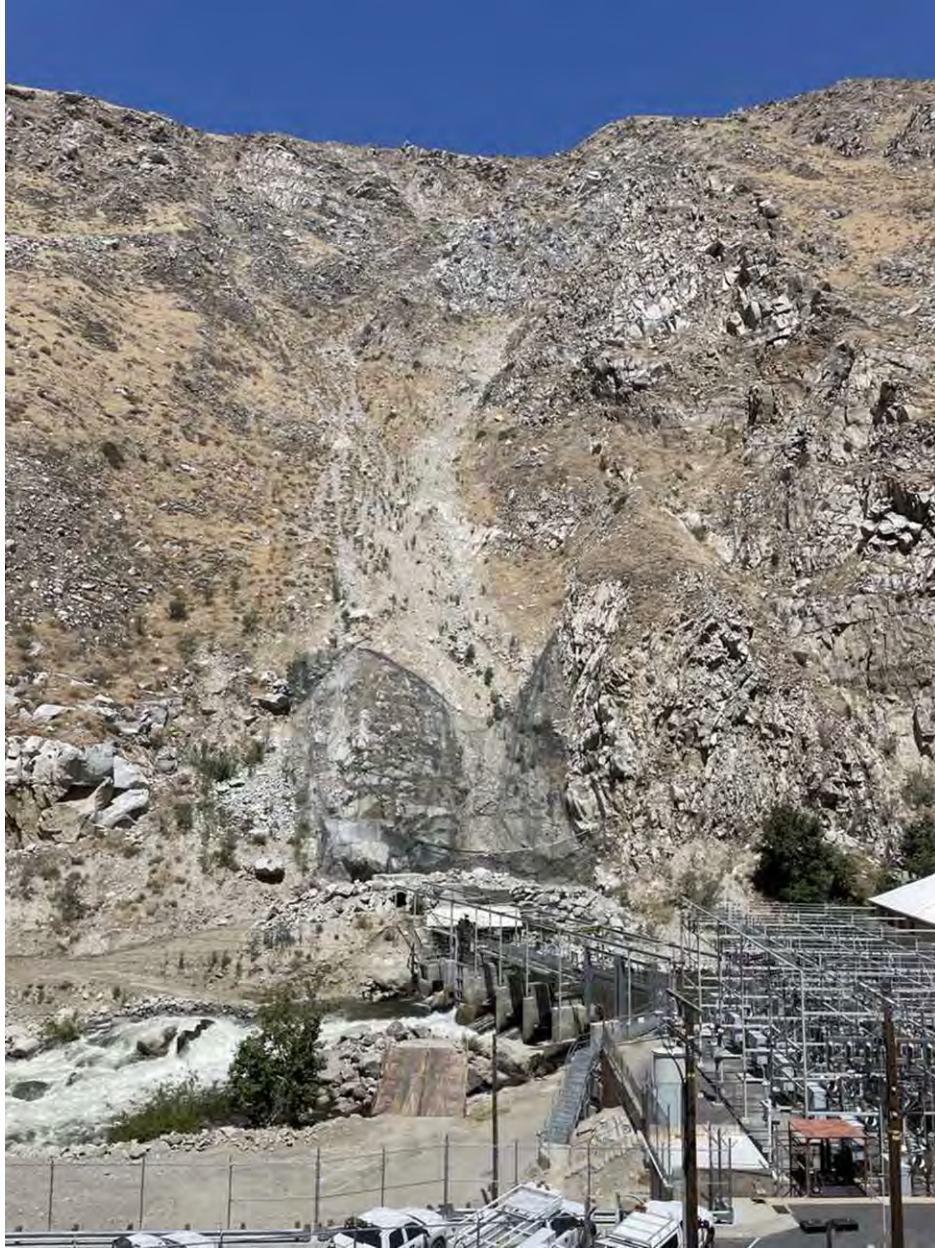
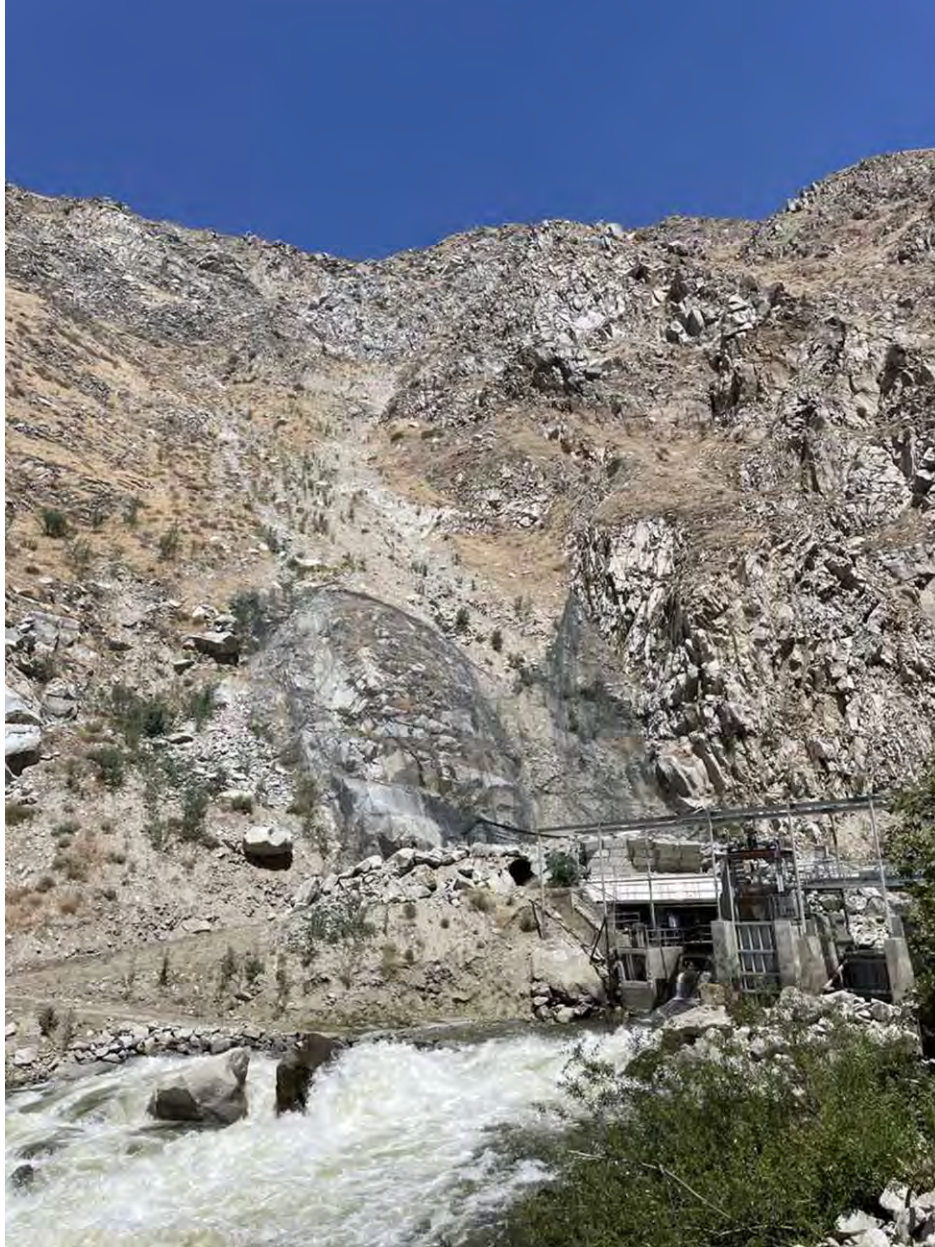
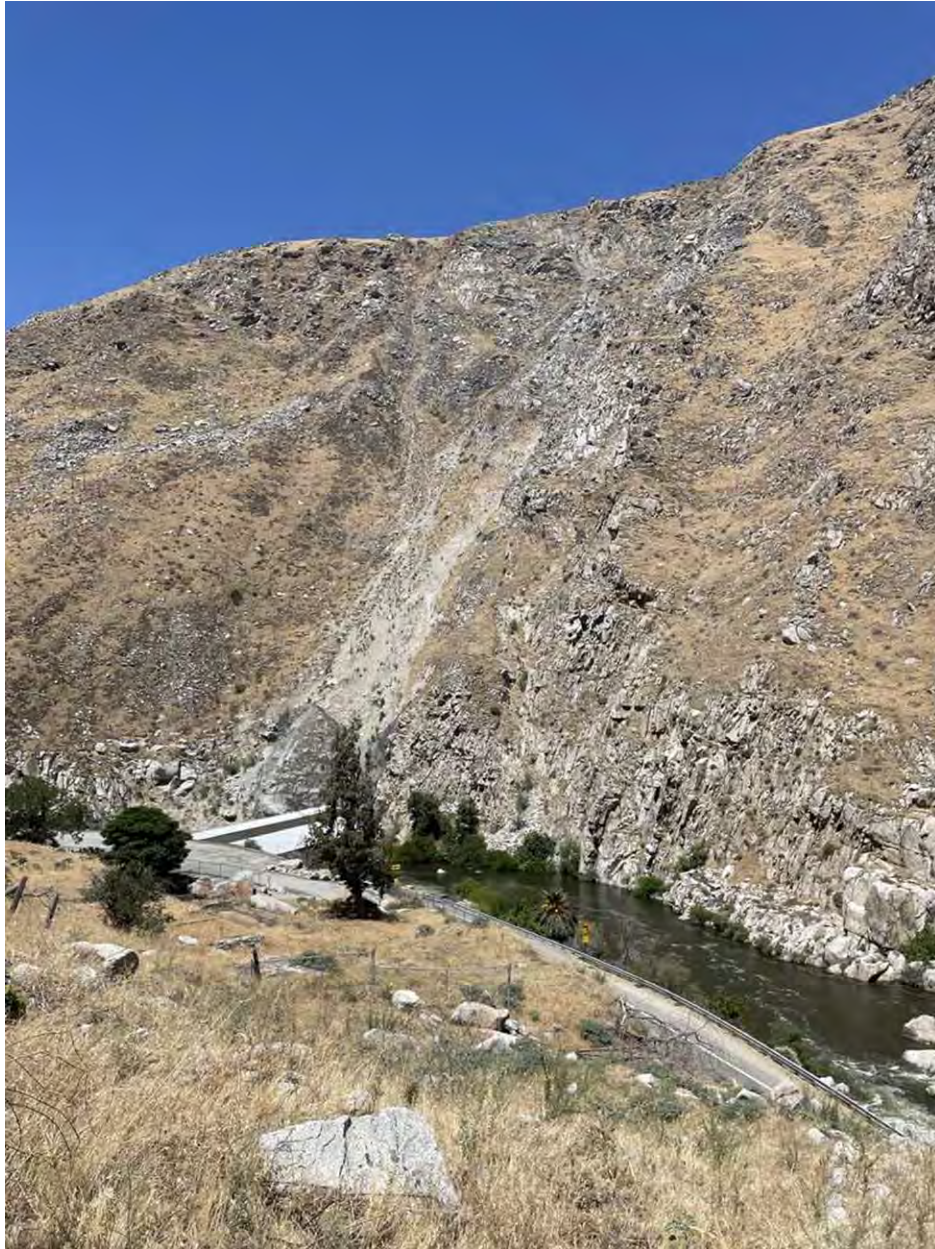
**Photo A-17. Natural Rockslide at KR1 Powerhouse**

**Photo A-18. Natural Rockslide at KR1 Powerhouse**

**Photo A-19. Natural Rockslide at KR1 Powerhouse**

At the time of field observation there was no active erosion occurring at any Project facilities. The forebay spill event discussed in Section 5.2.1 was the most significant documented erosion that has occurred in the vicinity of the Project. There is rockfall area on the other side of the river from the KR1 Powerhouse that has potential to affect the powerhouse. A steel rockfall mitigation fence has been installed to help protect the powerhouse (Appendix A, Photos A-17 to A-19). The rockfall area is not caused by Project facilities.

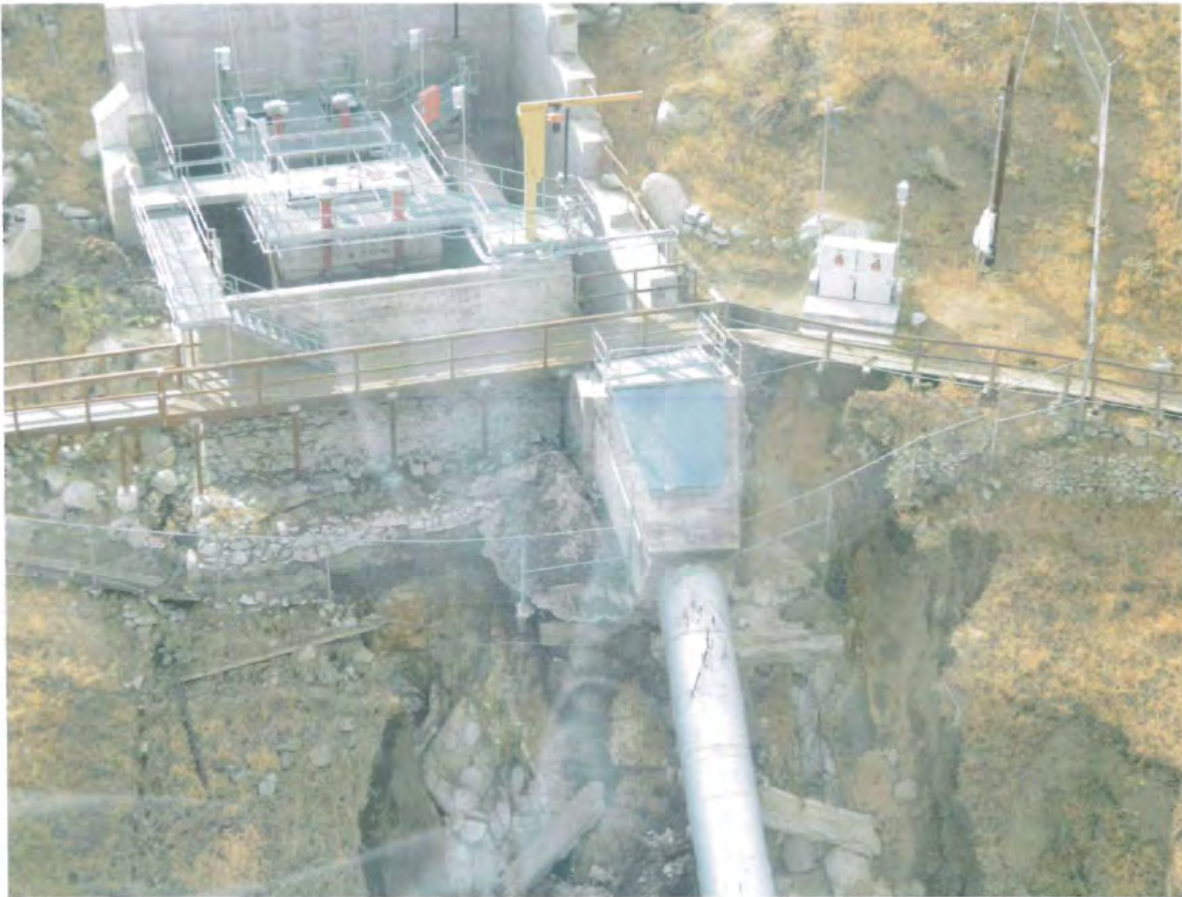
**Photo A-20. Erosion from the August 20, 2013, Forebay Spill Event (SCE 2013)**

During the storm, however, rock, mud, water, and plant material from a debris flow entered the KR1 conduit approximately 1 mile upstream of the forebay. This debris flow (mud and plant material) entered the flowline at Adit 17/18, which is an open-air vent location in the flowline. At Adit 17/18 the debris flow passed over and into the flowline at the vent location and this temporary surge of flow (with mud and plant material) continued down the flowline to the forebay. At the forebay an overflow spillway pipe would have handled the flow surge except for the mud and plant material caused the intake to the spillway pipe to plug. The overflow spillway pipe conveys flow surges to the Kern River. Due to the plugged intake the forebay was overtopped resulting in erosion of the hillside below the forebay and along (parallel to) the overflow spillway pipe (SCE 2013). Refer to Appendix A, Photos A-20 to A-22.

Following this event, SCE completed modifications to the flowline to prevent recurrence of a similar event. SCE has made modifications at the vent opening at Adit 17/18 to redirect any upslope runoff or debris flows over the opening and preventing flow, mud or plant material from entering the flowline. At the forebay measures were completed to prevent future overtopping by removing the screen/rack at the intake to the overflow spill pipe thus preventing plugging to allow any surge flow to enter the overflow pipe. Thus, this area is not subject to erosion/sedimentation due to ongoing, regular Project operations. Rather, the erosion was due to a unique, one-time event. At the time of field observations for this study, there was no evidence of ongoing active erosion observed at this location.

Site	Photographs (Appendix A)	Approximate Volume (CY)	Hydrology at the Time of the Survey	Project Related	Natural Causes	Description
8/20/2013 Forebay Spill	A-20	N/A	N/A	No*	Yes*	Rock, mud, water, and plant material from a landslide entered the KR1 conduit approximately 1 mile upstream of the forebay. This material continued downstream in the tunnel creating a temporary surge in flows at the forebay, causing the pipe spillway to plug and forebay to spill. This resulted in erosion of the hillside below the forebay and along the pipe spillway. This area is not subject to erosion/sedimentation due to ongoing, regular Project operations. Rather, the erosion was due to a unique, one-time event. At the time of field observations for this study, there was no evidence of ongoing erosion observed at this location.
8/20/2013 Forebay Erosion Deposit	A-21 to A-22	N/A	N/A	No*	Yes*

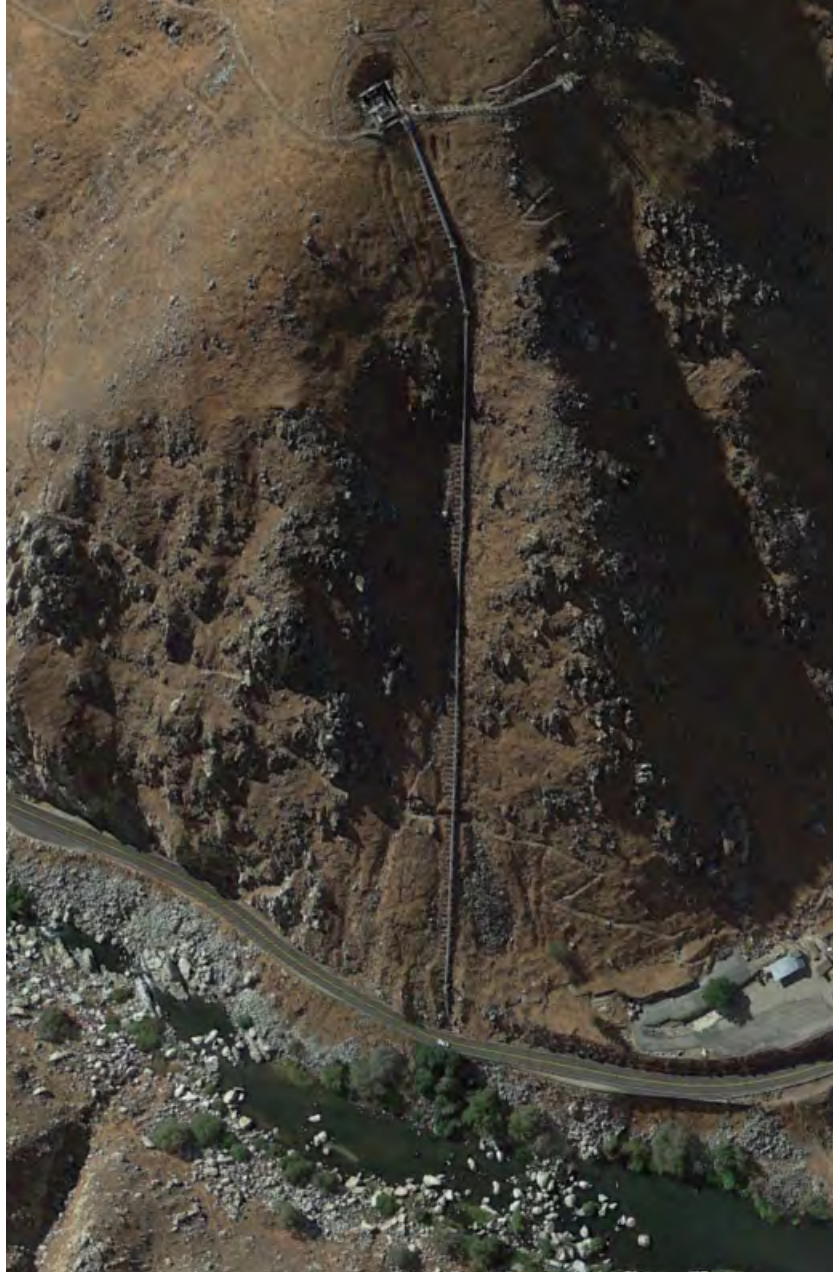
**Photo A-21. KR1 Penstock before the August 20, 2013, Forebay Spill Event (Google Earth Image, Date: 8/12/2013)**

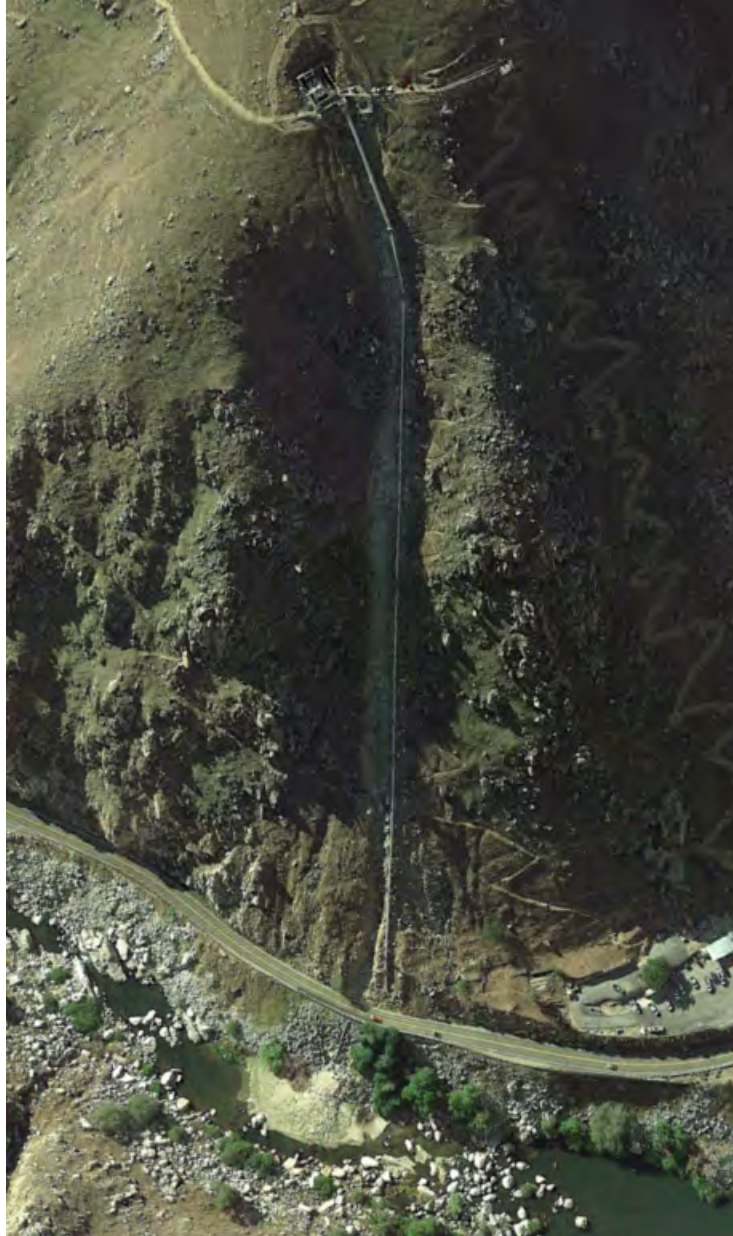
**Photo A-22. KR1 Penstock Erosion and Sediment Deposition in the Kern River Channel After the August 20, 2013, Forebay Spill Event (Google Earth Image, Date: 4/15/2014)**

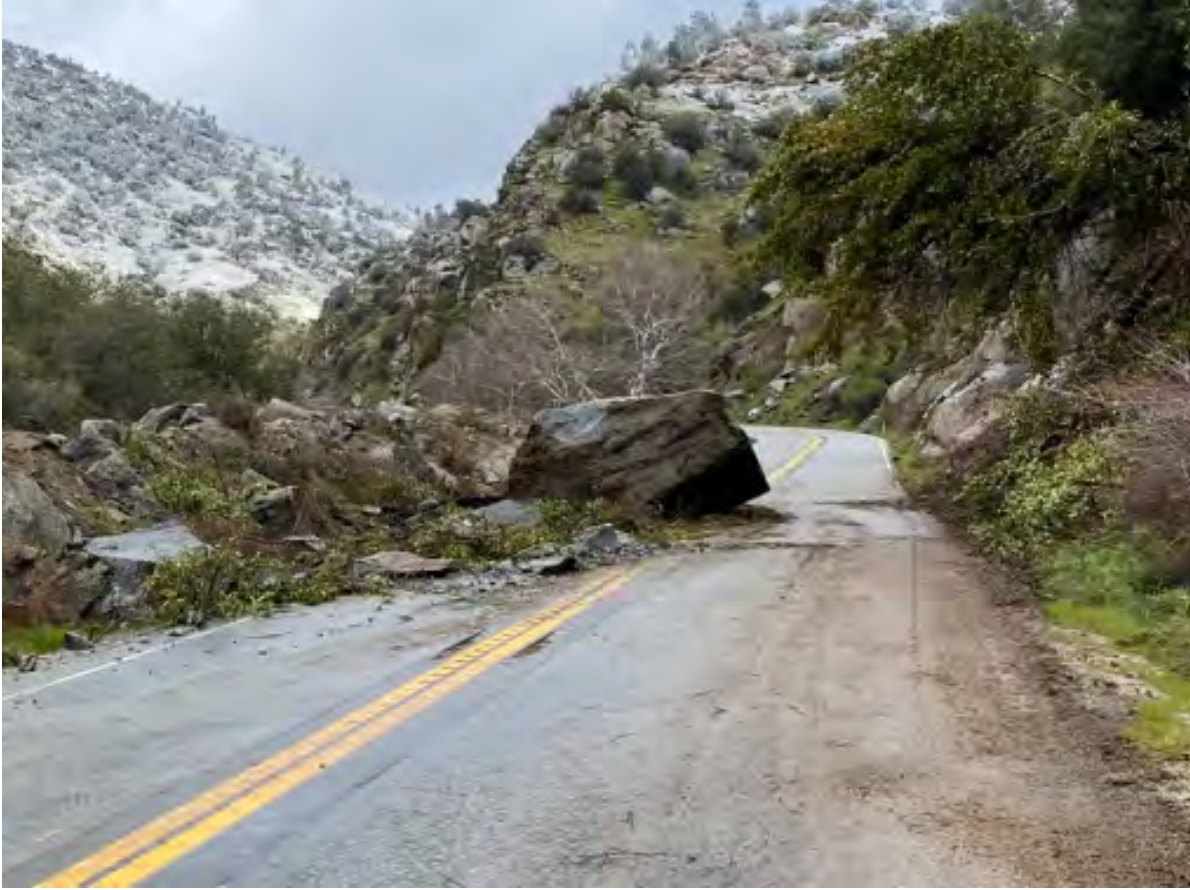
**Photo A-23. Debris Slide Closing SR-178 on March 1, 2023 (Caltrans 2023)**

Heavy rainfall on a record snowpack in the upper watershed's drainages caused debris slides and rockfalls which closed SR-178 for several days on March 1 and March 15, 2023 (Appendix A, Photos A-23 to A-24).

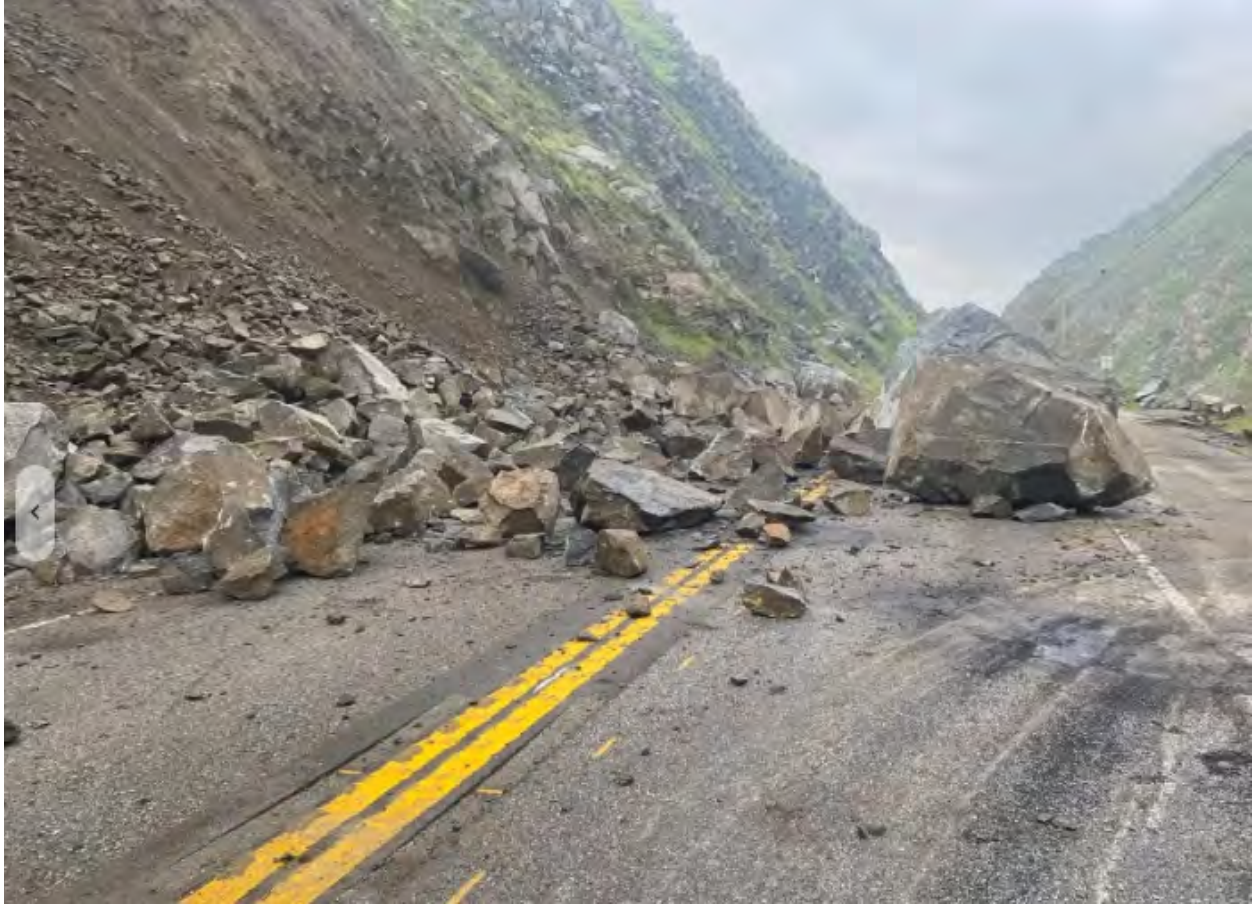
**Photo A-24. Debris Slide Closing SR-178 on March 15, 2023 (Caltrans 2023)**
