TERR 2 – WILDLIFE RESOURCES TECHNICAL MEMORANDUM

**KERN RIVER No. 1 HYDROELECTRIC PROJECT
*FERC PROJECT No. 1930***

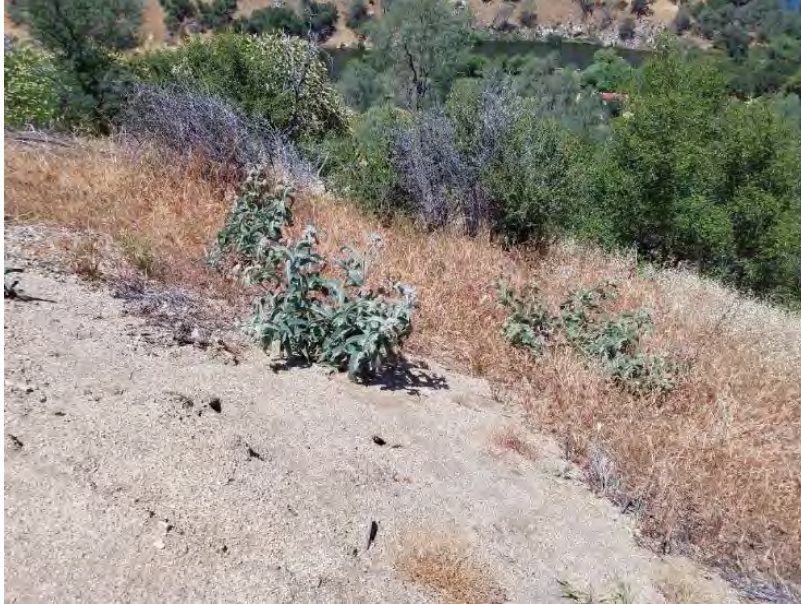
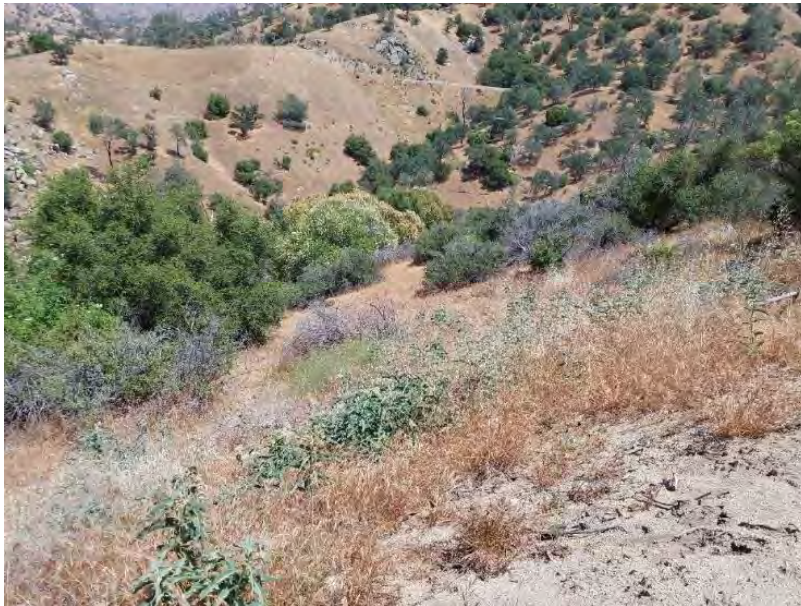
Photo A-1a, b. A large population of California milkweed (*Asclepias californica*) (Map ID ASC-1) found along Democrat Dam Road. This population is estimated to contain at least 70 individuals within approximately 6,500 square feet.

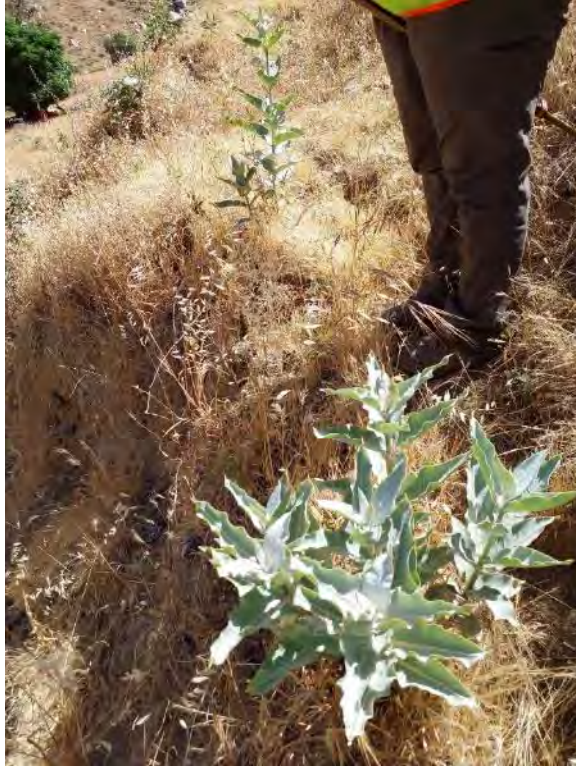
Photo A-2. A California milkweed identified along the Overflow Spillway Trail (Map ID ASC-3). This small population consists of two individuals within approximately 4 square feet.

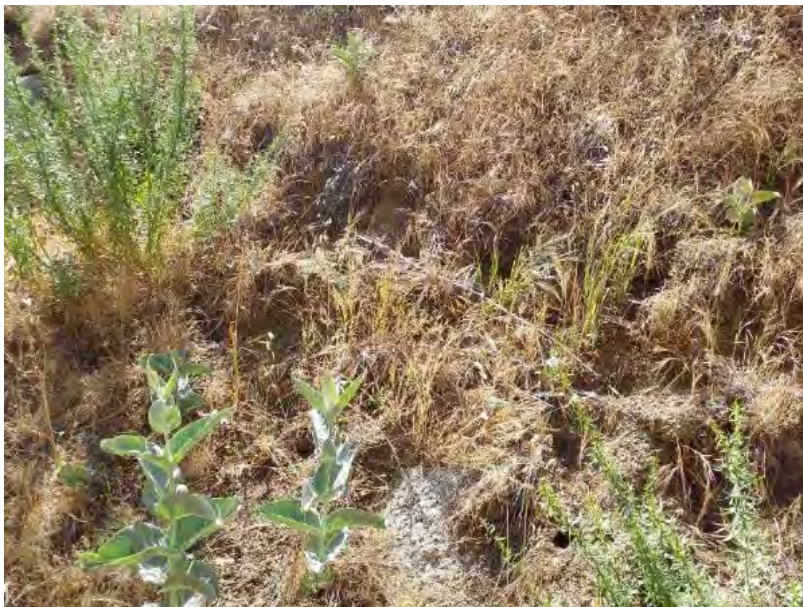
Photo A-3. A small population of California milkweed individuals found along the Overflow Spillway Trail (Map ID ASC-4). This population consists of seven individuals within approximately 40 square feet.

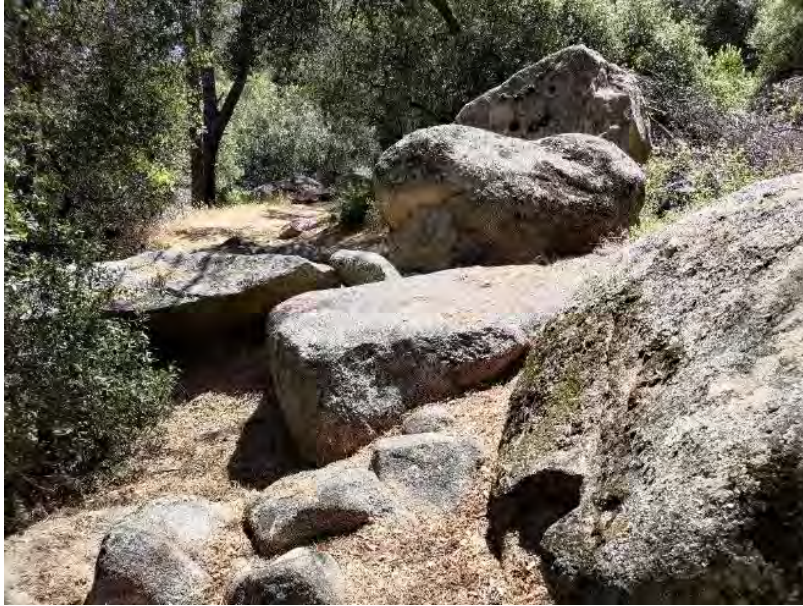
Photo A-8. Habitat for terrestrial reptiles was found throughout the Project area. Reptiles were most often seen on or along roads and trails where rock or vegetative cover was nearby. Both snakes and lizards were observed in areas with features similar to this photo (i.e. warm sunny areas, cracks in/between rocks, burrows, and vegetative cover).

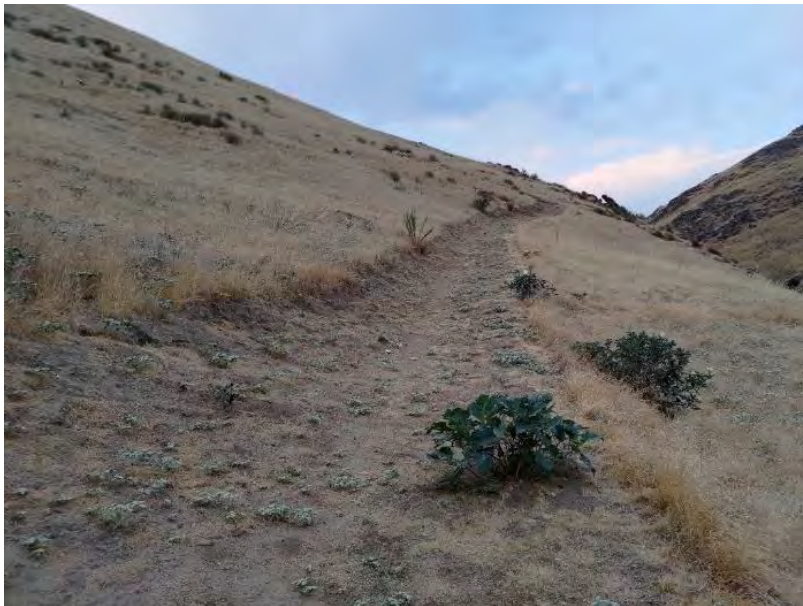
Photo A-9. This photograph of Lucas Creek Trail shows another typical trail and the surrounding terrestrial reptile habitat within the Project area. This photo was taken after SCE mowing maintenance in July 2024. Burrows of varying size were found along the length of the trail.

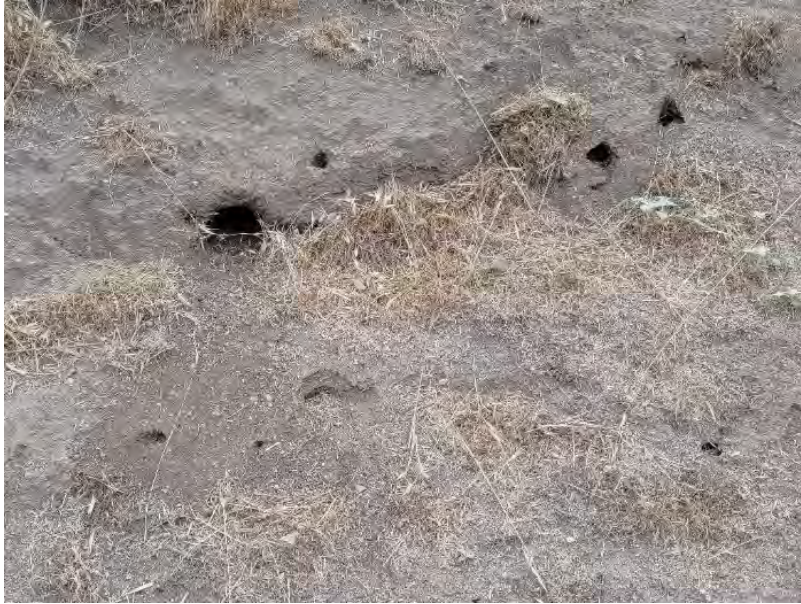
Photo A-10. Example of a typical variety of burrow sizes seen throughout the Project area. These burrows were observed along Lucas Creek Trail and provide habitat for terrestrial reptiles.

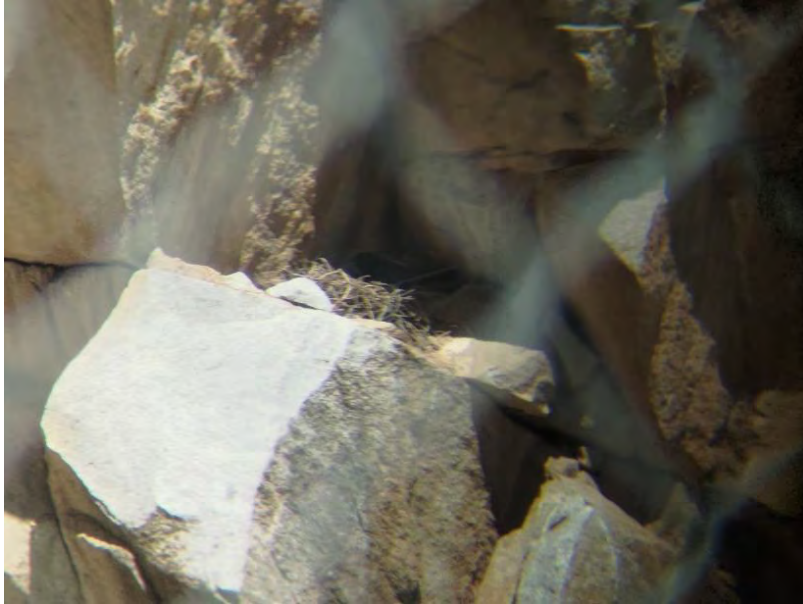
Photo A-12. The common raven nest is located to the west of Upper Powerhouse Road on the cliff bordering the Kern River outside the FERC boundary. Two adults were observed feeding two young within the nest.

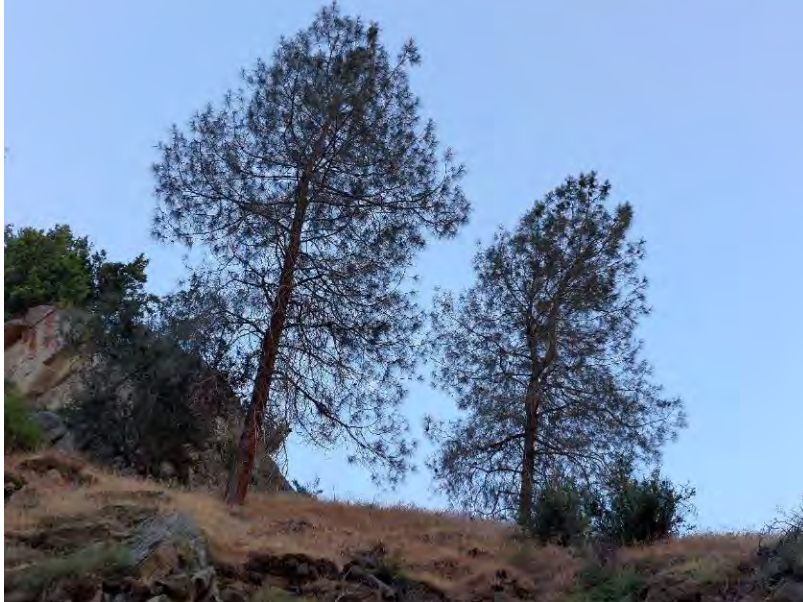
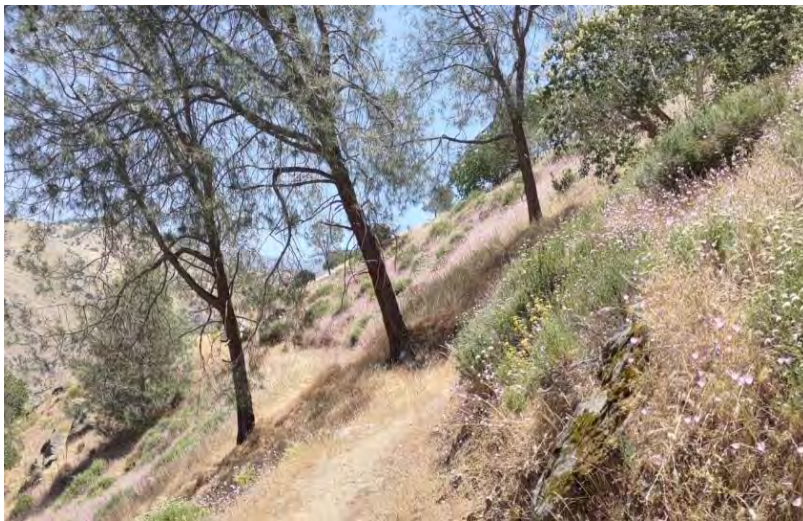
Photo A-13a, b. Photographs of typical Blue Oak–Foothill Pine CWHR habitat in the study area.

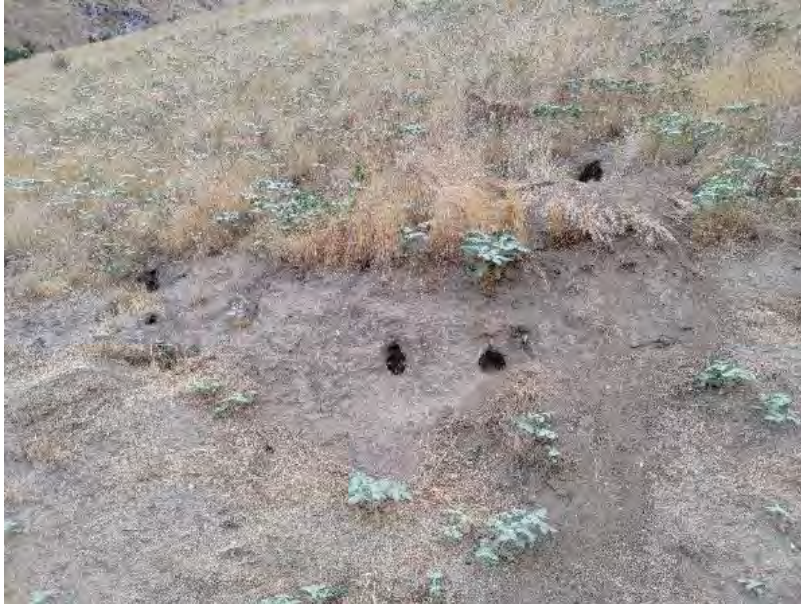
Photo A-17. This burrow complex (Map ID BUR-1, BUR-2, BUR-3) was found on Lucas Creek Trail. All the burrow entrances are approximately the same size ranging from three and a half to four inches tall and three to four inches wide. BUR-2 is collapsed and is only three inches deep. BUR-1 goes back approximately seven inches before turning while BUR-3 goes down approximately nine inches before turning. BUR-3 had some soil disturbance leading from the burrow and grass that was flattened around it indicating it may be active. No signs of kit fox habitation were observed.

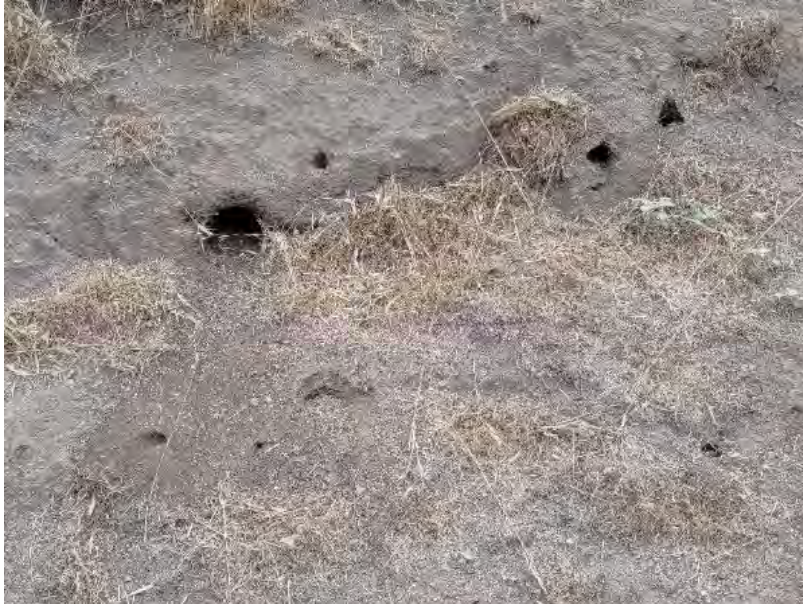
Photo A-19. This burrow (Map ID BUR-5) was found on Lucas Creek Trail. The entrance is four and a half inches tall and four and a half inches wide. The burrow goes back approximately one and a half feet before turning so the den chamber size could not be determined. The soil disturbance may be from unstable soils and not excavations. There are no other signs of occupancy.

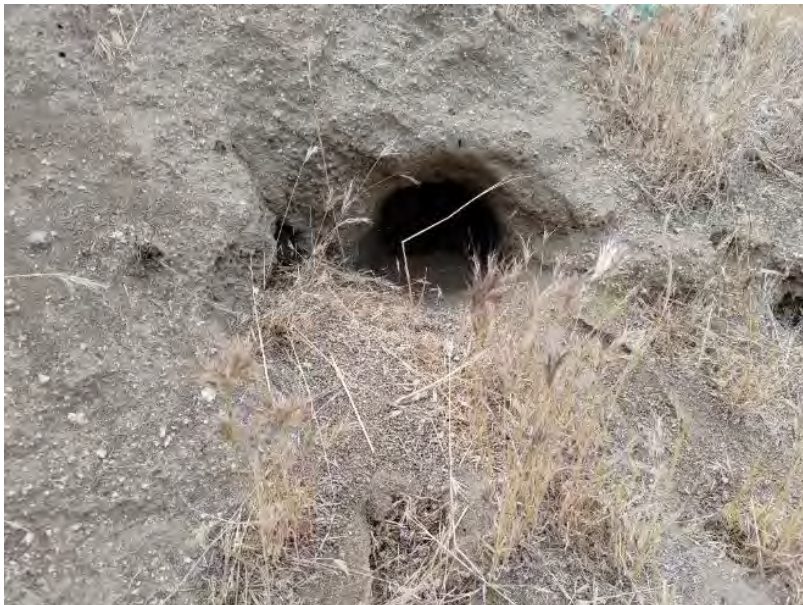
Photo A-20. This burrow (Map ID BUR-7) was found along Lucas Creek trail. The entrance is six and a half inches wide and five and a half inches tall. It is three to four feet deep with a visible chamber of approximately one foot by one foot. The burrow seems to have a second chamber that goes further and is part of a turn. There were no signs of occupation but the burrow is suitable size for kit fox. It is likely overgrown with grasses in the spring/summer.

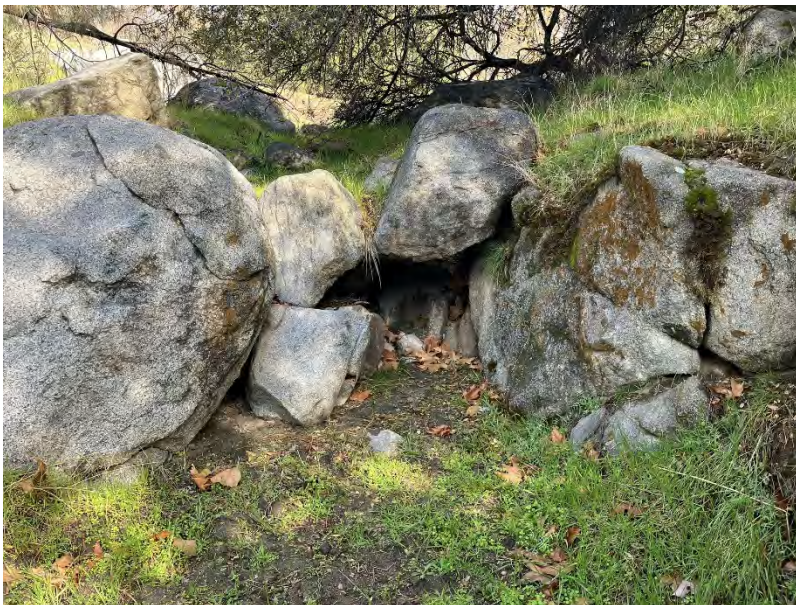
Photo E-1. An example of potential relictual slender salamander (*Batrachoseps relictus*) (FPE, CSC) habitat, dry during the assessment, observed within the Democrat Dam Impoundment area on January 27, 2025. This habitat was wet with slow flowing water and small pools at the time of the visual encounter survey. This photo shows that potential habitat can be dry during non-breeding periods.

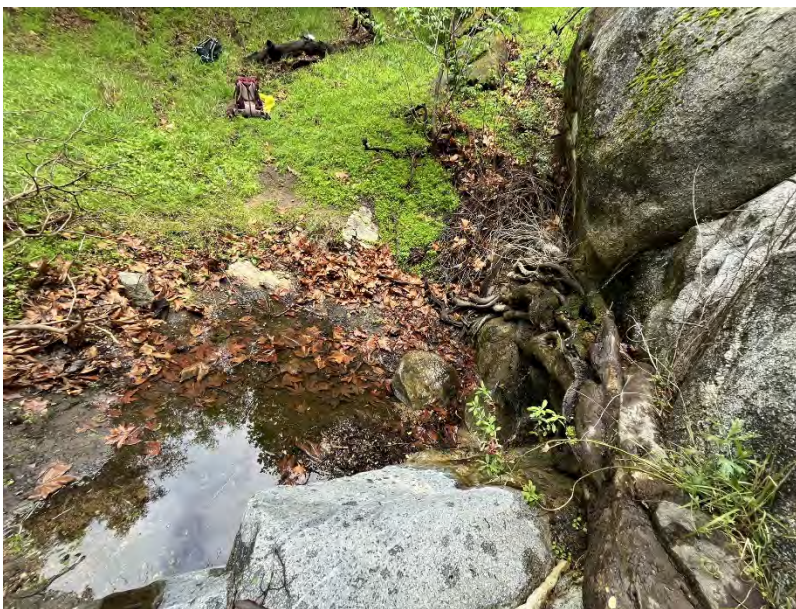
Photo E-2. An example of potential relictual slender salamander habitat with water present observed along Willow Spring Creek Road during the visual encounter survey on March 3, 2025.

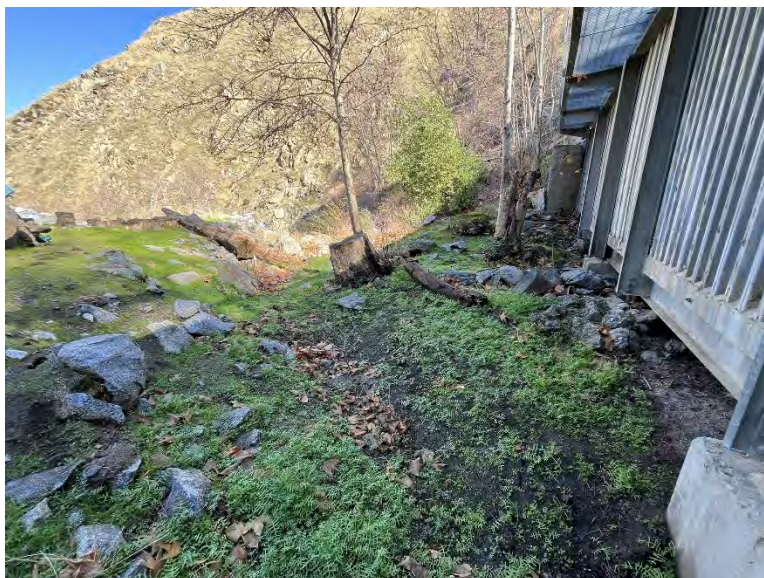
Photo E-3. An example of potential relictual slender salamander habitat observed at Flume No. 5 intersecting with Dougherty Creek observed during the habitat assessment on January 28, 2025.

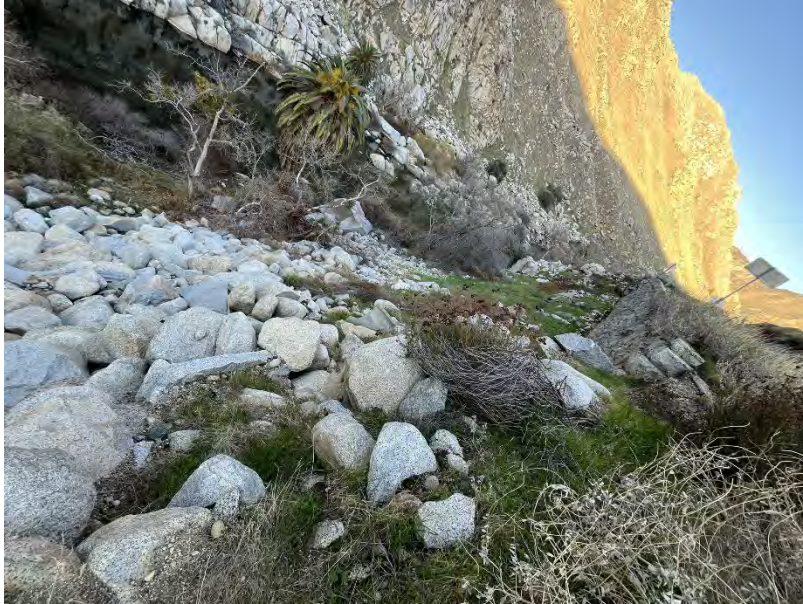
Photo E-5. An example of Kern Canyon slender salamander (*Batrachoseps simatus*) (FPT, CT) habitat observed east of the Kern River Powerhouse during the habitat assessment conducted on January 29, 2025.

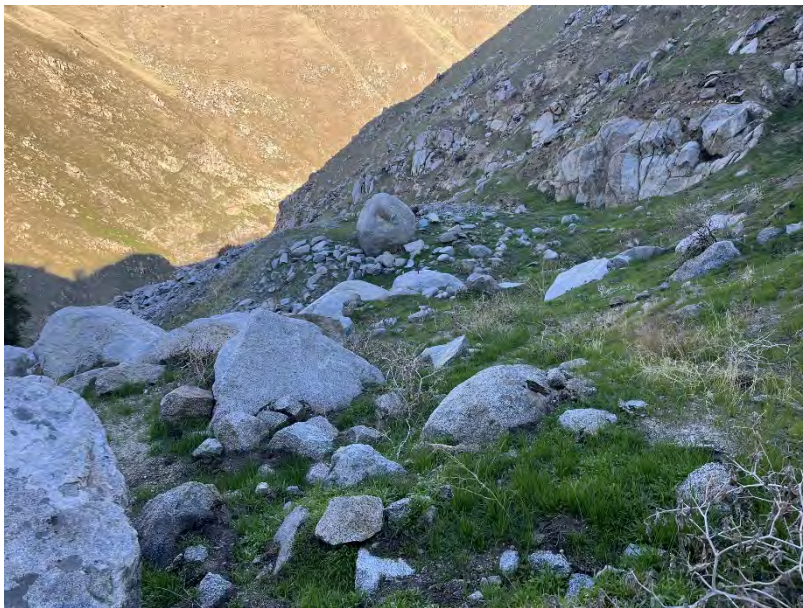
Photo E-6. An example of potential Kern Canyon slender salamander habitat observed at Adit 14 & 15 during the habitat assessment on January 30, 2025.

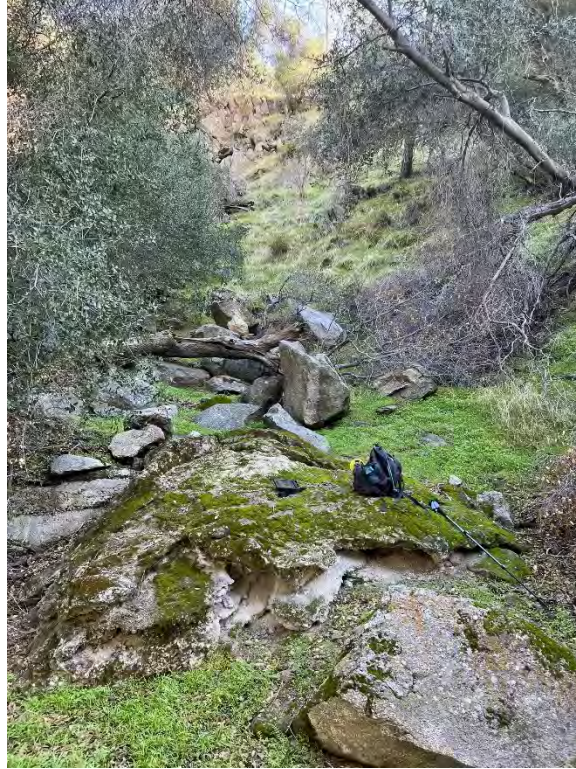
Photo E-7. An example of potential Kern Canyon slender salamander habitat observed at Conduit No. 6 during the habitat assessment on January 29, 2025.

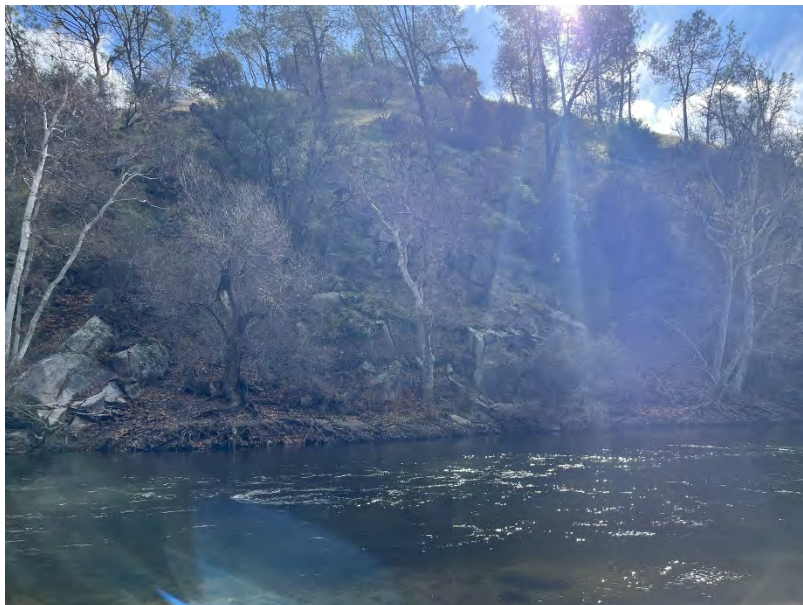
Photo E-8. An example of potential Kern Canyon slender salamander habitat observed along the Democrat Impoundment during the habitat assessment on January 27, 2025.

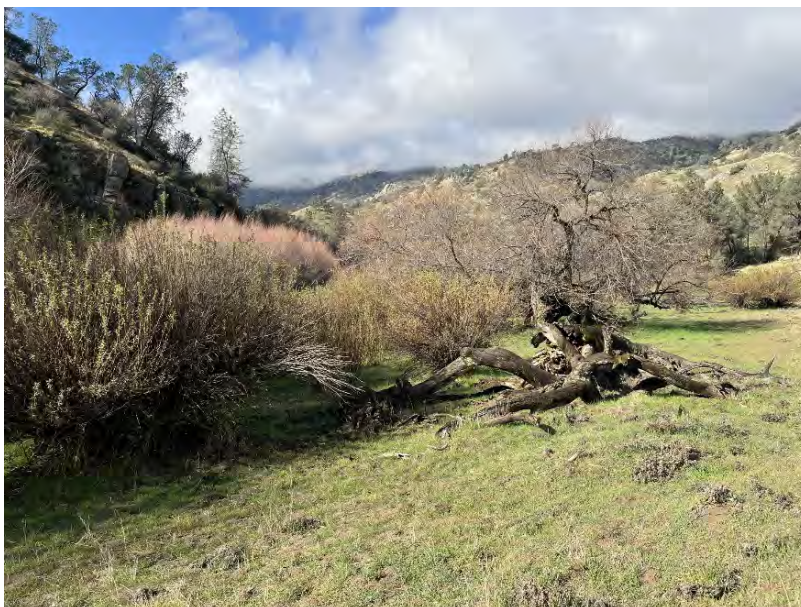
Photo E-9. An example of potential yellow-blotched salamander (*Ensatina eschscholtzii croceater*) (FSCC, WL) habitat found along the Democrat Dam Impoundment during the habitat assessment on January 27, 2025.

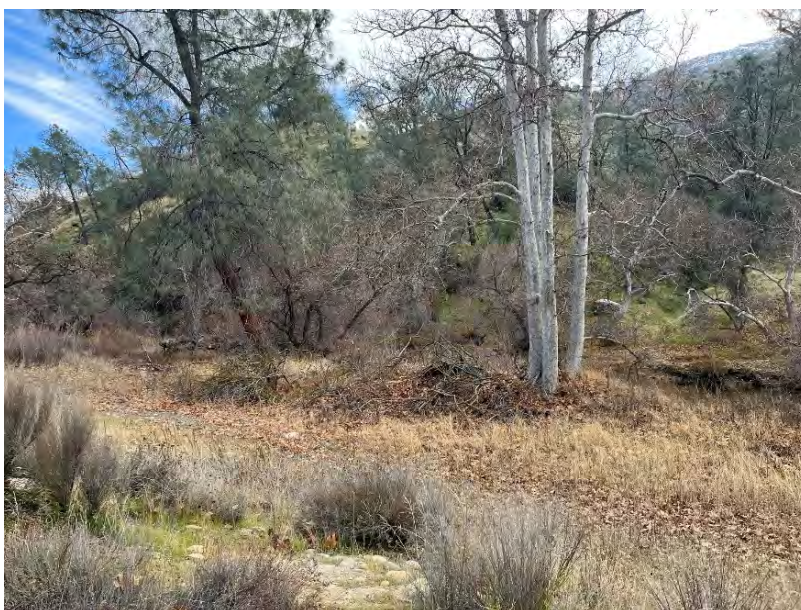
Photo E-10. Another example of potential yellow-blotched salamander habitat, found on the island within the Democrat Dam Impoundment during the habitat assessment on January 27, 2025.

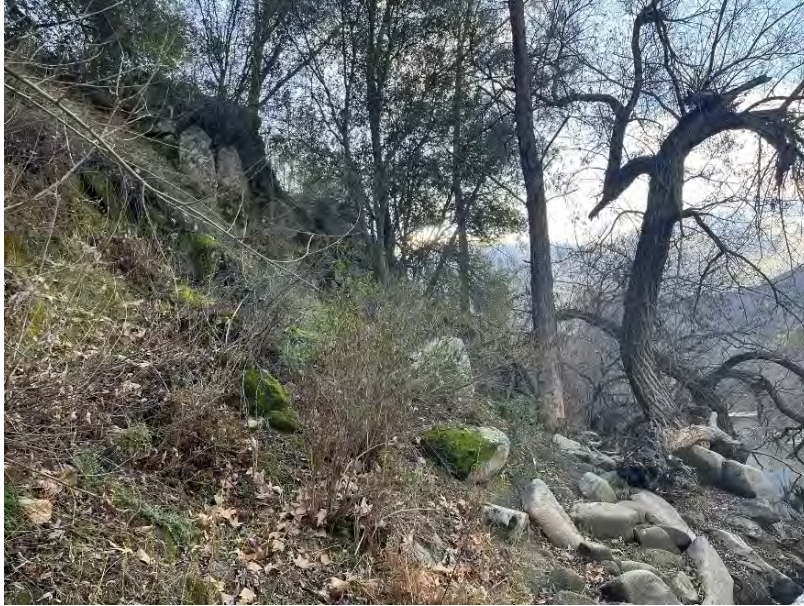
Photo E-11. Potential yellow-blotched salamander habitat found along the Democrat Dam Impoundment during the habitat assessment on January 27, 2025.

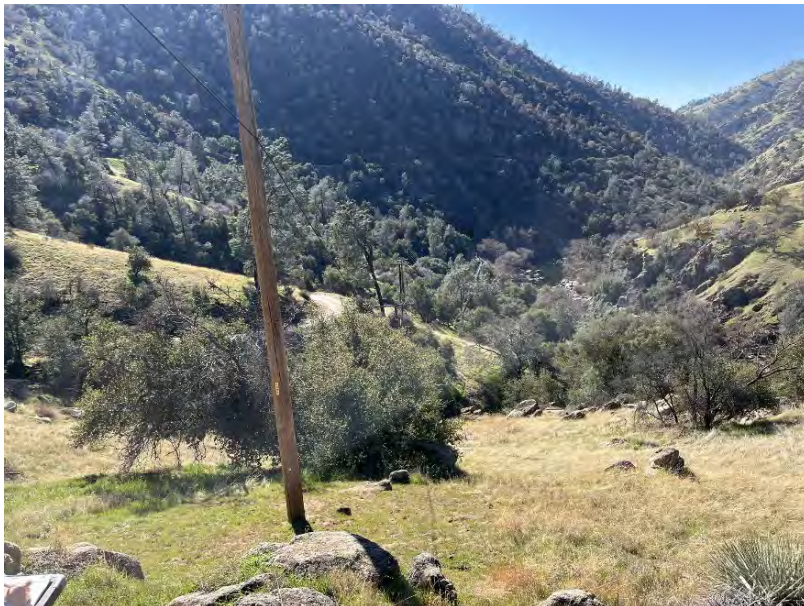
Photo E-12. Potential yellow-blotched salamander habitat found along the Intake Gatehouse to Flume No. 1 Powerline boarding Willow Spring Creek Road, dry during the habitat assessment on January 27, 2025.

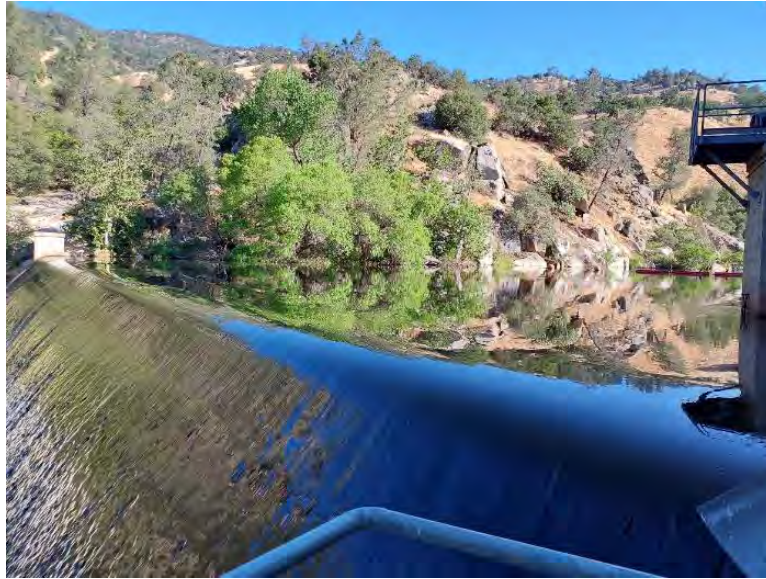
Photo G-1. Democrat Dam: The Democrat Dam is regularly submerged in the water and is not suitable habitat for roosting bats. The support buildings contain roofed elements but the wind exposure is too high for bat roosting and there are limited area bats can grasp for roosting.

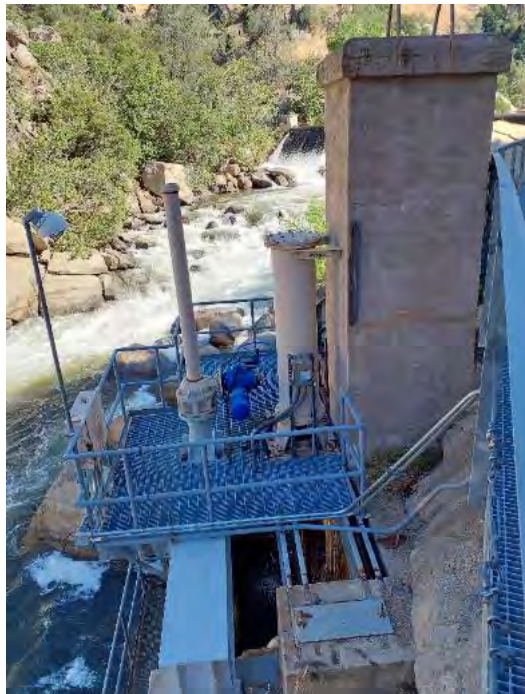
Photo G-4. Drainage Tunnel Outlet: The drainage tunnel outlet is a textured concrete structure with some vertical steel, and roofed elements. This structure could act as a potential night roost. No guano or signs of roosting were observed. This facility is not currently being utilized by bats.

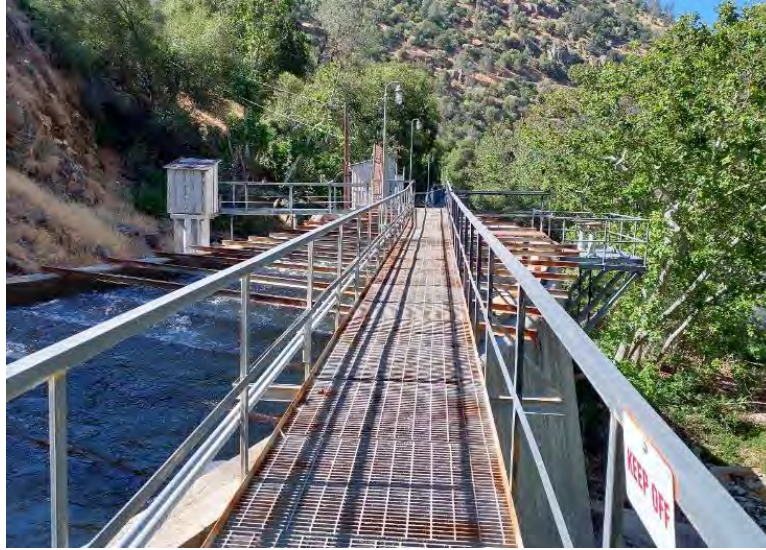
Photo G-5: Democrat Dam Access Walkway: The grated walkway is composed of steel and is exposed. It is not suitable habitat for maternity or day roosting. The roofed elements and vertical structures could potentially support bat roosts at night. The unnamed buildings on the walkway were found to have guano and are suitable night roosting habitat. An active western mastiff bat colony is present adjacent to the walkway on a connected rock crevasse.

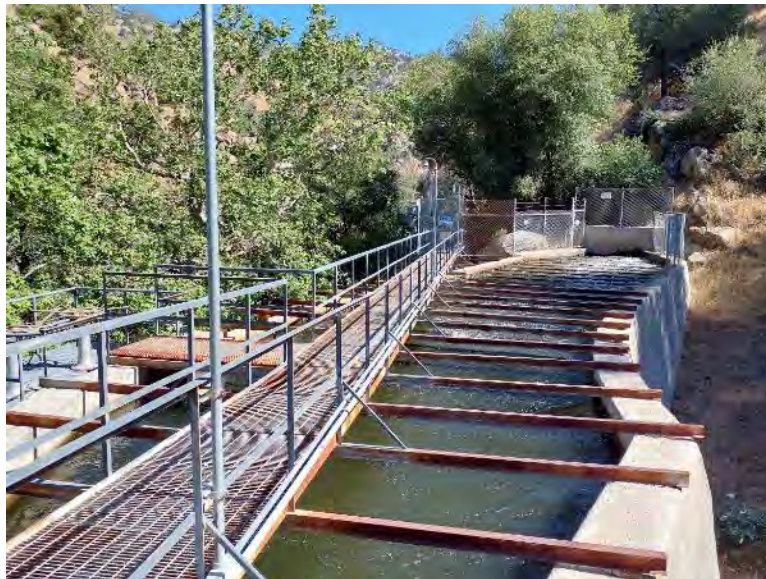
Photo G-6. Sandbox: This Project facility is an open water conveyance system. It is a concrete structure with no cracks or roofed elements that could support bat roosting. This facility is not suitable for roosting.

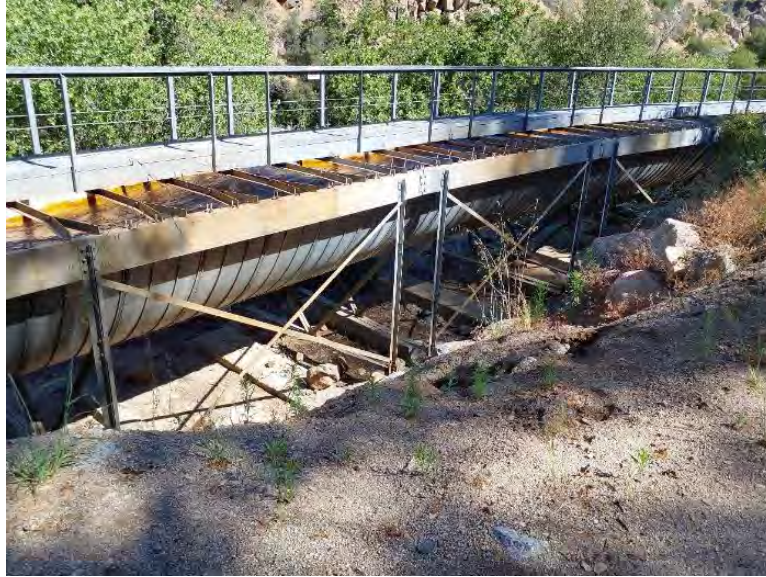
Photo G-7. Flume No. 1: This Project facility supports vertical structures and roofed elements but the vibration from the flow of water and cold metal makes utilization unlikely. This facility is not suitable for roosting.

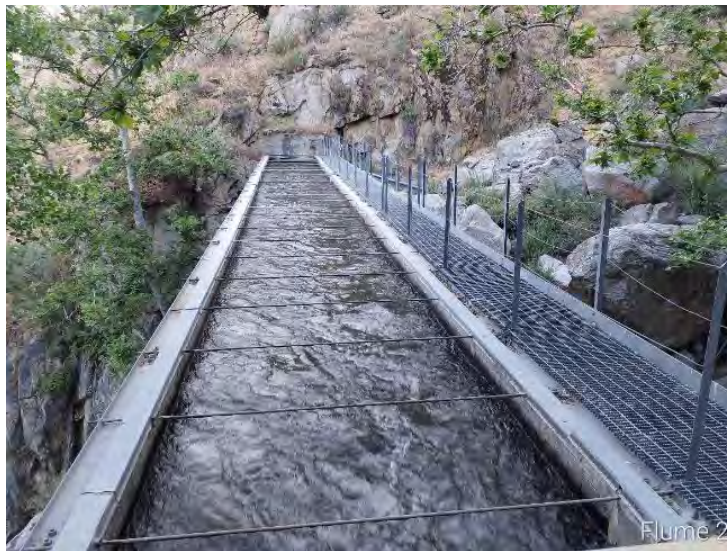
Photo G-12. Flume No. 2 Cow Flat Creek and Gauge 11192000 (SCE 410): The flume consists of metal with no point of attachment for bats and is filled with flowing water. Old guano was present along the walkway between the facility and Stilling Well No. 2. The facility is likely used as a water source but is not currently being used for roosting. The flume could be utilized for roosting if mud nests are present as observed on Flume No. 4 (Lucas Creek).

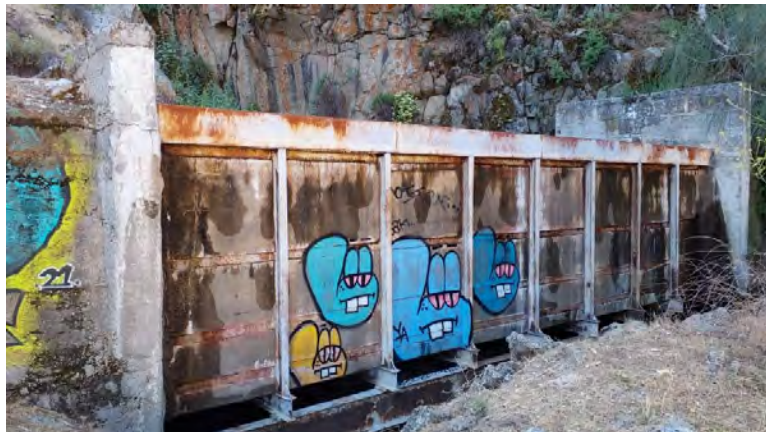
Photo G-14. Flume No. 3: The facility is an exposed steel structure with rapidly flowing water. This facility is not currently being used for roosting but is a potential water source. The flume could be utilized for roosting if swallow mud nests are present as was observed on Flume No. 4 (Lucas Creek). Bats are not currently utilizing this facility.

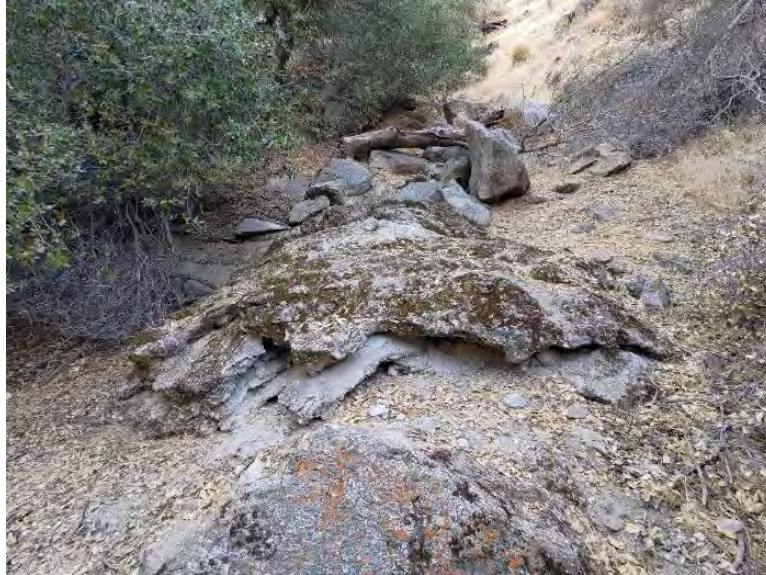
Photo G-15. Conduit No. 6: The conduit is entirely enclosed with concrete and eroded granite. The conduit has some crevices bats could utilize. However, the conduit is too close to the ground and potential predators. This facility is not suitable for roosting.

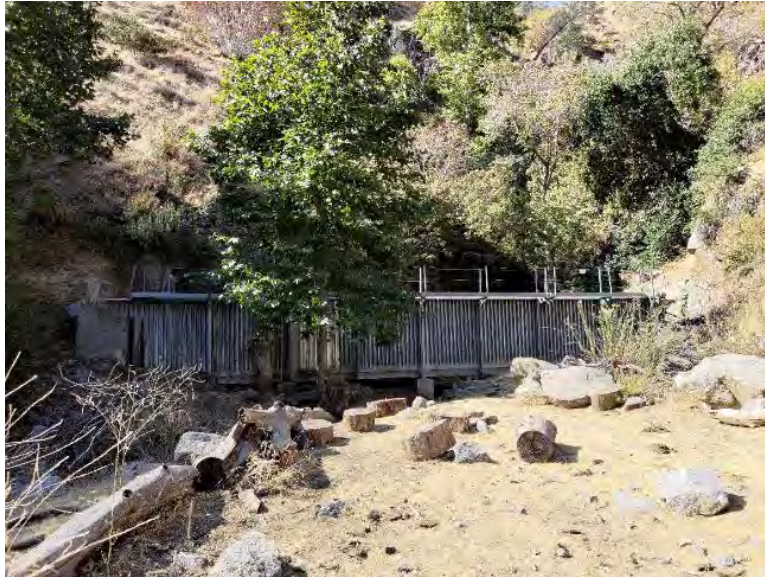
Photo G-17. Flume No. 5 Dougherty Creek/Conduit No. 7: The flume is made of metal and has steel roofed elements that bats could utilize for roosting under appropriate conditions. It also has concrete in some areas which could be used for roosting. The flume could be utilized for roosting if swallow mud nests are present as was observed on Flume No. 4 (Lucas Creek). Bats are not currently utilizing this facility.

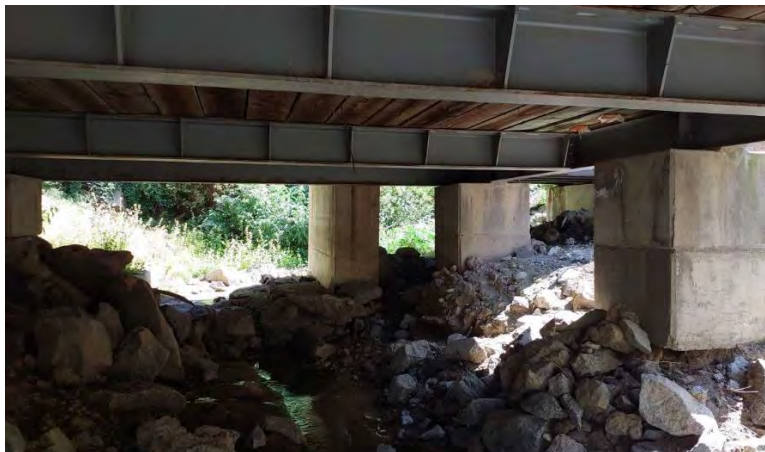
Photo G-18. Access Platform: The underside of the platform is very open with no good roosting locations on metal girders and wooden planks where bats could be sheltered. Cattle also often disturb this area passing under this location. This facility is not suitable for roosting.

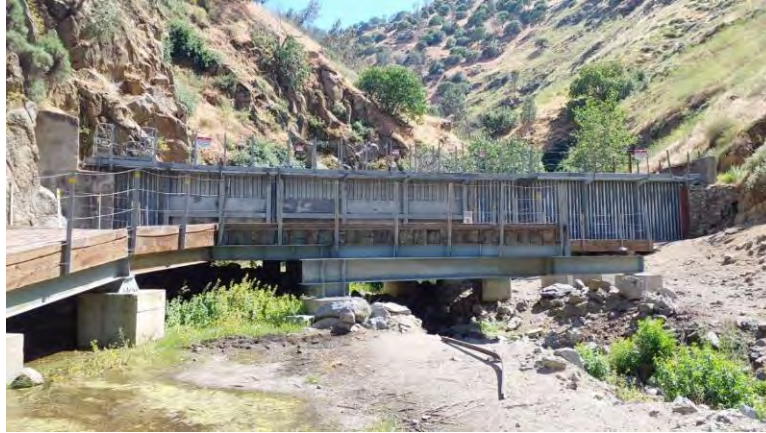
Photo G-19. Flume No. 6 Stark Creek/Conduit No. 8: The flume is made of metal and largely not suitable habitat for roosting bats. The conduit is made of concrete with no cracks or areas that bats could utilize. The flume could be utilized for roosting if swallow mud nests are present as was observed on Flume No. 4 (Lucas Creek).

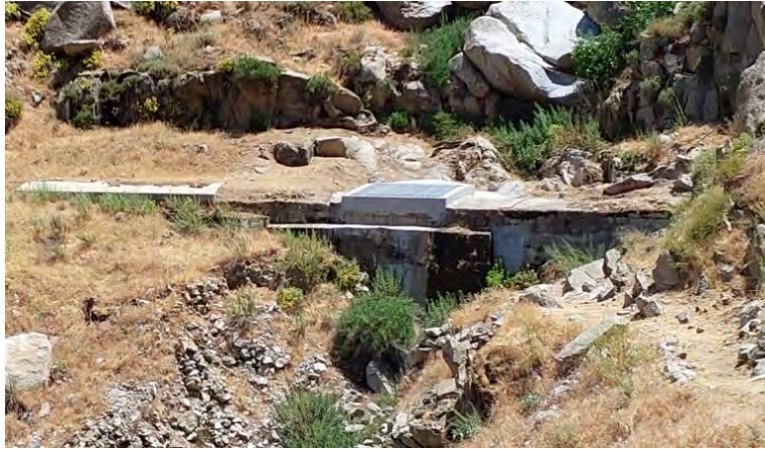
Photo G-23. Conduit No. 9: The concrete structure has a metal covering that bats could enter but it contains flowing water and is not suitable roosting habitat. The exterior has no cracks or crevices. The facility is not suitable for roosting.

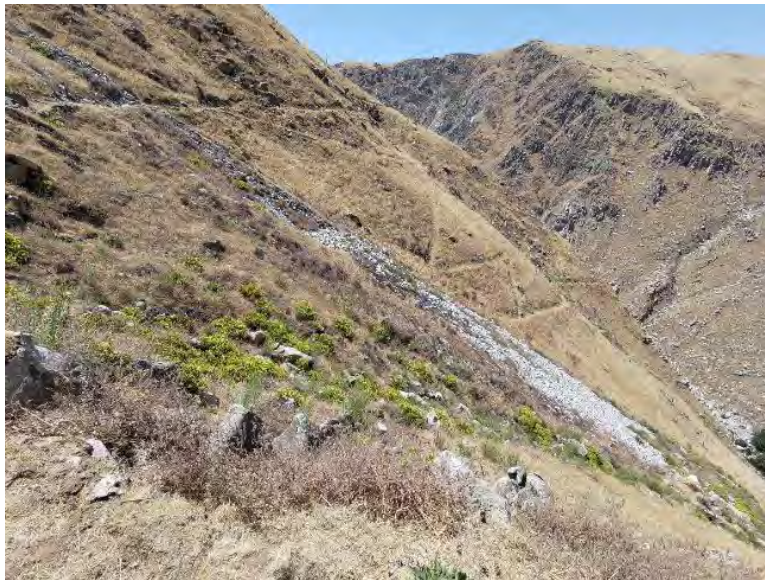
Photo G-24. Adit 18 & 19: This adit is composed of a pile of granite rocks on a steep slope. Rocks too close to the ground and does not have suitable entry points for bats. The facility is not suitable for roosting.

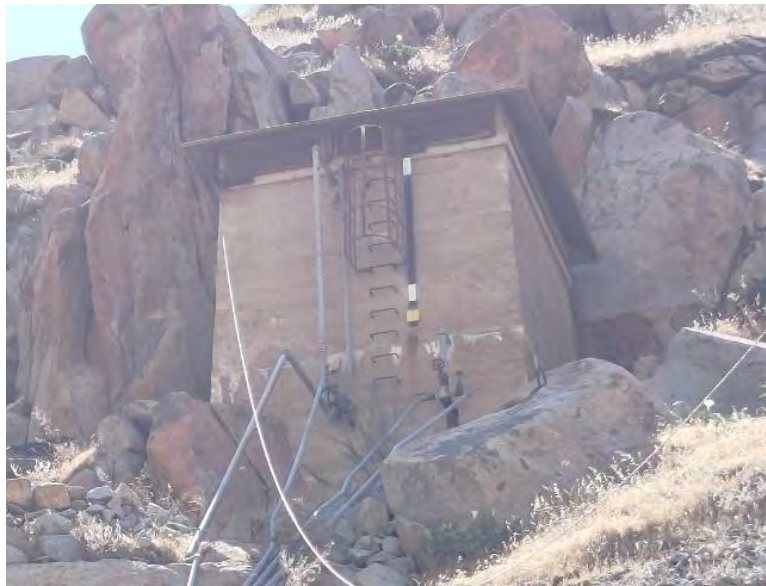
Photo G-28. Water Tank: The water tank has vertical structures, overhangs, and a textured concrete base. The area where the roof joins the wall provides suitable night roosting habitat. A guano pile was found between water tank and rock wall. This facility supports a night roost and a potential day roost.

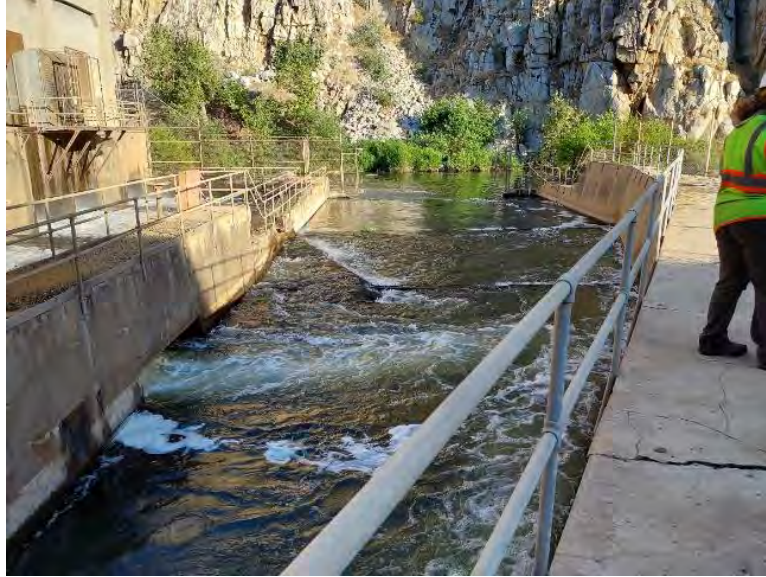
Photo G-29. Trailrace: The tailrace does not support suitable bat roost habitat. It is an open waterway and does not contain roosting elements though bats may drink from it.

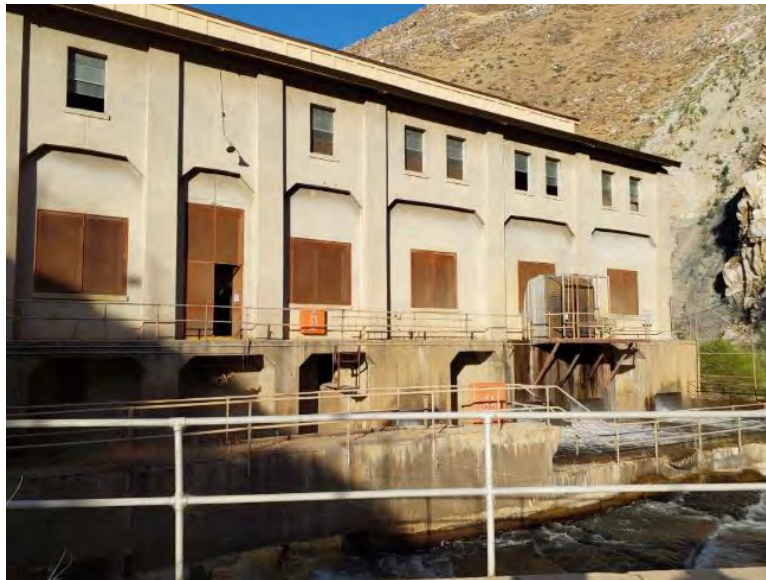
Photo G-30. Kern River No. 1 Powerhouse: Bat roosts are present inside and outside of the building. There are rooms, hallways, stairwells, and corners where bat urine and feces were observed. The operations manager stated that bat activity is seen often. Big brown bat observed (dead). This facility supports an active night roost. It also supports a seasonal day and maternity roost.

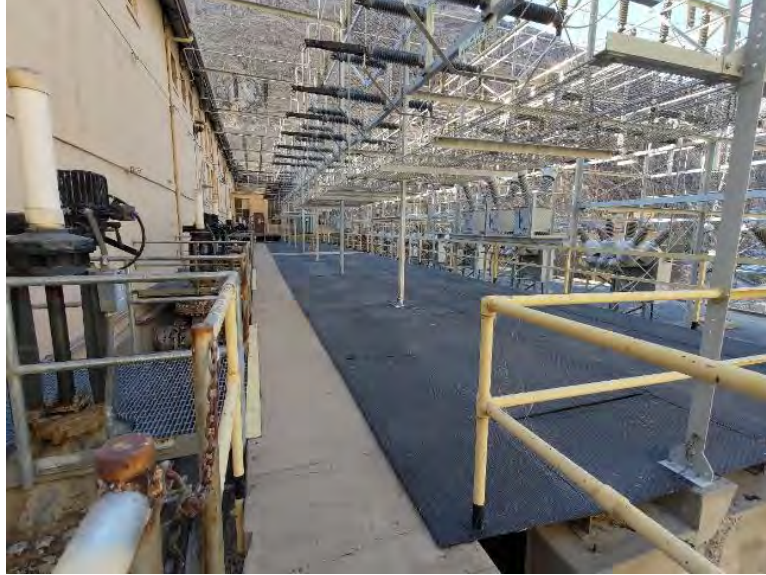
Photo G-31. Kern River No. 1 Switchyard: The facility consists of active electrical equipment and potential roosting areas are highly exposed to the elements or electrical current. Facility is not suitable for roosting but bats may pass through to enter the Powerhouse.
