Rush Creek Project, FERC Project No. 1389

AQ 5 – Geomorphology 2024 Parts A & B  
Draft Technical Study Report

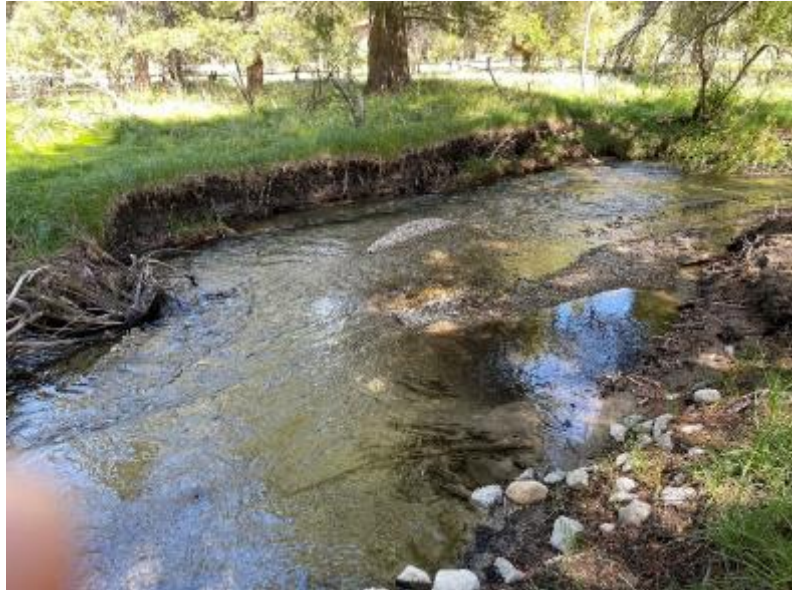
**Photo AQ 5-17. Reversed Creek in Meadow downstream from Hwy.158, one of the few sites observed with erosion (left bank, view is downstream).**

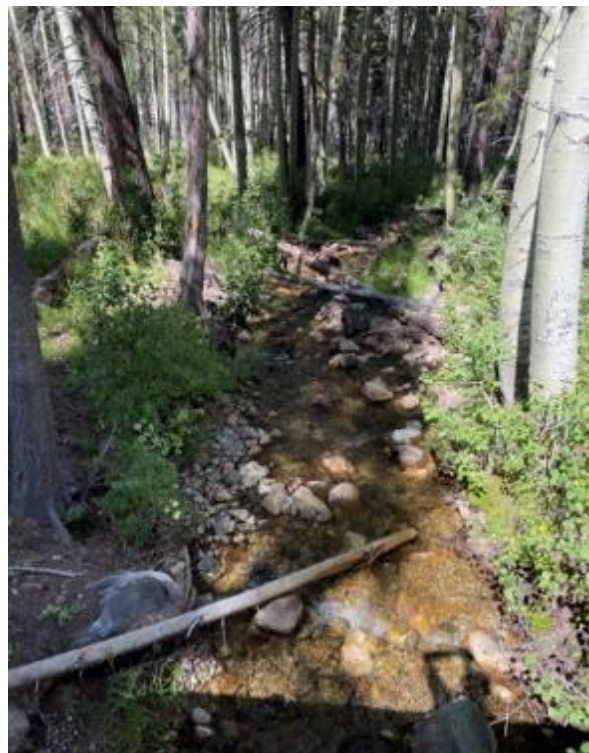
**Photo AQ 5-18. Fern Creek near the Fern/Yost trailhead loop road off Boulder Road (Hwy 158). Low, cobble banks, forested. No erosion.**

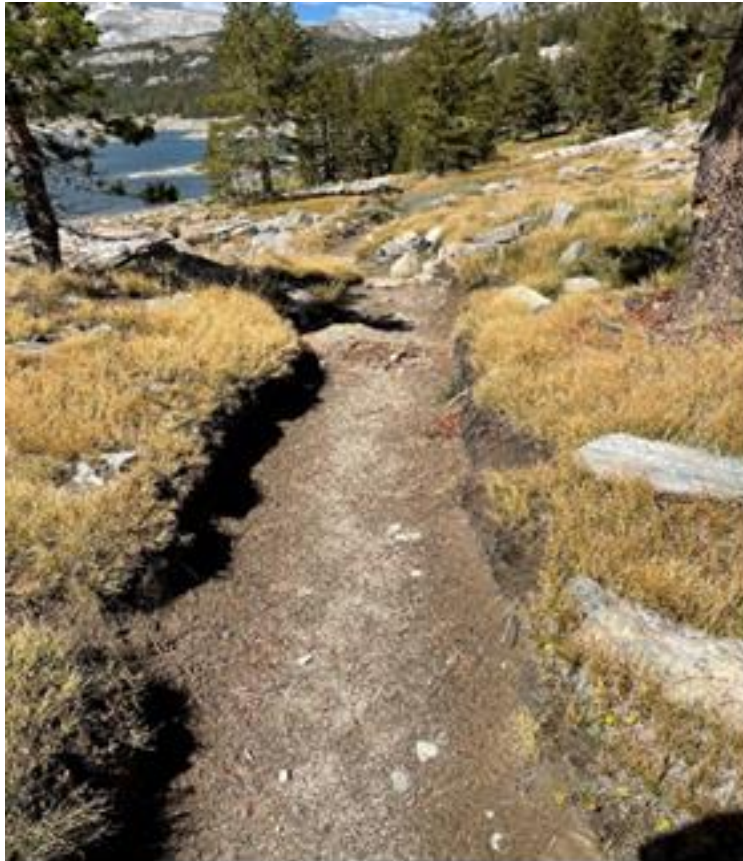
**Photo AQ 5-23. Prolonged surface wear and erosion of the trail bed coupled with diversion of surface flow from upslope has caused incision (location TE-1).**

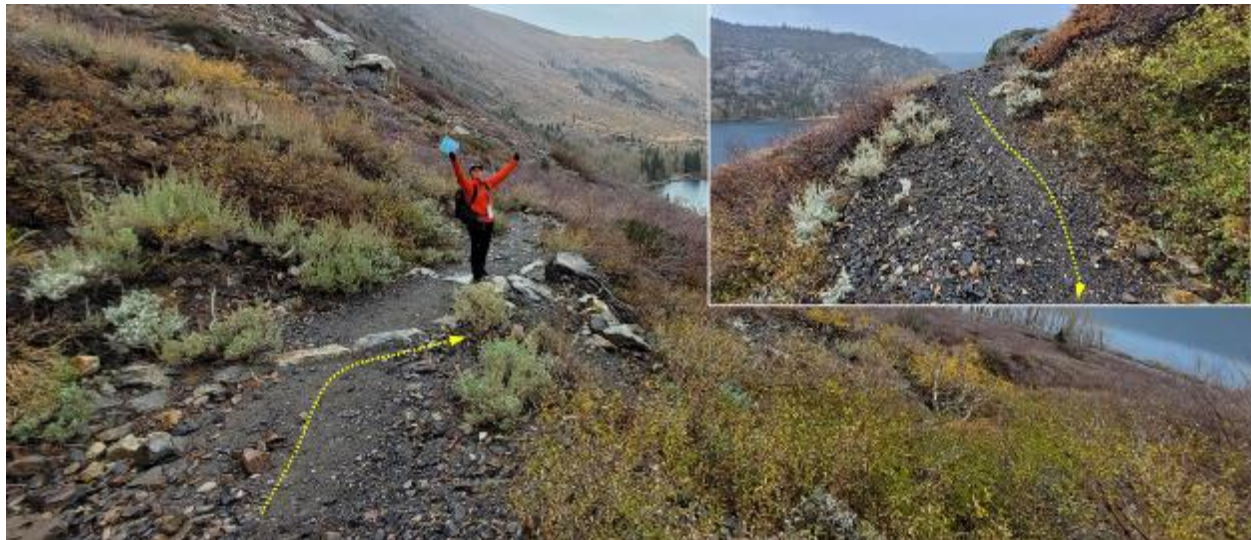
**Photo AQ 5-24. Example of a trail runoff diversion structure with minor sediment accumulation due to trail bed surface erosion (location TE-2).**

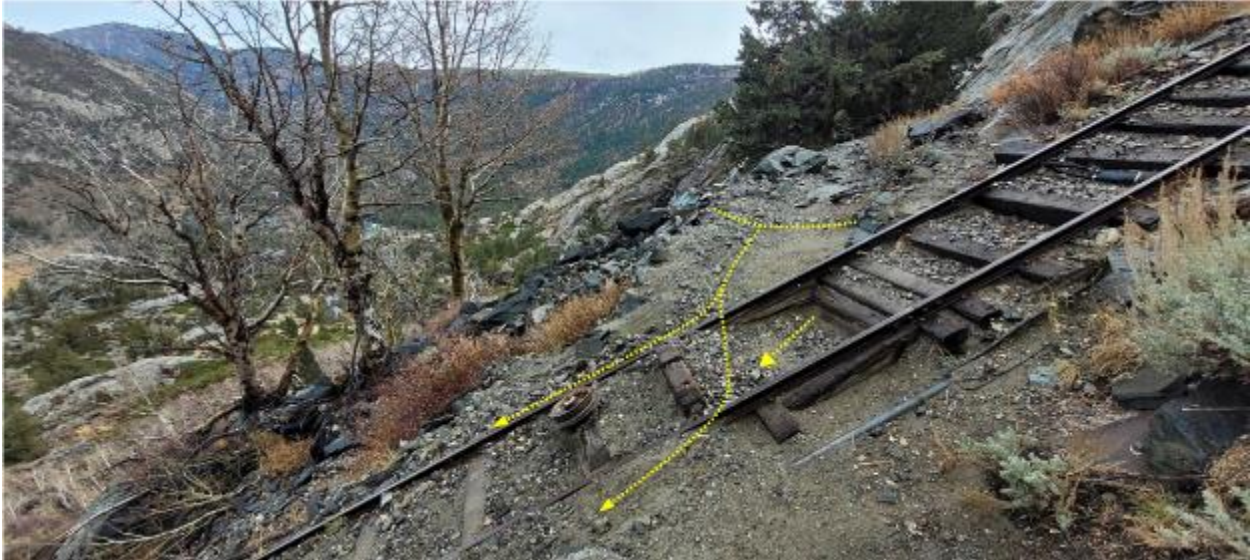
**Photo AQ 5-25. Example of worn concave trail surface and erosion at the intersection of the tramway (location TE-3).**

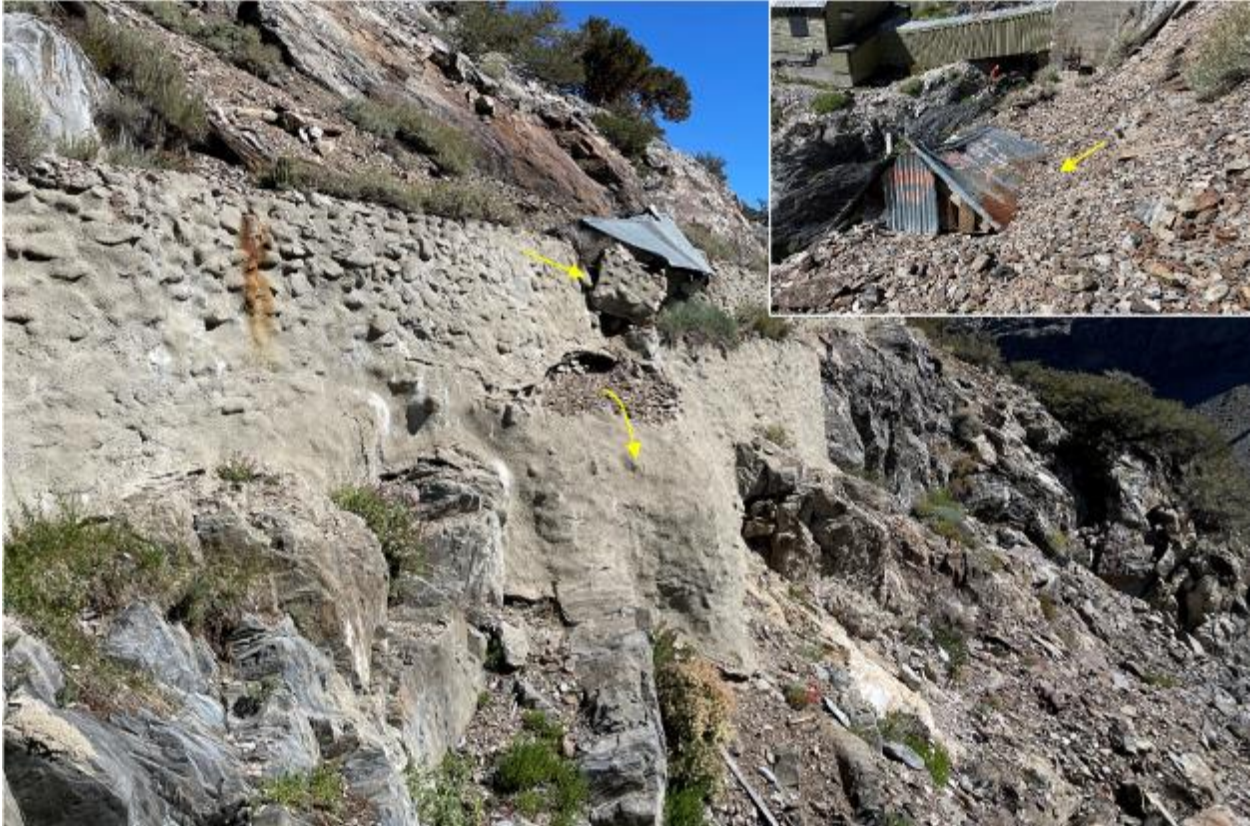
**Photo AQ 5-43. Rock and shotcrete/gunite retaining wall failures below the Gem to Agnew junction flowline and slumping/collapsing in around the shack (upper right photo). Location PE-2.**

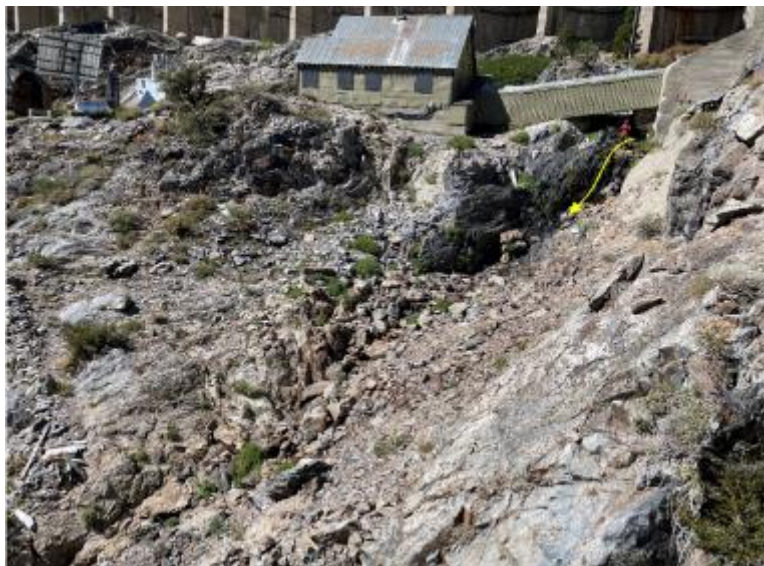
**Photo AQ 5-44. Historical erosion of hillslope and drainage below the penstock outlet (location PE-3).**

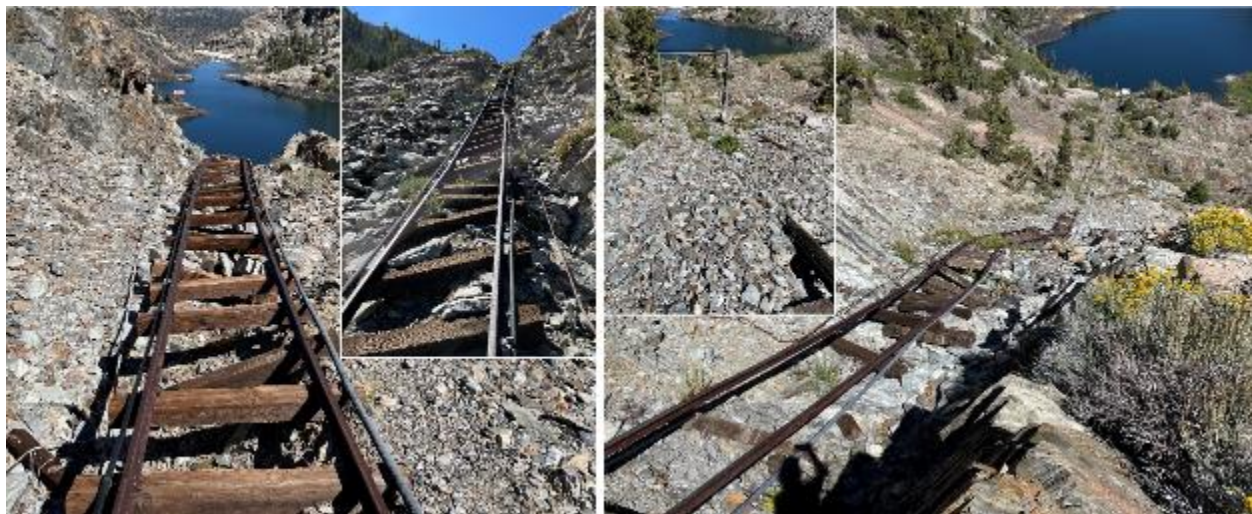
**Photo AQ 5-48. Various perspectives of the eroded tramway caused by runoff diversion from the culvert crossing that became plugged in the 2017 runoff season (location PE-6).**

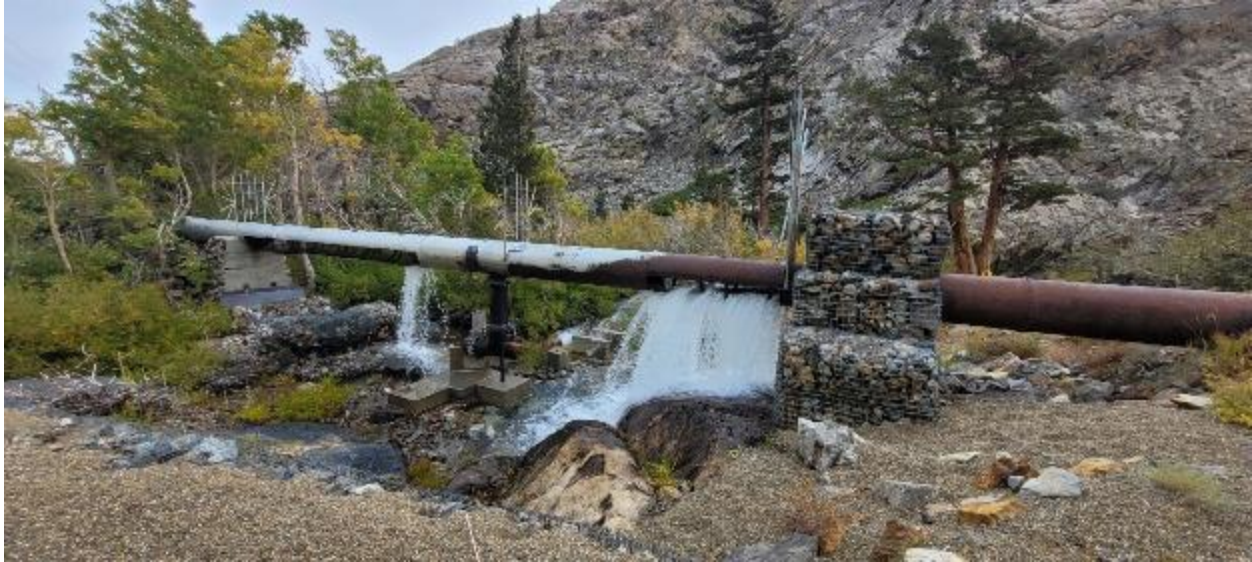
**Photo AQ 5-49. Surface erosion and approximately 100 linear feet of gully/channel erosion to Rush Creek from the 2017 emergency cut in the Agnew penstock (location PE-7).**

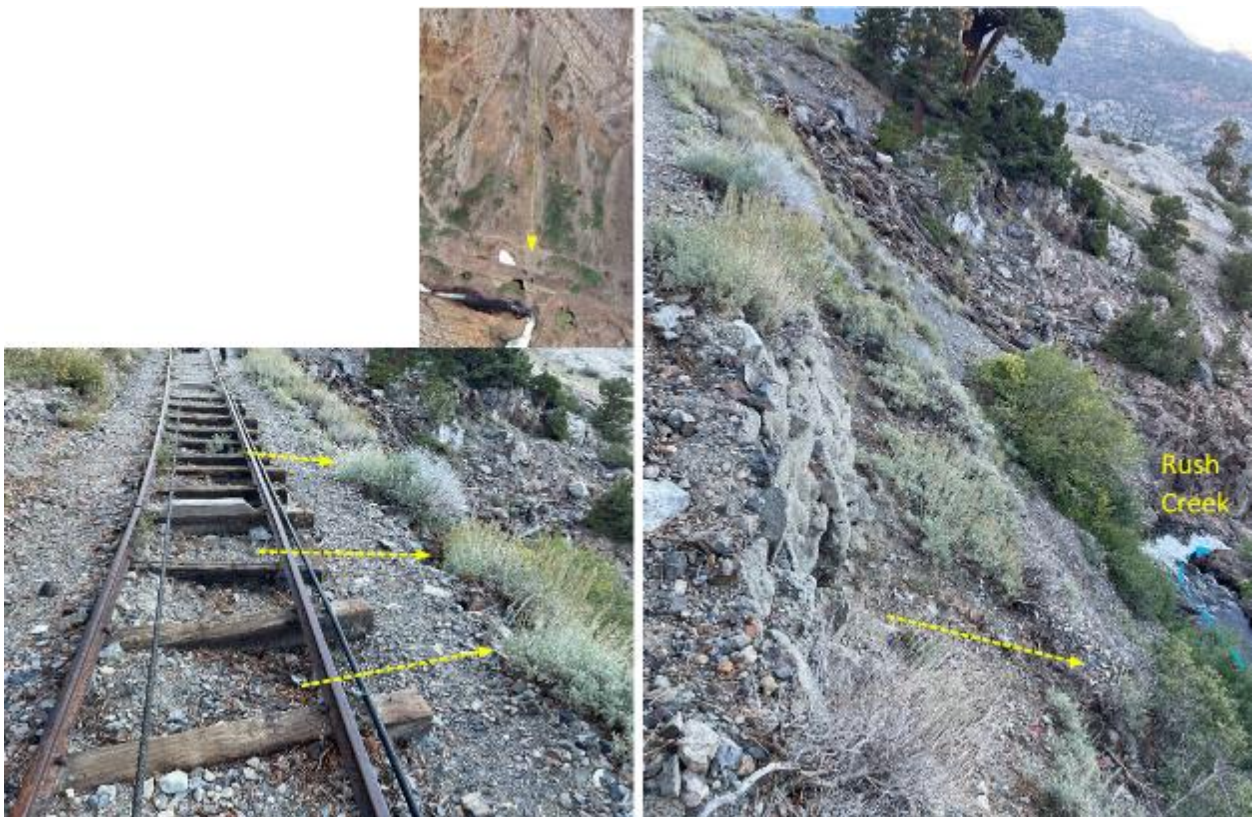
**Photo AQ 5-52. Surface erosion from around the tramway (lower left) and hillslope erosion below the retaining wall (right) from a combination of prior tram/wall construction/repairs and mass wasting of the mountainside (top left). Location PE-10.**

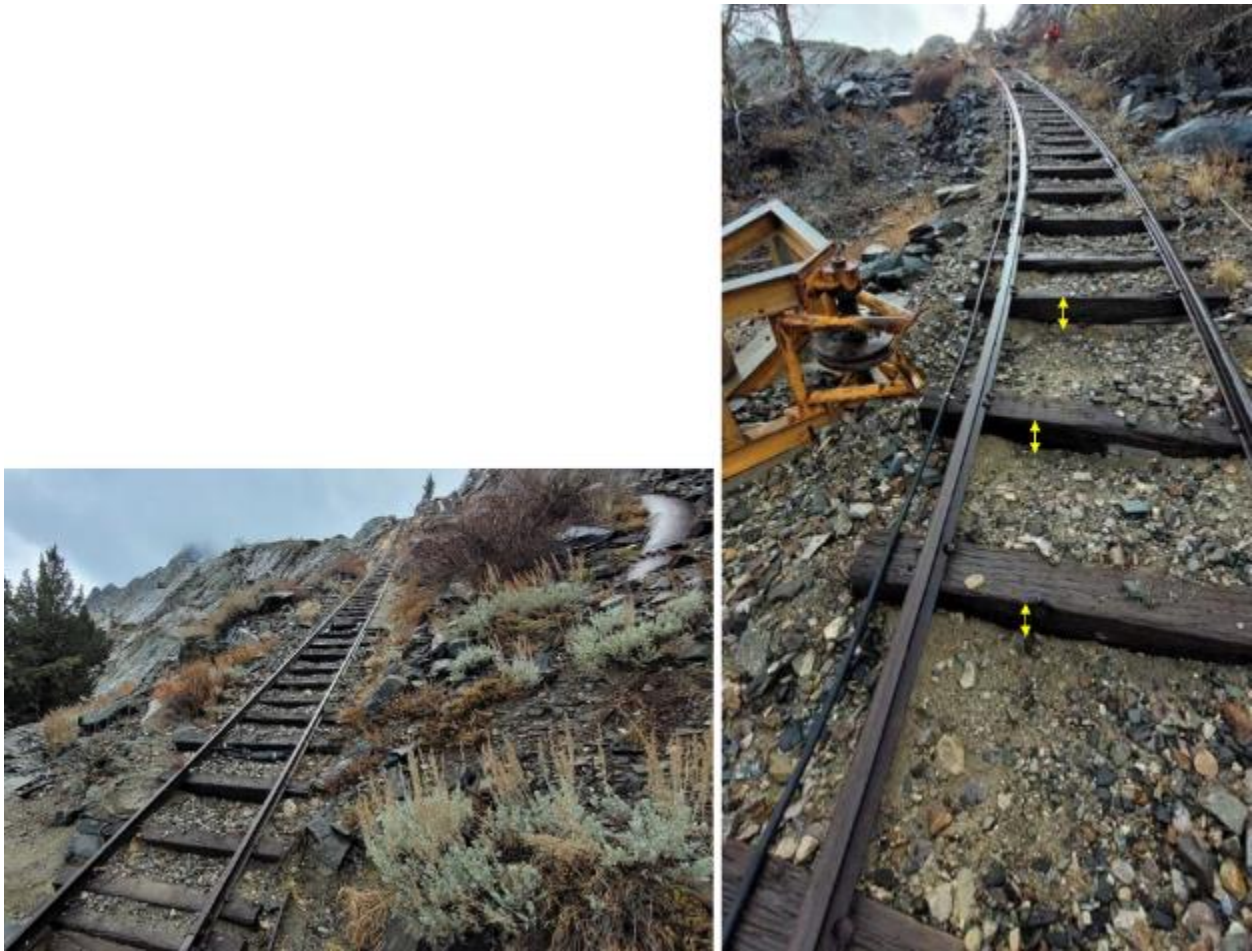
**Photo AQ 5-53. Typical surface erosion from around the rail ties in the middle portion of the tramway below Agnew (location PE-11).**

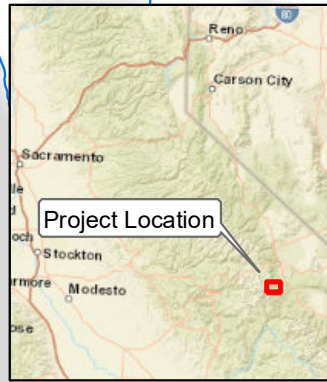
Projection: UTM Zone 11  
Datum: NAD 83

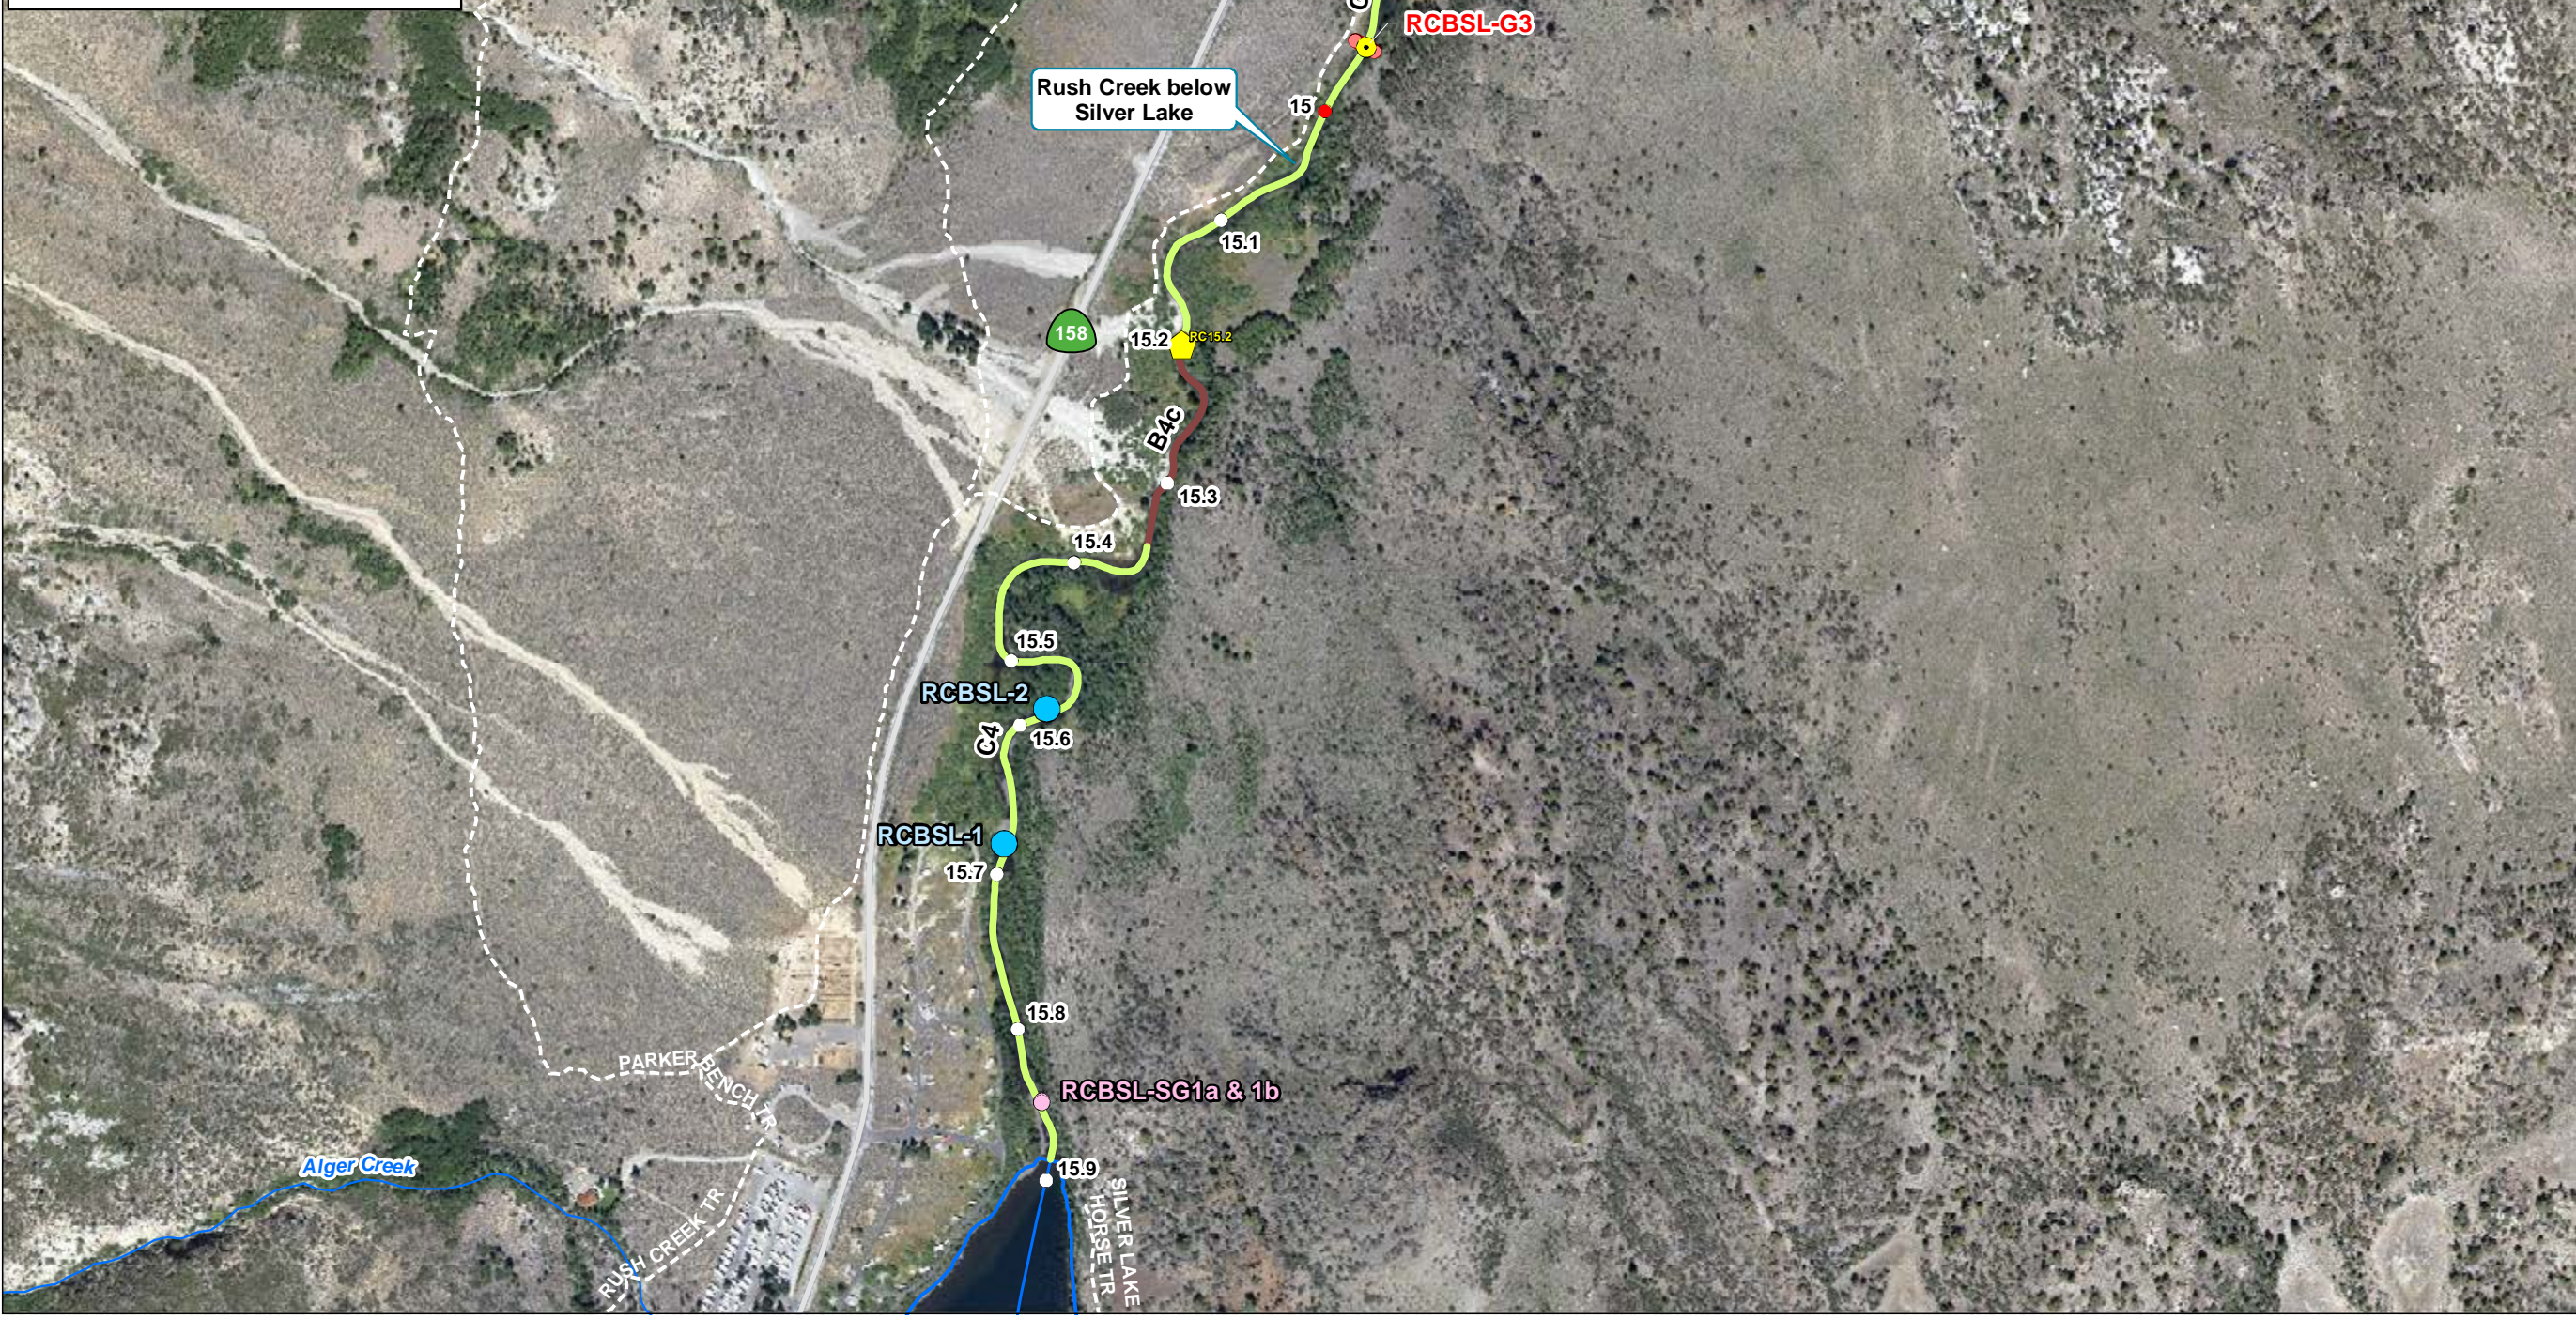
This Page Intentionally Left Blank
