JACKASS MEADOW INUNDATION STUDY

Big Creek ALP FERC License Implementation

Jackass Meadow
South Fork San Joaquin River

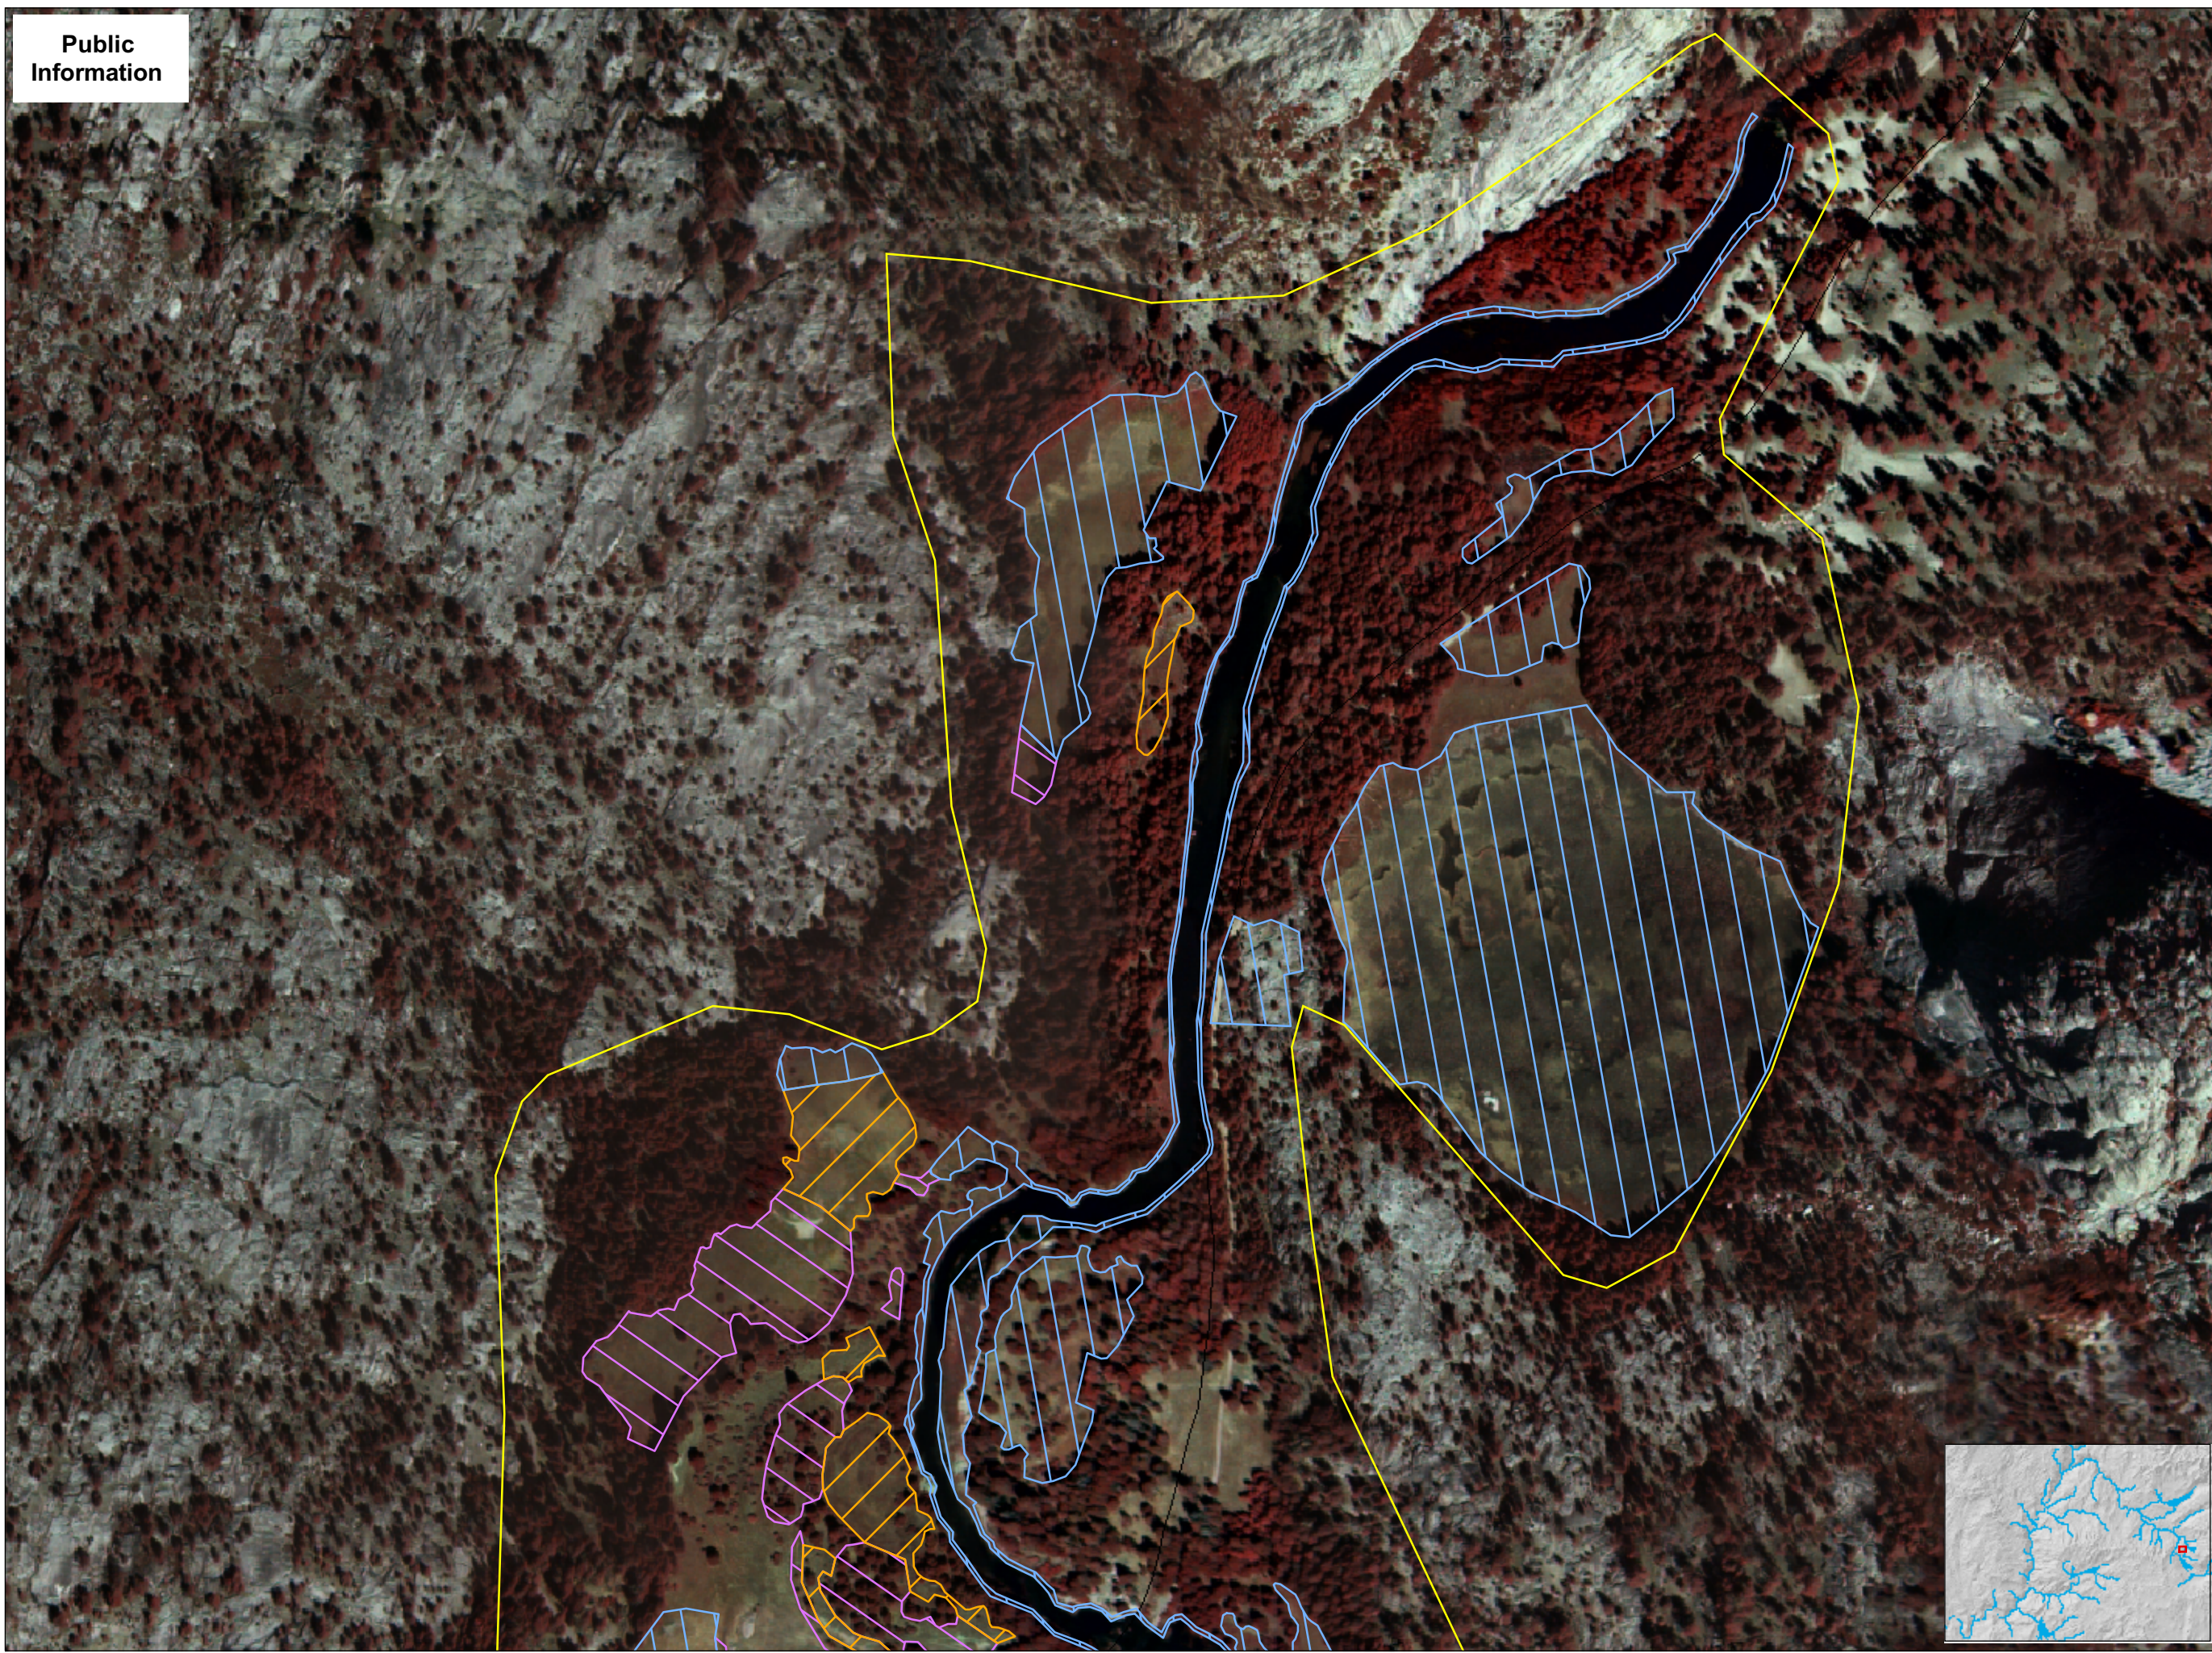
Figure 2a

**Extent of Inundation
6/22/05**

The extent of inundation was compared at these various locations, as well as others, such as bars. A map showing the extent of inundation at the three flows is provided in Figures 2a and 2b. The approximate areas inundated (in m² and acres) are below:

Flow (cfs)	Incremental Area Inundated (m ²) (acres)	Total Inundated Area (m ²) (acres)
516	162,045 (40)	162,045 (40)
1,250	59,429 (15)	221,474 (55)
1,679	35,679 (9)	257,153 (64)

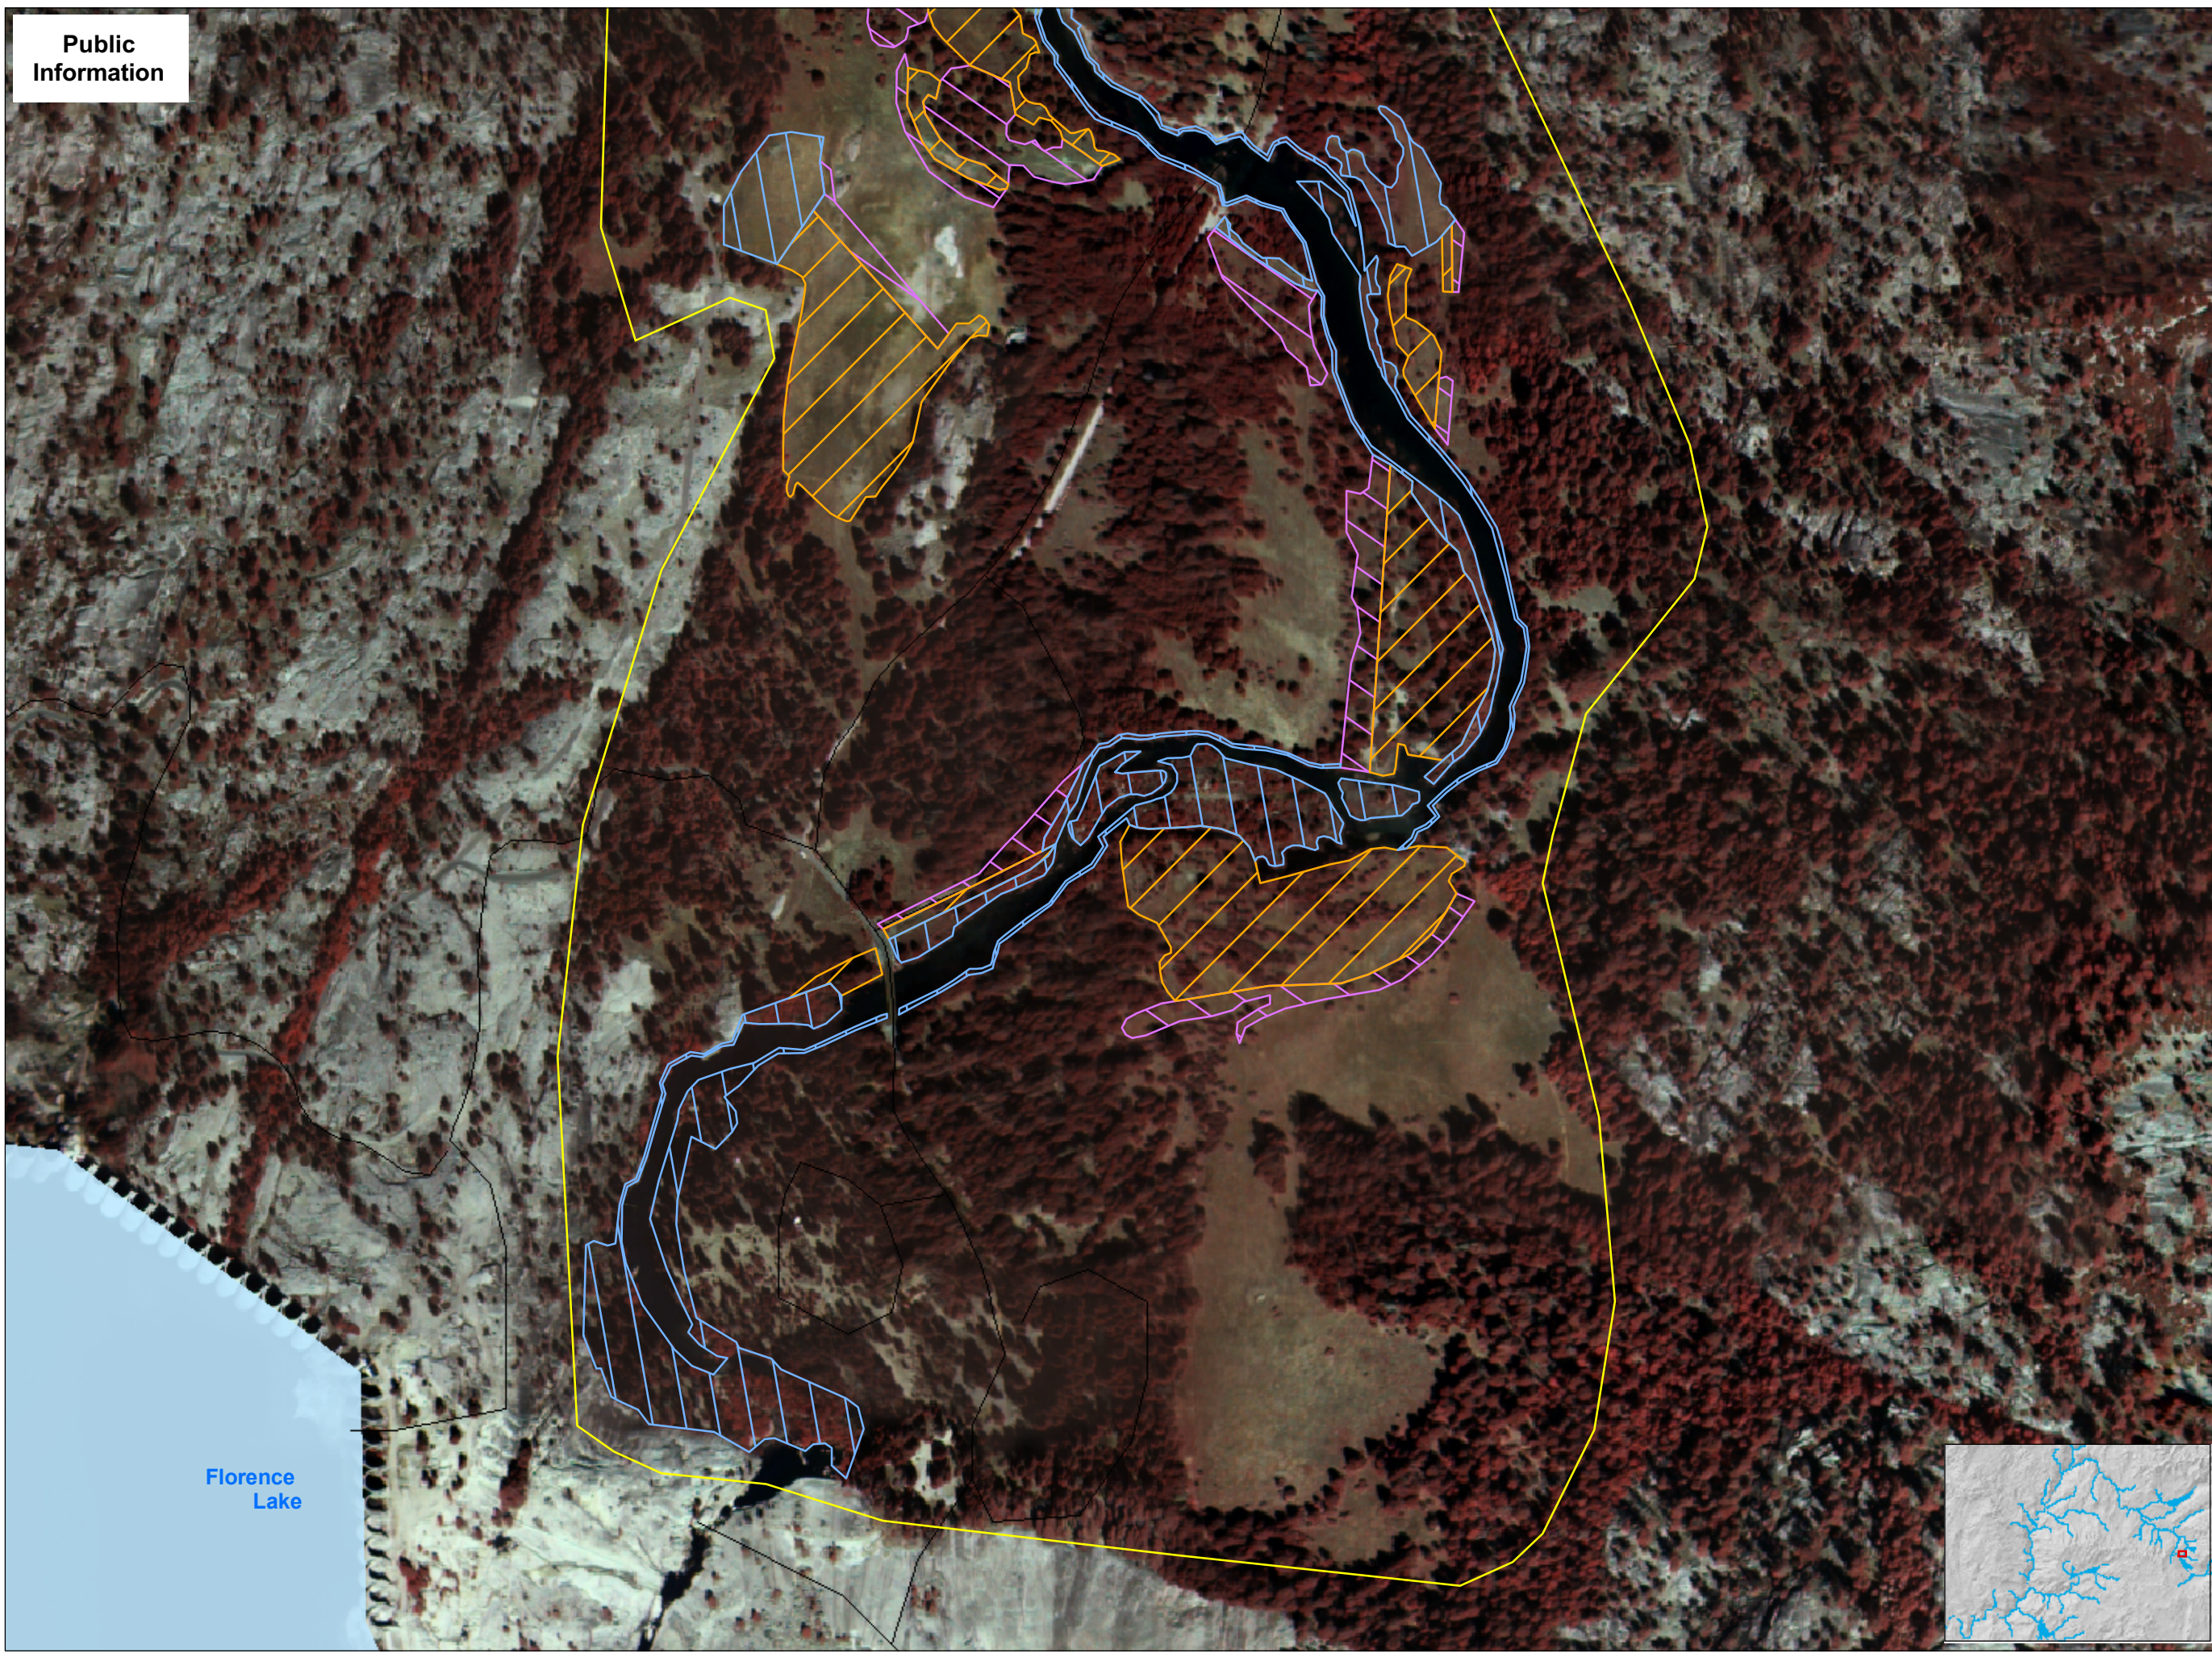
Figure 2b

**Extent of Inundation
6/22/05**

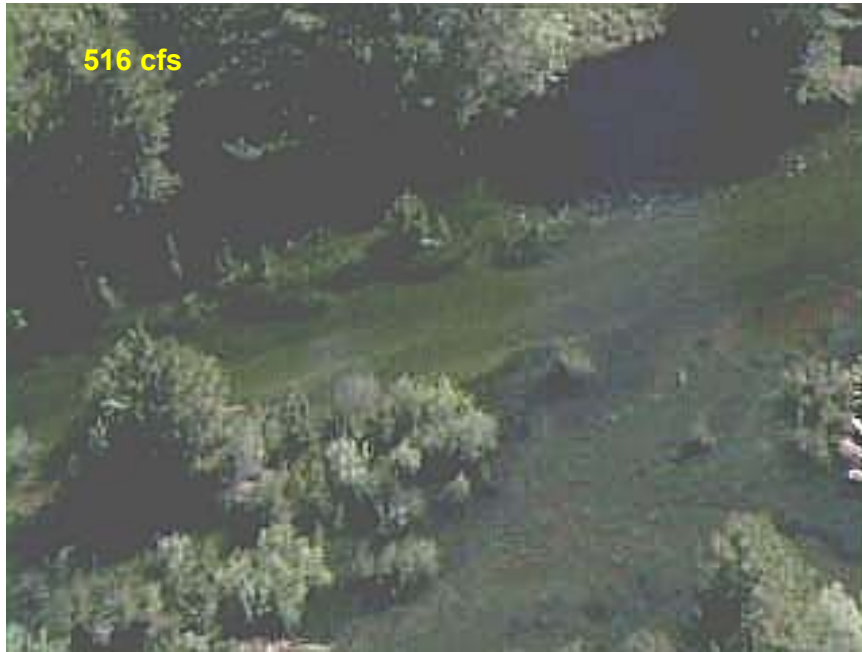
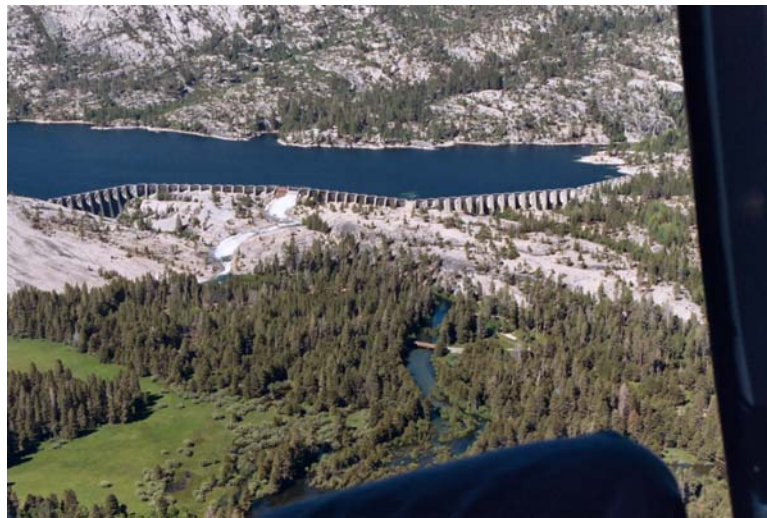
Figure 3. Examples of Bar Inundation on the South Fork San Joaquin River, Jackass Meadow area, at Approximately 516 cfs.

At 516 cfs, the channel bars were inundated except for the highest elevations (Figure 3). Specifically, bars upstream of the auto bridge crossing, near Tombstone meadow, and upstream and downstream of the low flow crossing were inundated (Meadows 31, 36, 26, 28, 30, and 34). The vegetation along the stream margins was also inundated. Meadow 31 was inundated almost to the fence line. Over-banking was not observed. Photographs taken during the initial flight show the extent of inundation at the various meadow locations (Figures 4 to 9).

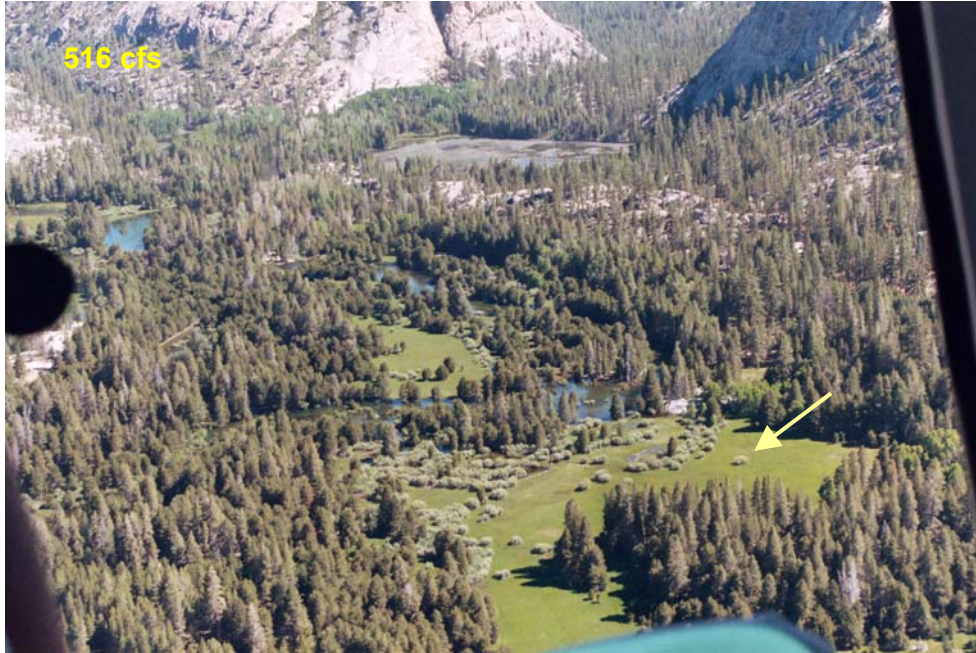
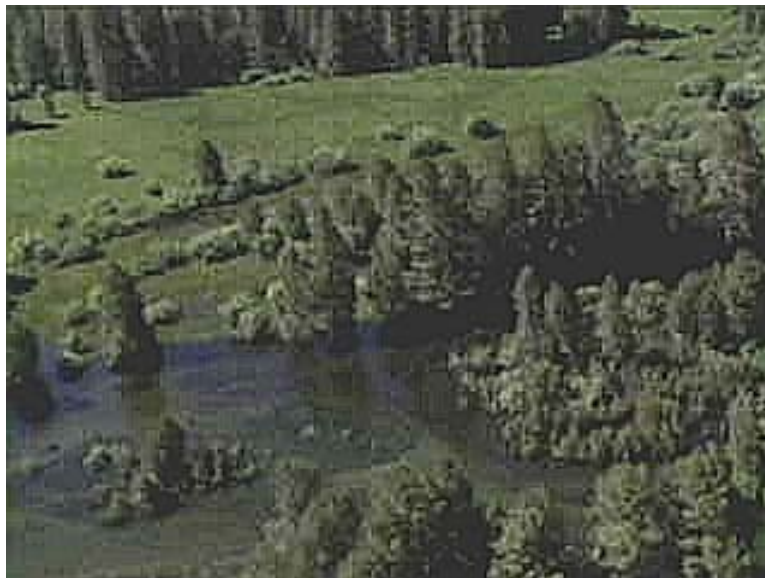
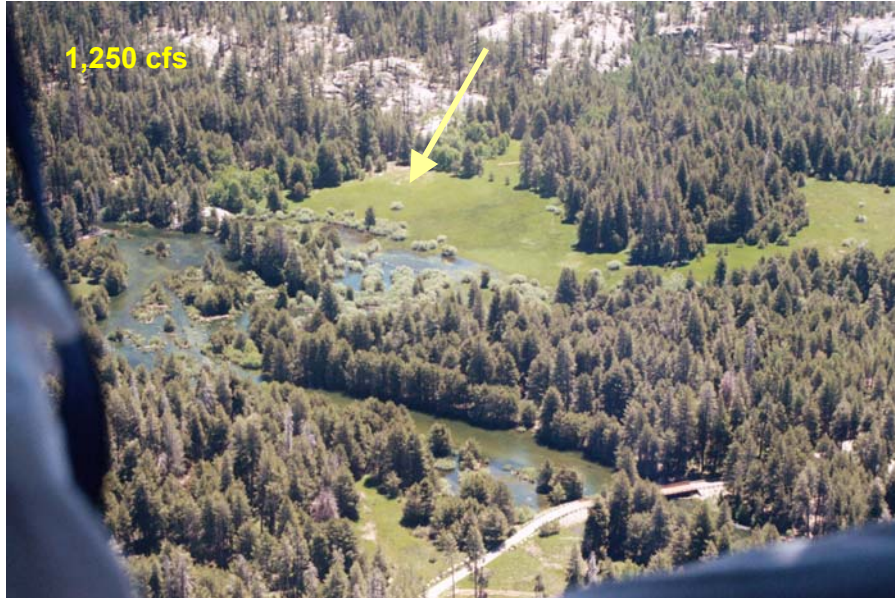
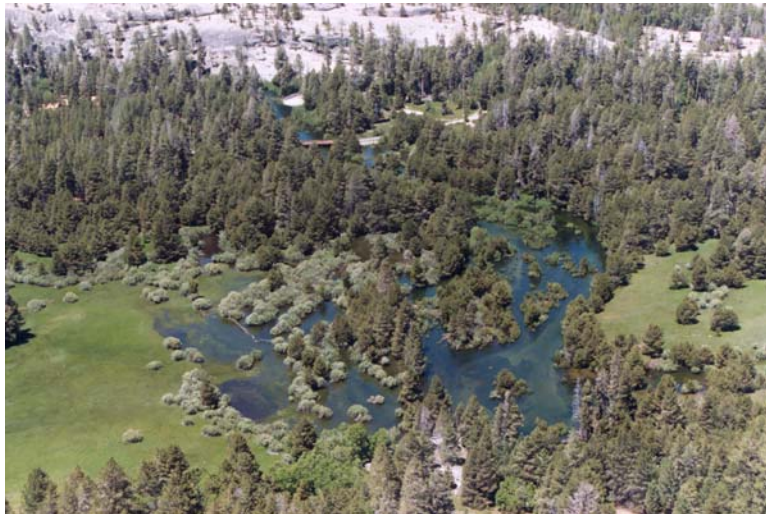
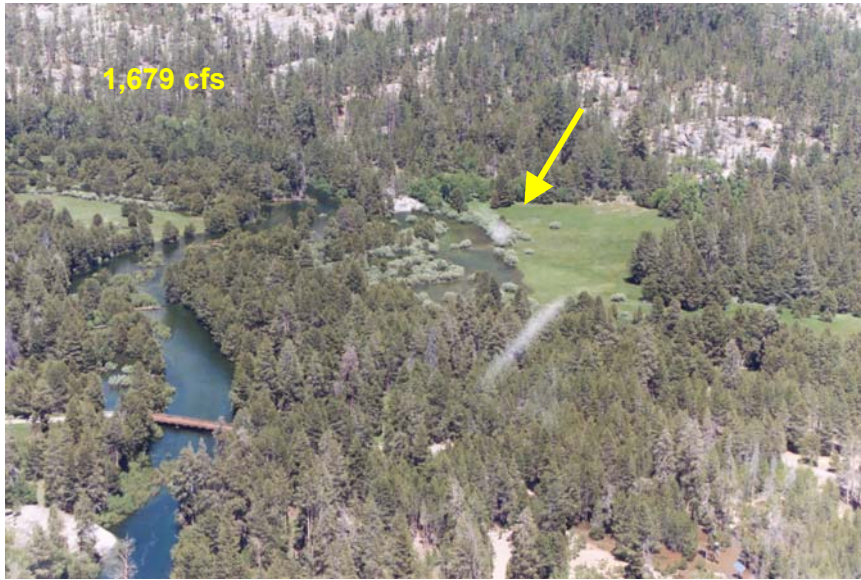
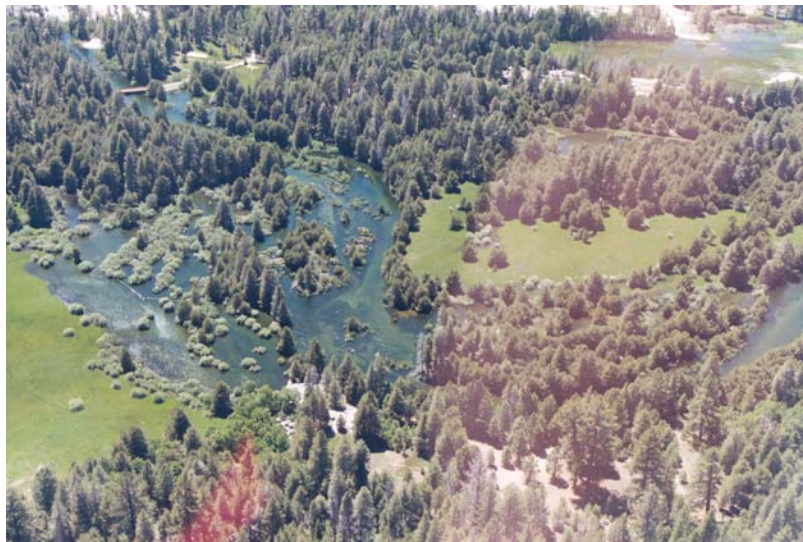
Figure 4: Comparison of Inundation Extent (516 cfs, 1,250 cfs, and 1,679 cfs) along the Right Bank Downstream of the Auto Bridge Crossing, near the Tombstone Creek Confluence (Location A).

Figure 4: Comparison of Inundation Extent (516 cfs, 1,250 cfs, and 1,679 cfs) along the Right Bank Downstream of the Auto Bridge Crossing, near the Tombstone Creek Confluence (Location A) (continued).

Channel-floodplain connectivity was observed at specific locations, particularly in the vicinity of Meadows 31, 34, and 28 (Locations A and D). Within Meadows 31 and 34, increases in the extent of inundation were fairly obvious at many locations along the river compared to the initial observations at 516 cfs, with inundation extending approximately to the bands of willows within the meadows. A greater floodplain area is inundated at Location B, across from Meadow 31 (Figures 4 to 9).

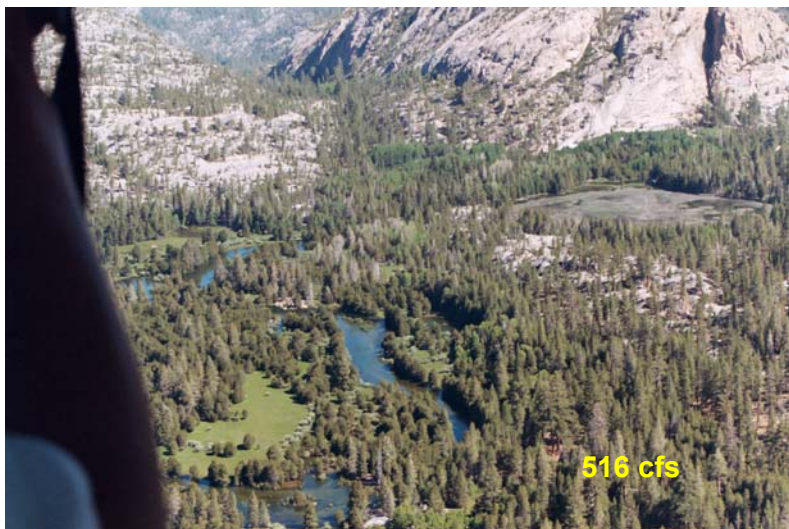
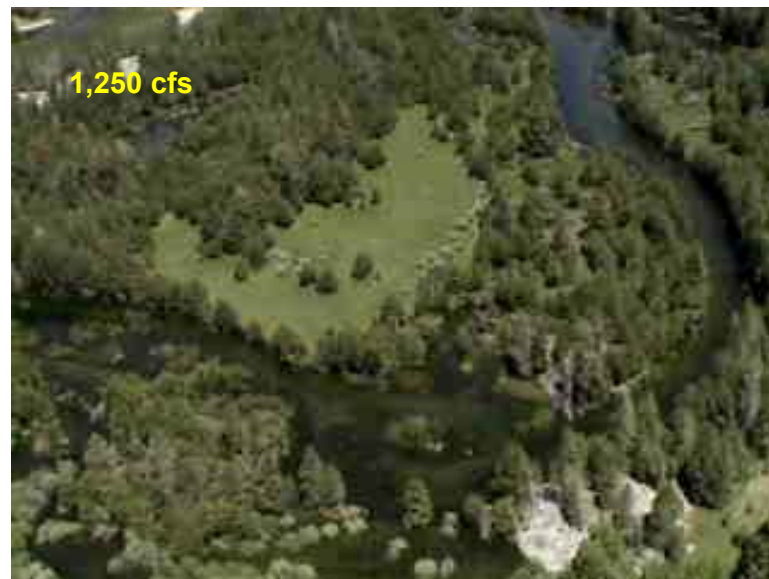
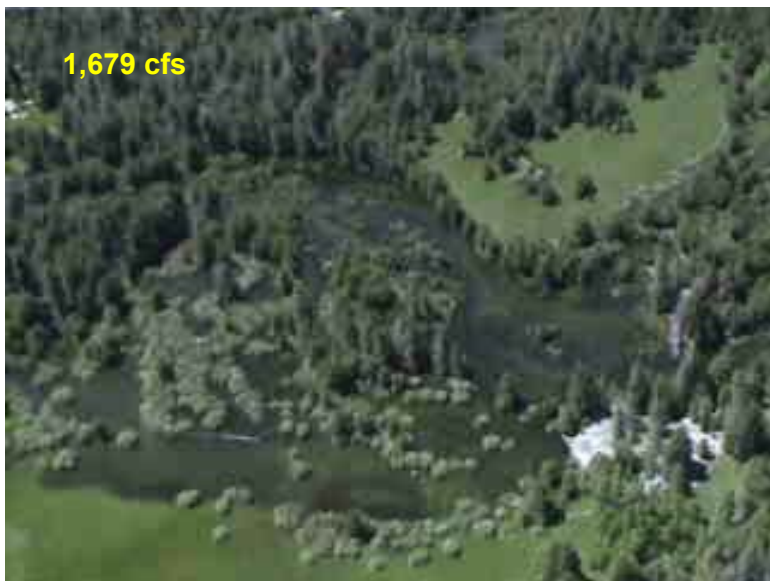
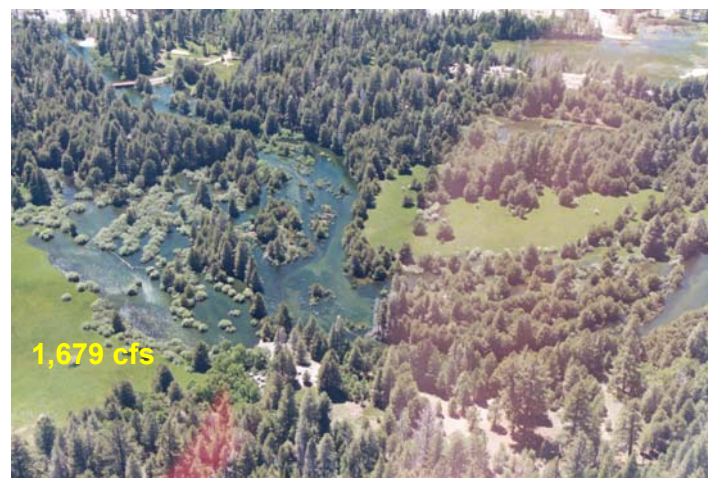
Figure 5. Comparison of Inundation Extent (516 cfs, 1,250 cfs, and 1,679 cfs) on the Left Floodplain Across from Meadow 31 (Location B).

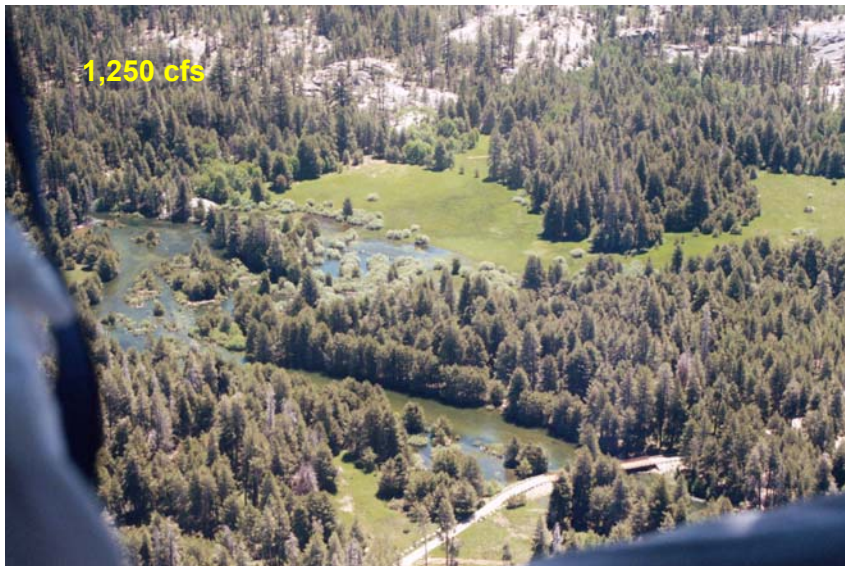
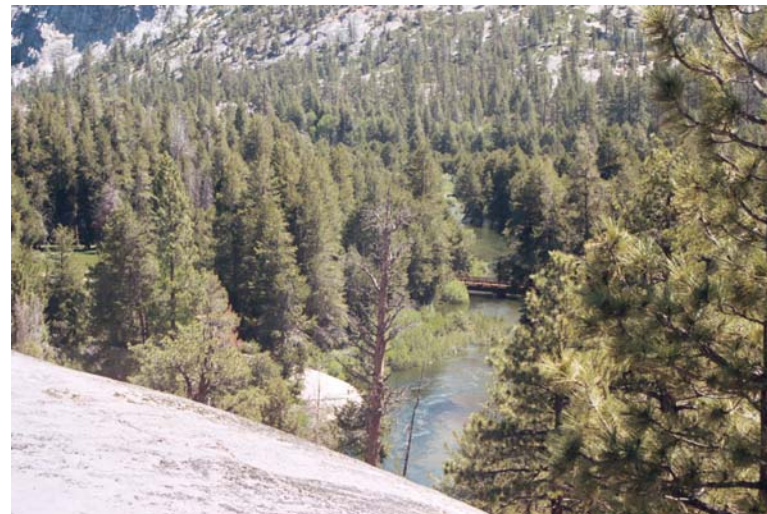
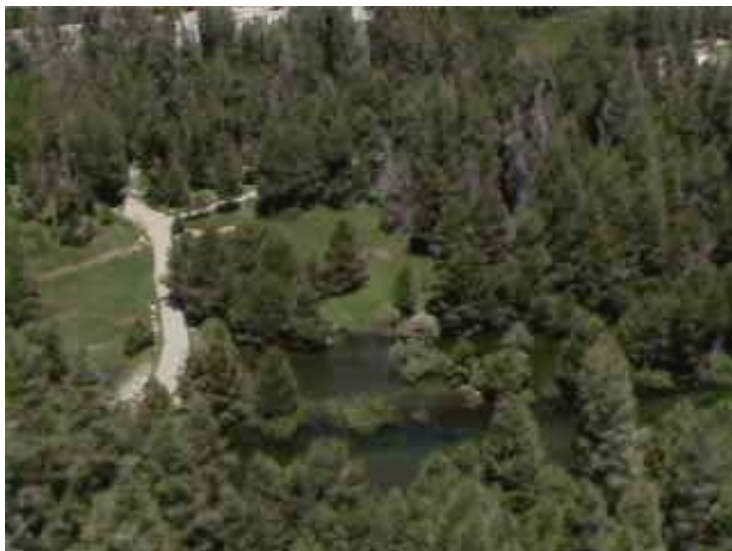
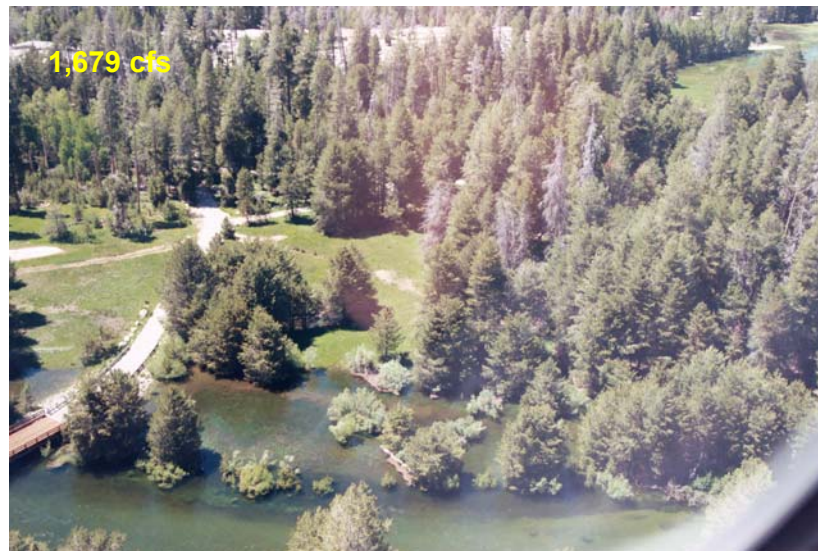
Figure 6. Comparison of Inundation Extent (516 cfs, 1,250 cfs, and 1,679 cfs) at the Auto Bridge Crossing and Meadow 36 (Location C).

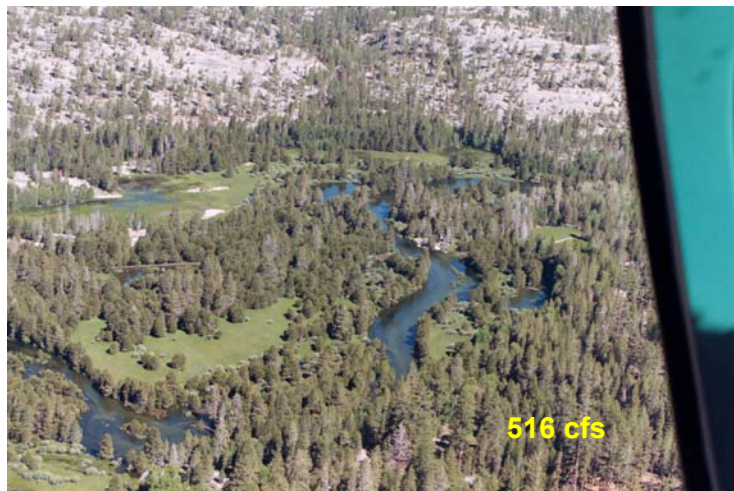
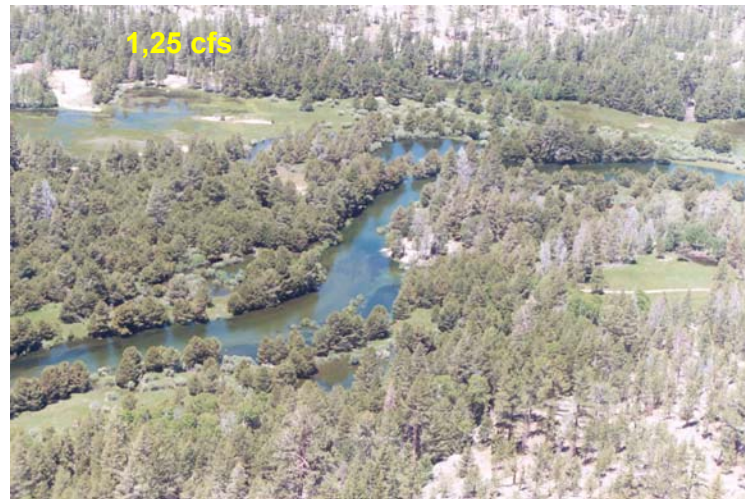
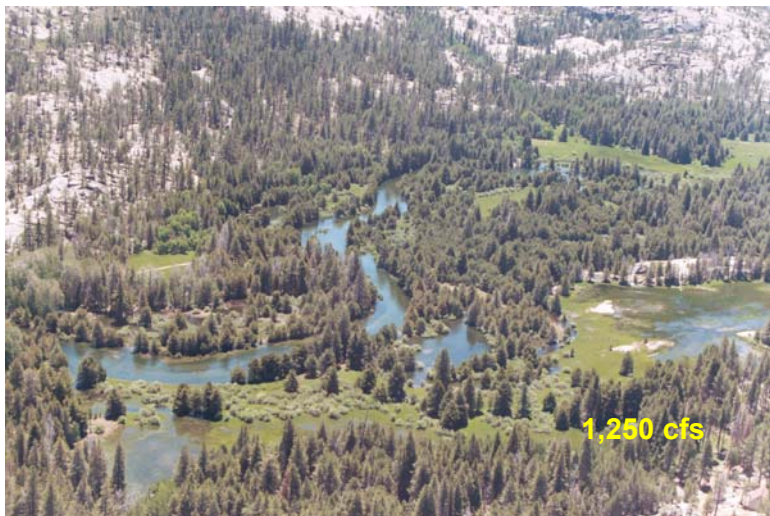
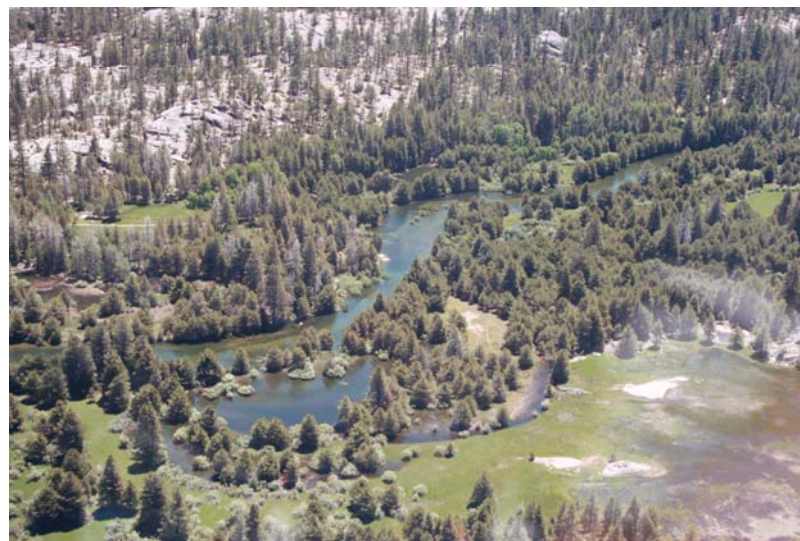
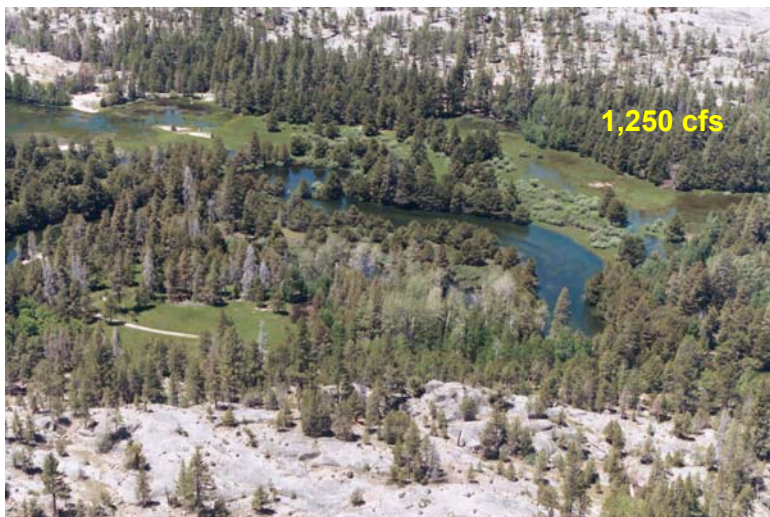
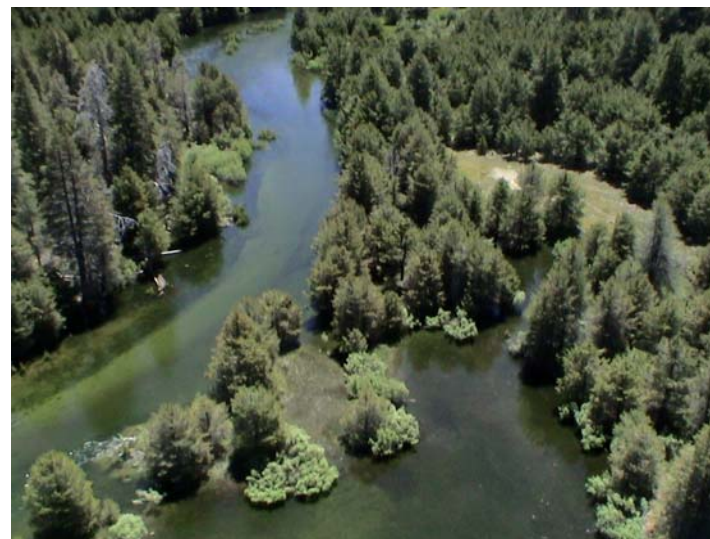
Figure 7. Comparison of Inundation Extent (516 cfs, 1,250 cfs, and 1,679 cfs) along Meadows 26, 28, 30 and 34 (Location D).

Figure 7. Comparison of Inundation Extent (516 cfs, 1,250 cfs, and 1,679 cfs) along Meadows 26, 28, 30 and 34 (Location D) (continued).

At 1,679 cfs, greater meadow areas were inundated, particularly on the left floodplain downstream of the low flow crossing (Figures 2 to 9) (Location D). The left bank floodplain area in between Locations B and D was also inundated. The right bank floodplain, upstream of the low flow crossing, was connected to the channel at 1,679 cfs. The extent of inundation increases a relatively small amount, about nine additional acres, compared with the total area of inundation at 1,250 cfs, although the area is noticeable when compared to permanent markers on the floodplain. For example, water extends past the band of willows within the meadows at Locations A and D.

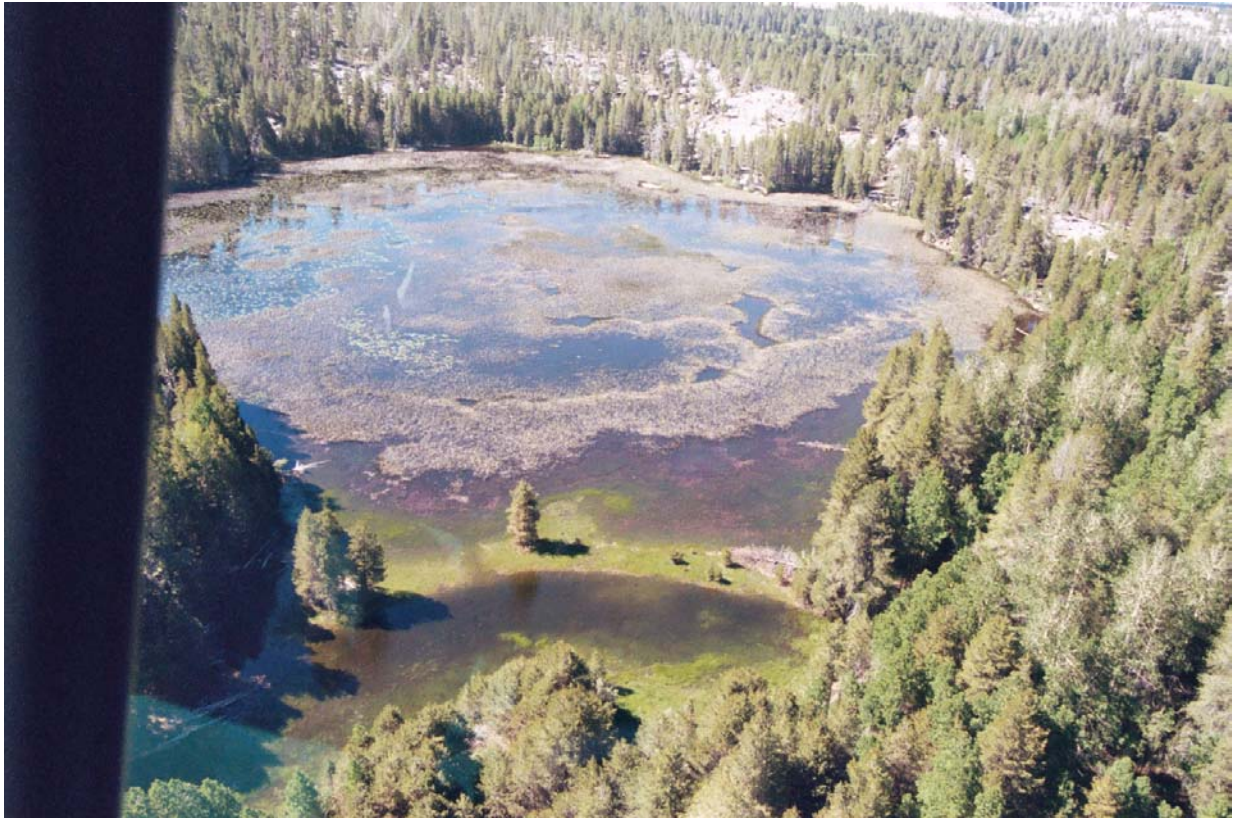
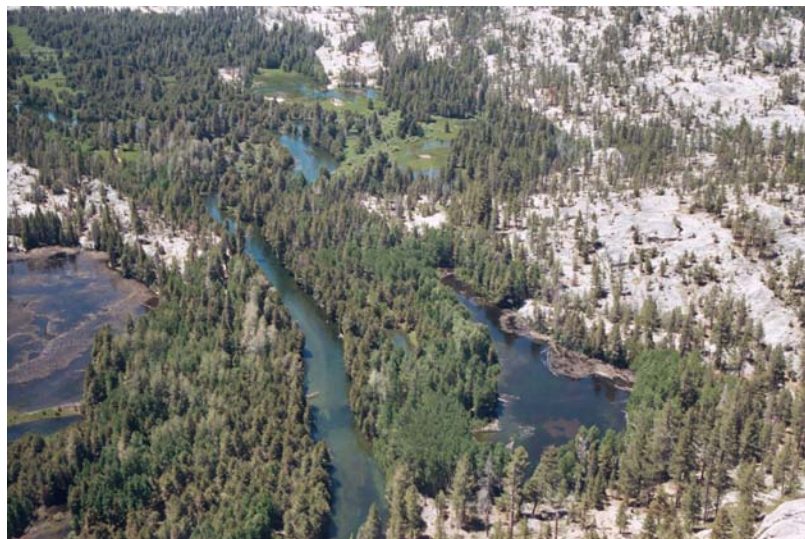
Figure 9. Meadow 32, Photographed when Flow within the South Fork San Joaquin River was 516 cfs (left) (Location E). Accumulations of Large Woody Debris within Meadow 33 are Shown in the Right Photograph (taken at 2,150 cfs) (Location E).

Meadows 32 and 33 (Location E) were completely inundated at the initial study discharge and appear to have been inundated prior to the study, probably from local runoff and/or previous high flows. A raft of large woody debris observed within Meadow 33 suggests that previous high flows did enter into the meadow, transporting large woody debris. It is unlikely though, based on studies conducted during the CAWG 11, Riparian studies (SCE 2004, Volume 3, SD-D), that flows overtopped the banks at this location to enter into this meadow. Rather, it is more probable that flows entered into the meadow at a point upstream and flowed down-valley within the floodplain.
