LAND-9 VISUAL QUALITY ASSESSMENT

1.0 EXECUTIVE SUMMARY

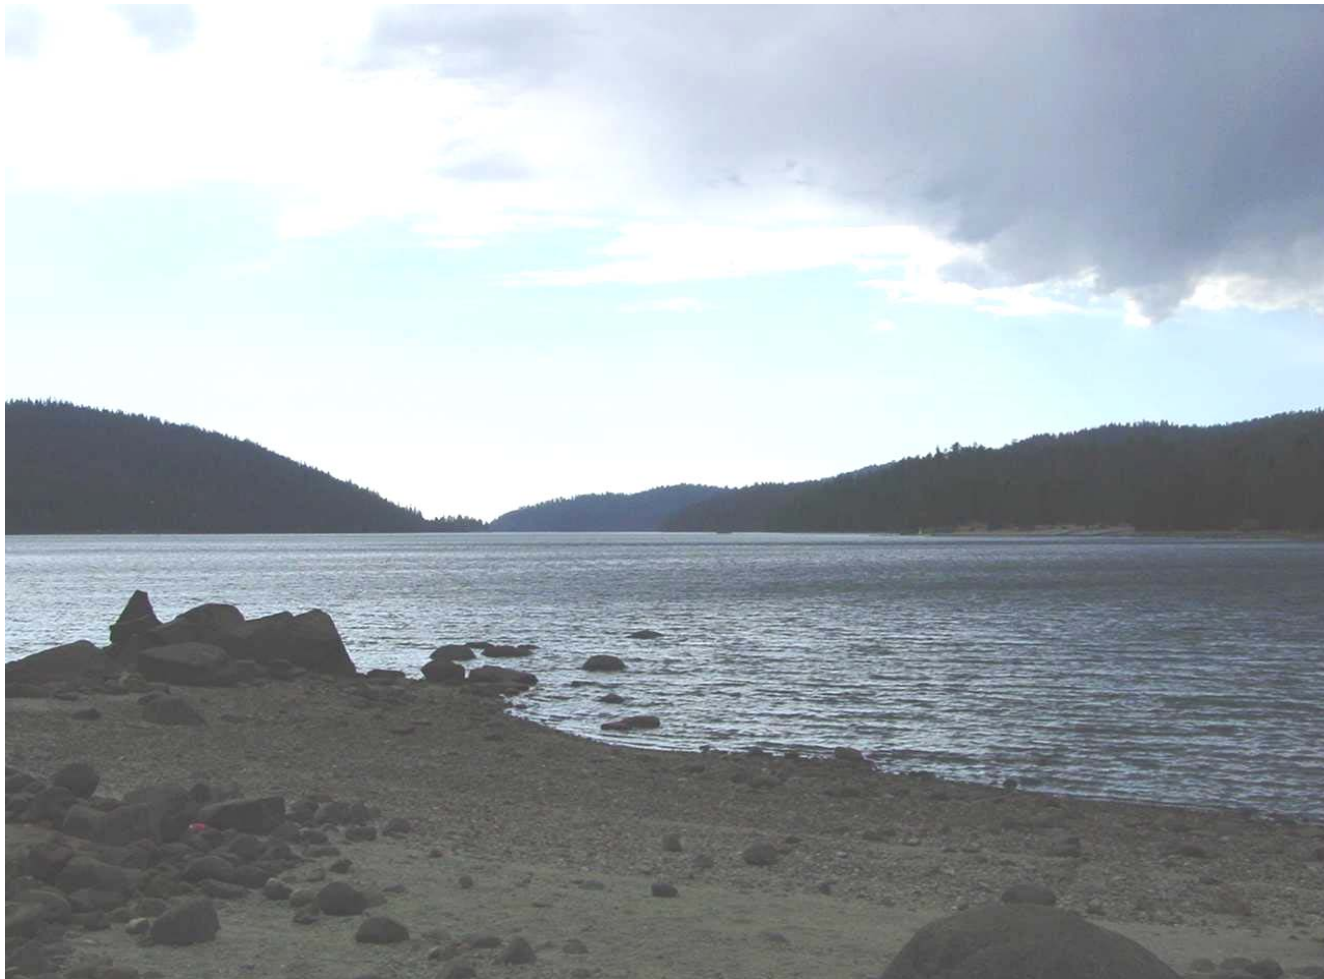
KOP 2 - Photo 2

View of Huntington Lake looking west from Rancheria Campground (October 1, 2001)

Photo 2 is a view to the west from the campground looking out at Huntington Lake, which extends to the background. Rancheria Campground is located on the eastern shore of Huntington Lake.

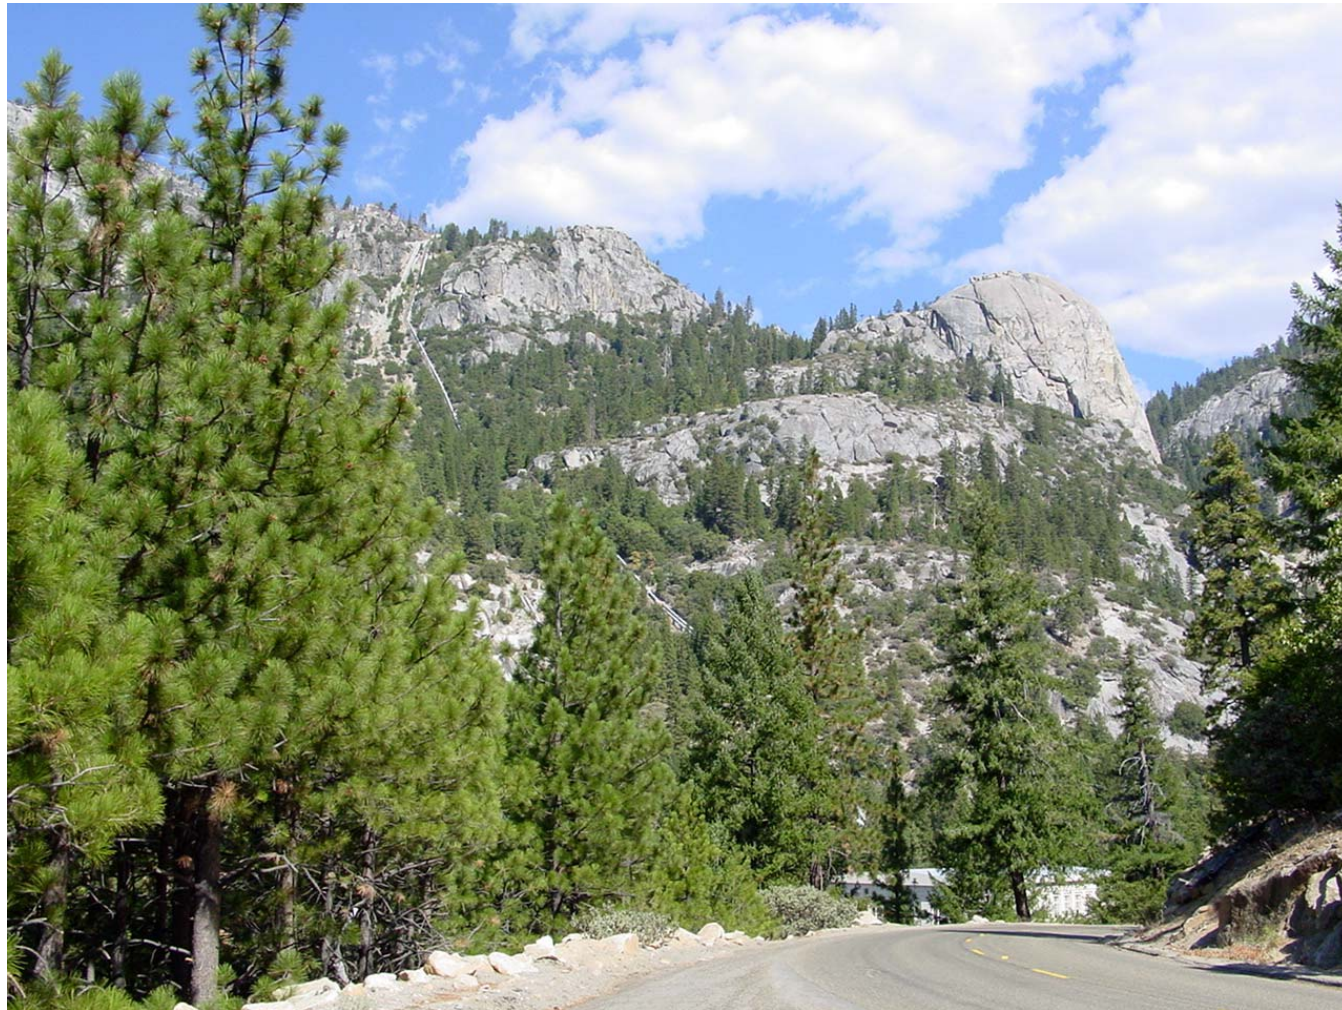
KOP 8 - Photo 8a
View of Big Creek No. 1 penstocks looking north east from Huntington
Lake Road (October 2, 2001)

Photo 8a is a northeastern view of the Big Creek No. 1 penstocks from a turnout on Huntington Lake Road. The powerhouse is barely visible behind some trees in the middleground and the penstocks can be seen in the background. Photo 8b is a view of the Big Creek No. 1 switchyard to the north from the same location. Photo 8c is a view of Big Creek No. 1 powerhouse north from Huntington Lake Road.

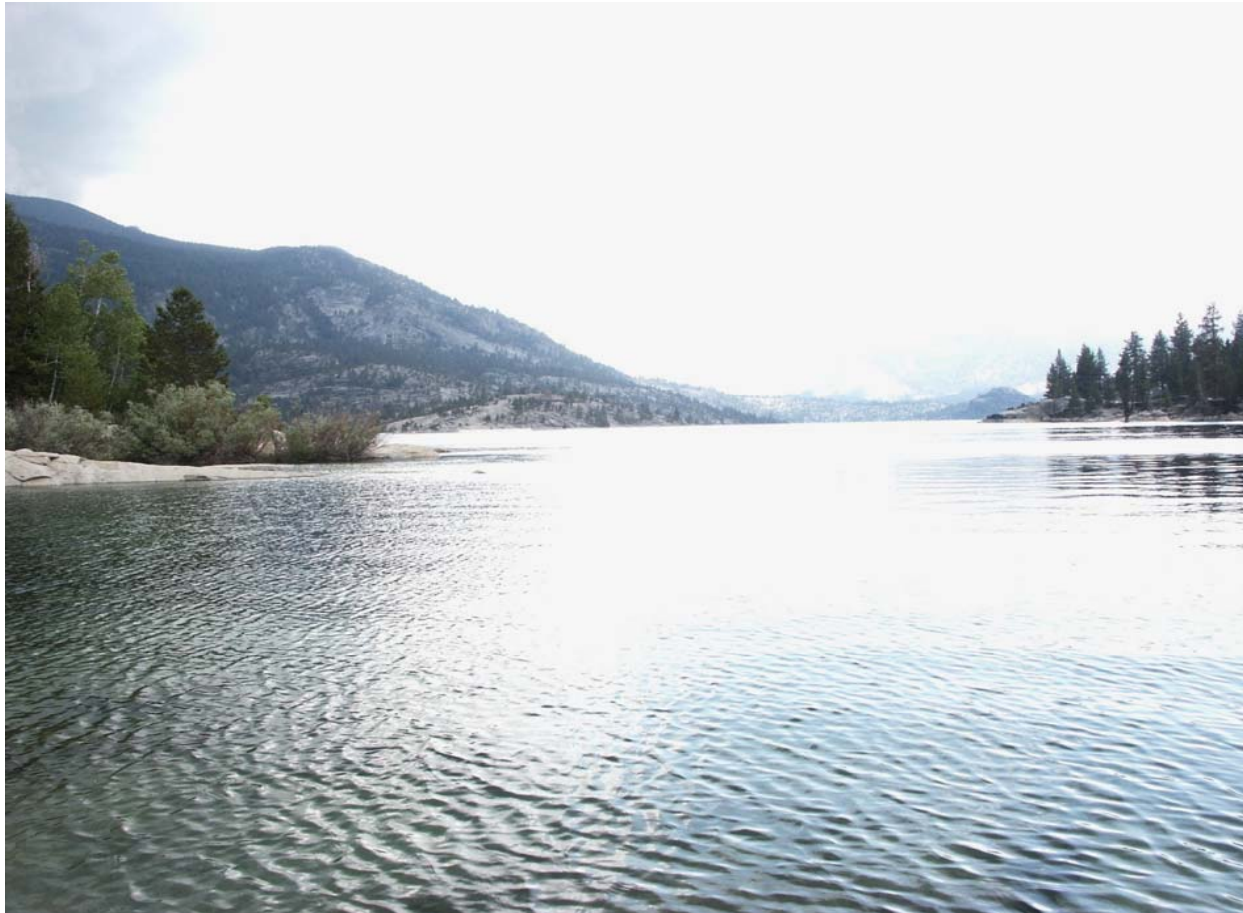
KOP 11 - Photo 11
View of Florence Lake Dam looking east from Florence Lake Picnic Area (July 2, 2002)

Photo 11 is a view across Florence Lake looking east from the Florence Lake Picnic Area. Florence Lake Dam is barely visible, where the lake transitions to land in the distance.

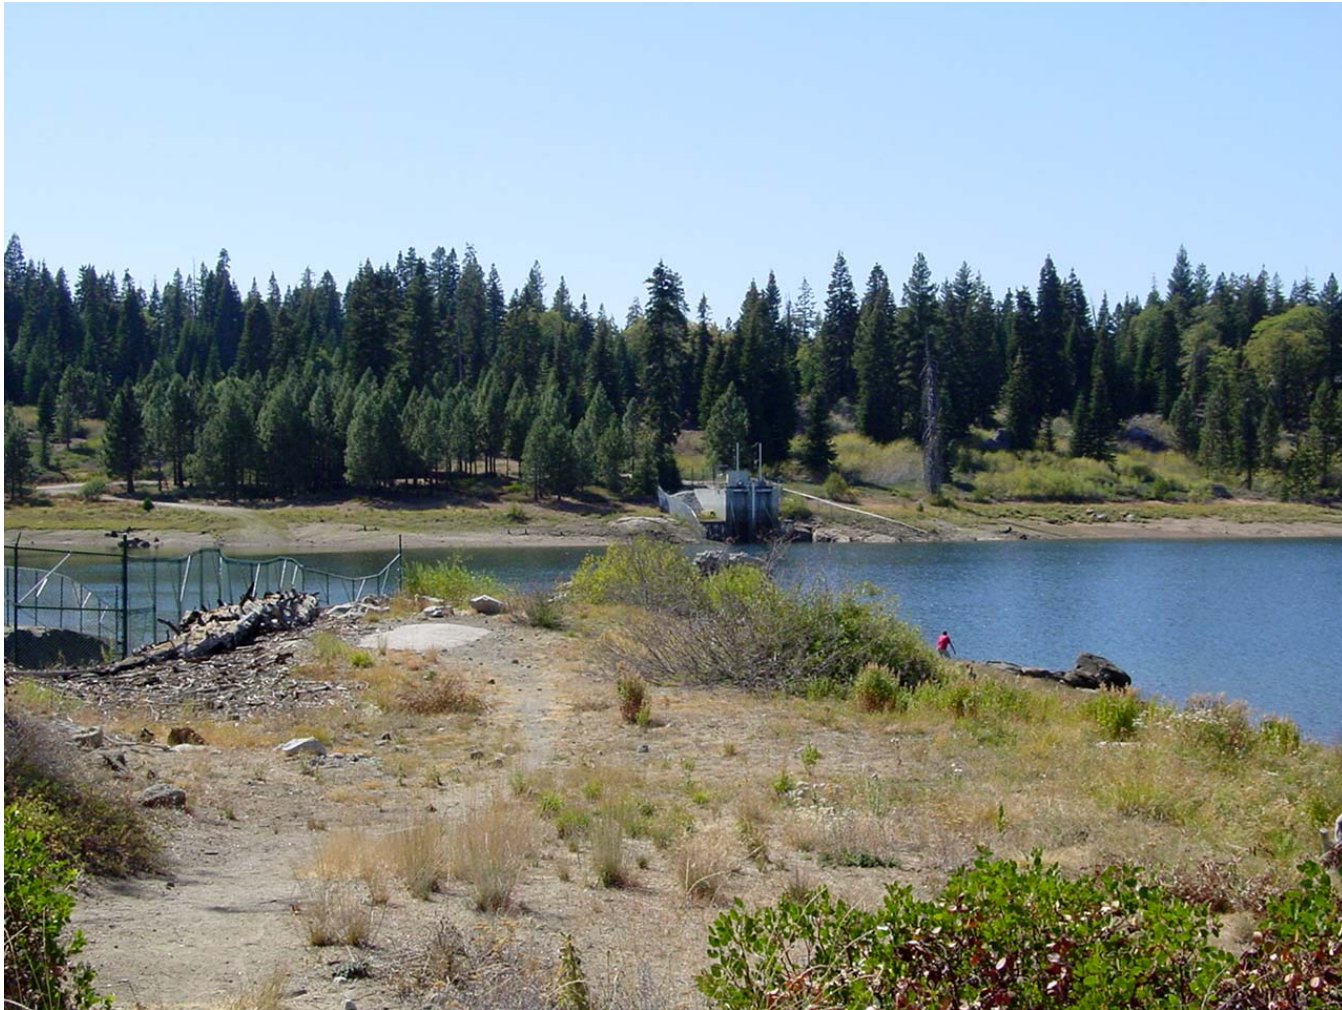
KOP 19 - Photo 19c
View of Balsam Meadows outlet gate looking north west from Balsam Meadows Forebay (October 2, 2001)

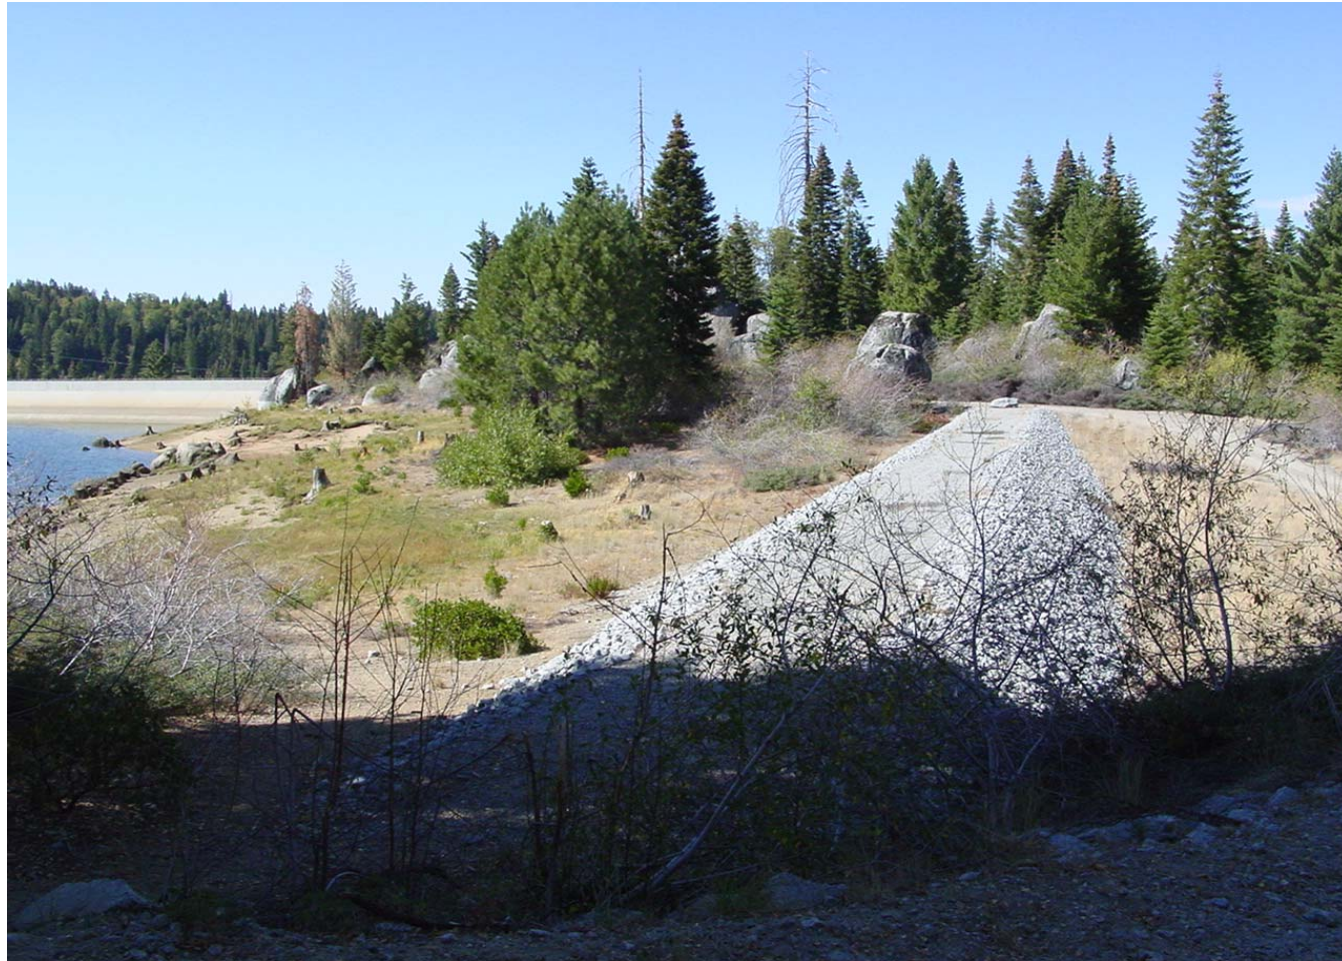
KOP 19 - Photo 19d

View of Balsam Meadows Secondary Dam looking north west from Balsam Meadows Forebay (October 2, 2001)

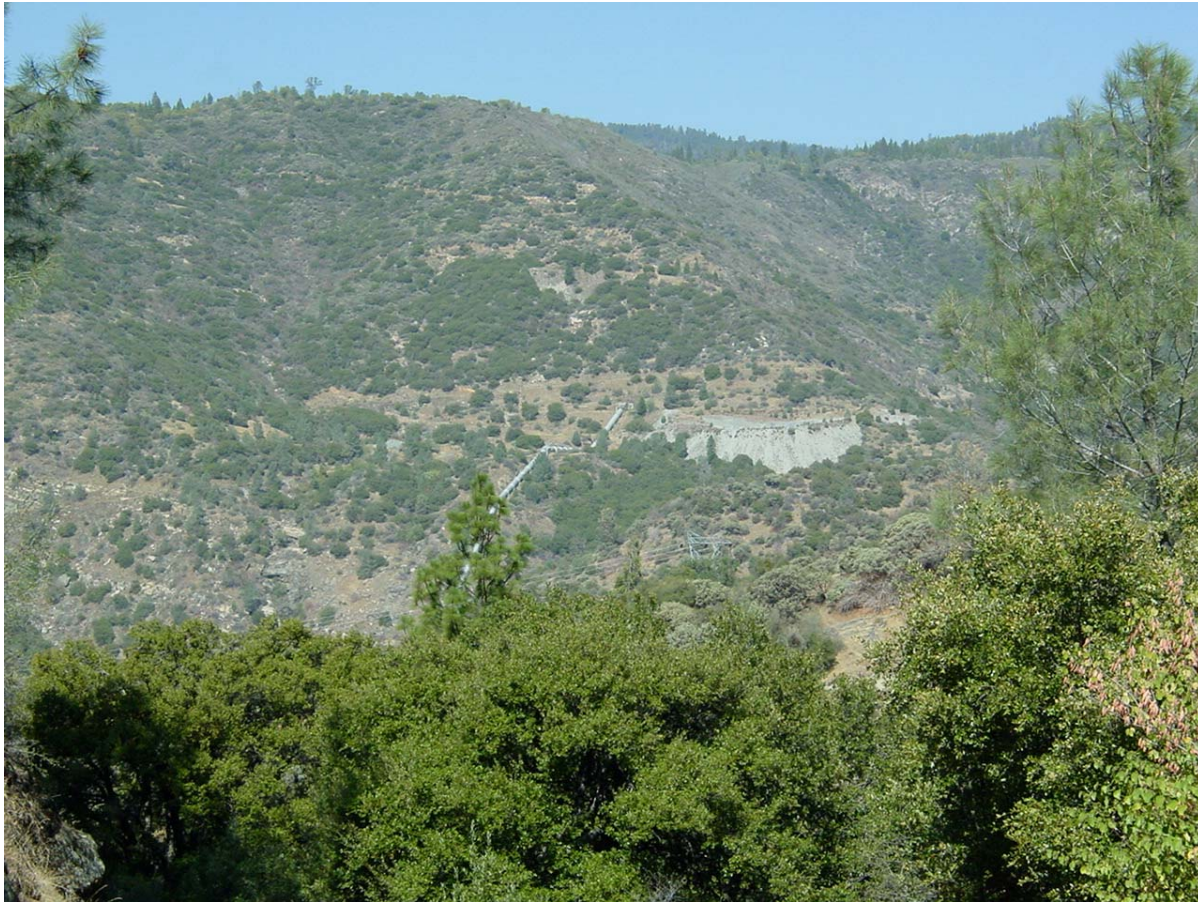
KOP 31 - Photo 31
View of Mammoth Pool penstock north west from Canyon Road between
Big Creek No. 2/2A and Big Creek No. 8 (October 4, 2001)
