**MONO CREEK SEDIMENT TRANSPORT AND FLOODPLAIN CONNECTIVITY STUDY**

## Mono Creek Sediment Transport and Floodplain Connectivity Study

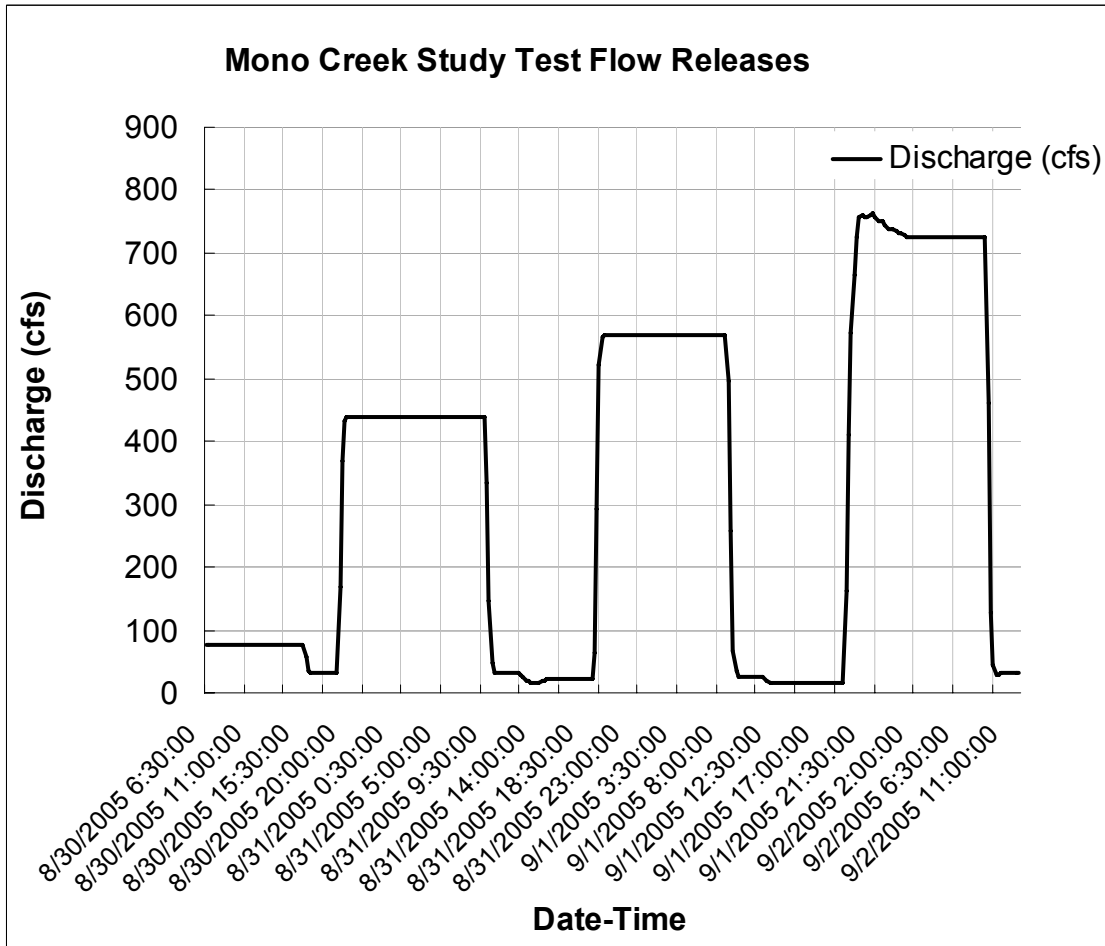
**Figure 2. Mono Creek Study Test Flow Releases (August 30, 2005 to September 2, 2005).**

The duration of each release was approximately 12 hours. Figure 2 depicts the magnitude and duration of these flows during the test period.

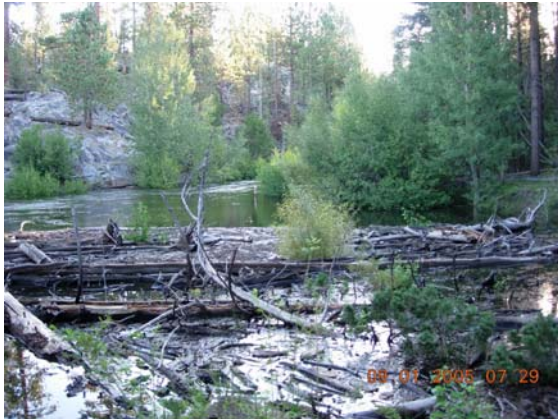
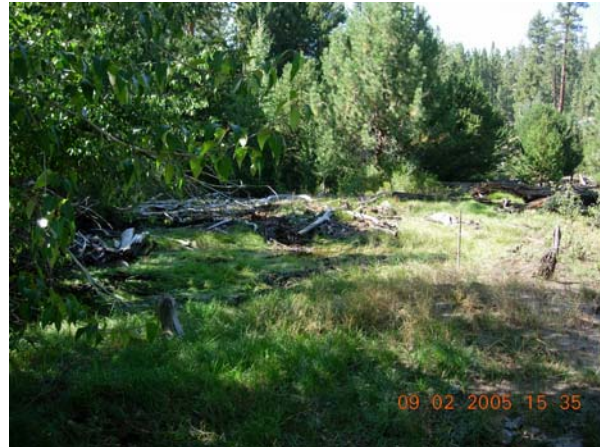
Large woody debris (LWD) was transported at all test flow releases. A relatively greater amount of LWD transport was observed following the 700 cfs release, but this could be the result of cumulative effects from the two preceding test flows (425 cfs and 580 cfs) (Figure 3).

**Figure 3. Large Woody Debris Deposited on Bars During and Following 580 cfs (left photo) and 700 cfs (right photo) Test Flow Releases.**

- Large Woody Debris was transported at all test flow releases
  - Observed a relatively greater amount of LWD transport following the 700 cfs release, but this could have been the result of cumulative effects from the 425 cfs and 580 cfs test flows.

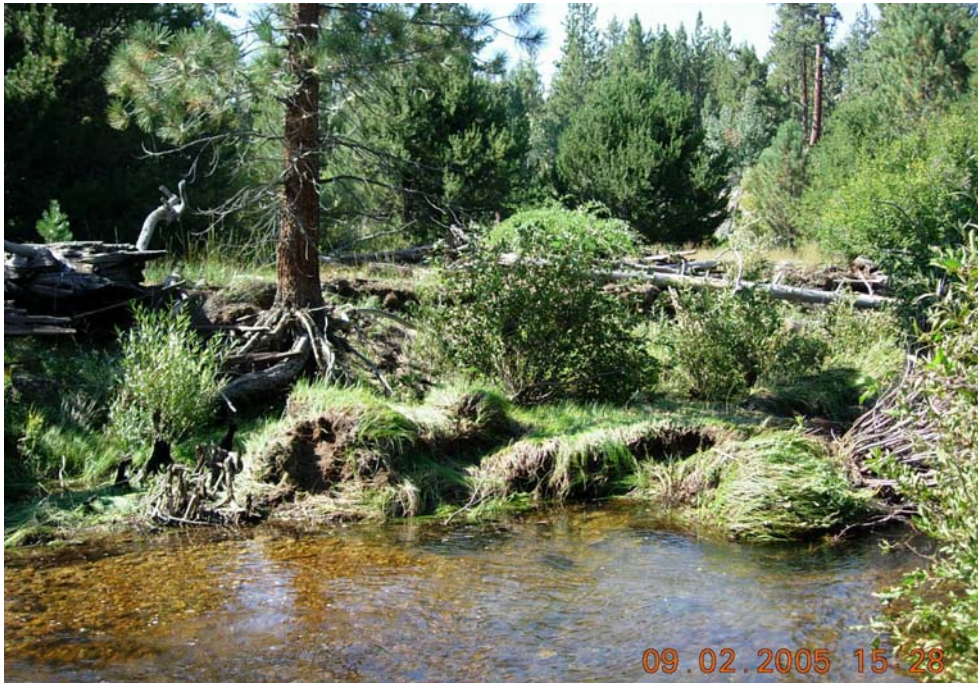
Minor bank erosion was observed in a few locations following the 700 cfs test flow release, often in association with LWD movement (Figure 4). Although substantial bank erosion was not observed at either the 425 cfs and 580 cfs flows, bank erosion observed after the 700 cfs release may be due to cumulative effects of all 3 test flows.

**Figure 4. Bank Erosion Observed on Left Bank at Upper Adjustable Reach Following the 700 cfs Test Flow Release. (Note that some of the erosion in the photograph existed prior to this study).**

- Minor amounts of bank erosion were observed following the 700 cfs release
  - Although no substantial bank erosion was observed at either the 425 cfs or 580 cfs flows, the bank erosion occurring with the 700 cfs release may be due to cumulative effects of all three test flows.

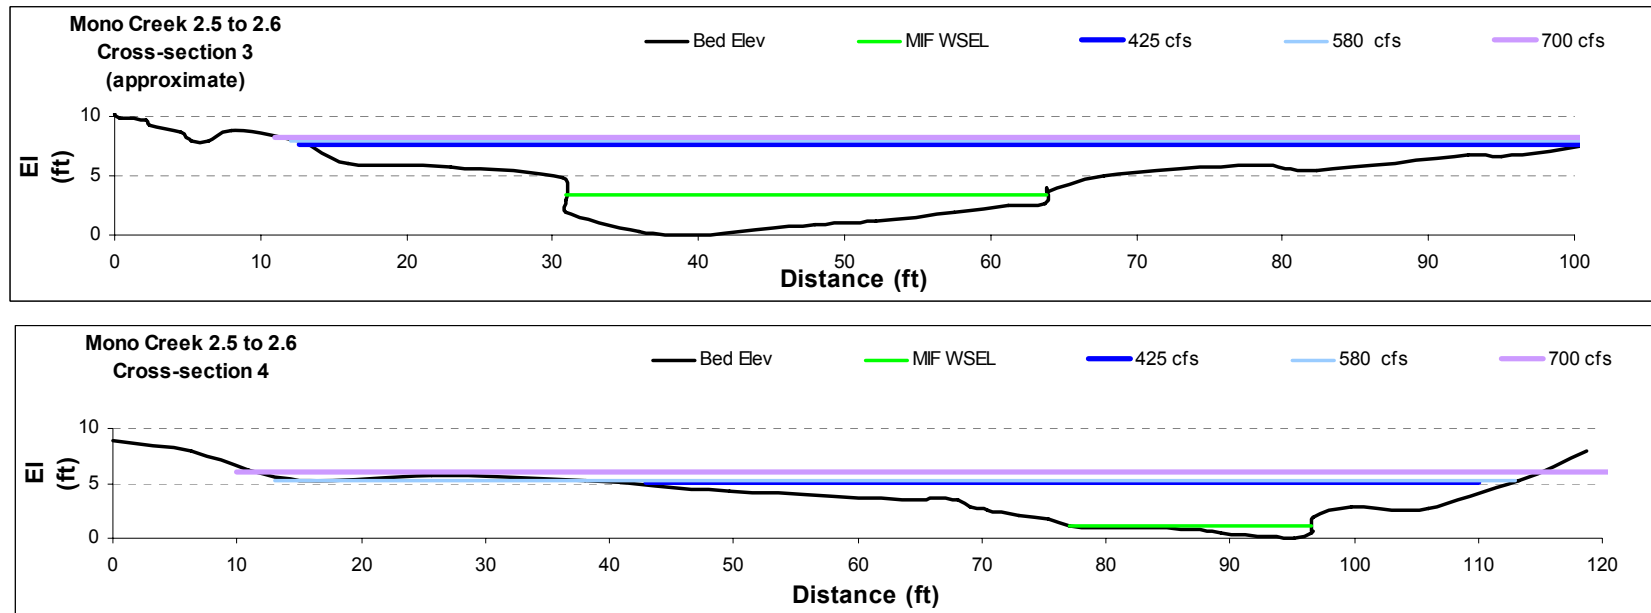
**Lower Reach**

Floodplain connectivity was evaluated in the two adjustable study reaches. Wetted-width measurements were conducted at the same locations as those used for the hydraulic modeling performed during earlier studies (refer to CAWG 2, Geomorphology, 2003 TSR (SCE 2004)), following the test flow releases. Portions of the floodplain were connected at all test flow releases. Observed wetted widths and water depths for each of the test flow releases were greater than indicated by the hydraulic modeling at most of the surveyed cross-sections. Cross-sections with observed wetted widths at the three test flow releases are shown in Figure 5.

**Figure 5. Observed Water Surface Elevations in the two Adjustable Reaches Along Surveyed Transects at the Three Test Flow Releases.**

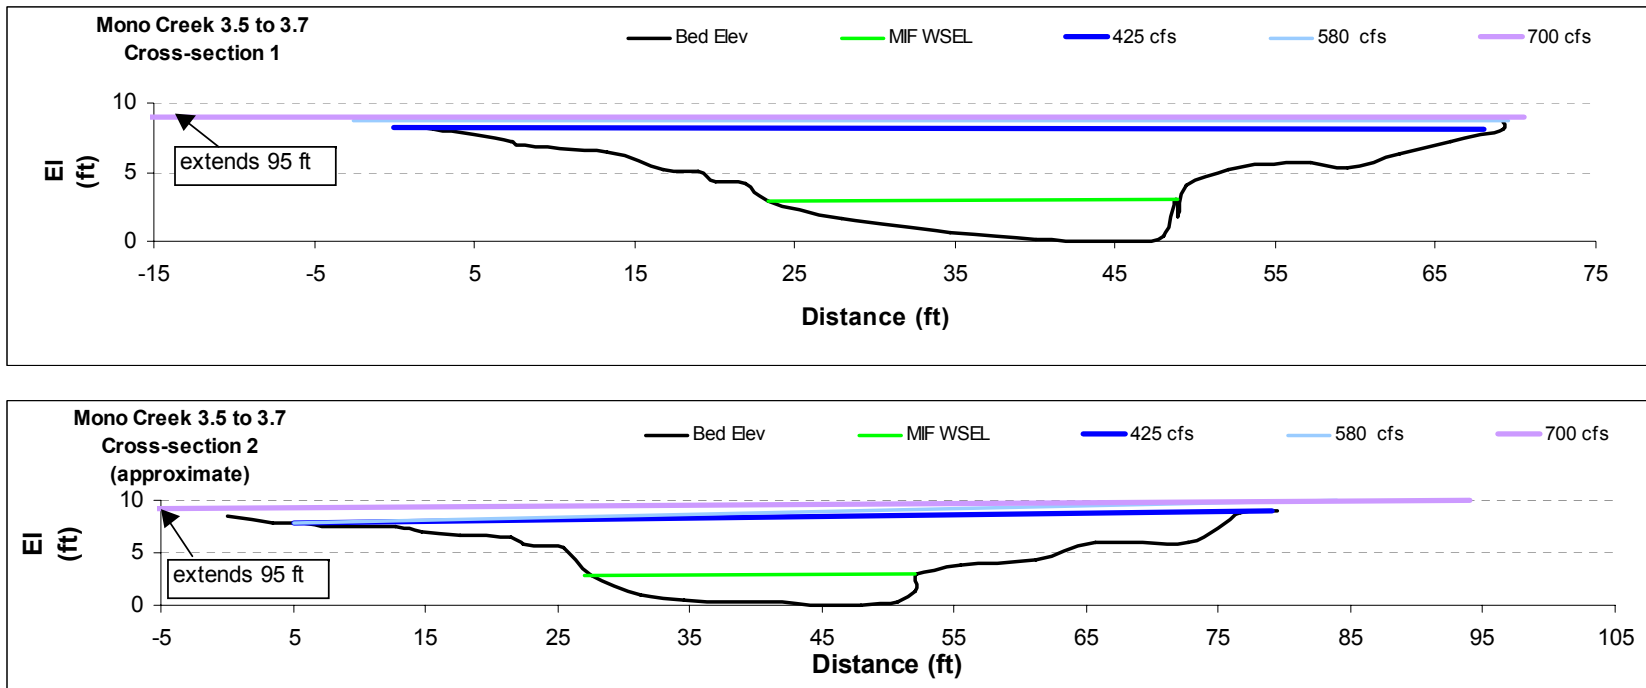
**Upper Reach**

**Figure 5. Observed Water Surface Elevations in the two Adjustable Reaches Along Surveyed Transects at the Three Test Flow Releases (continued).**

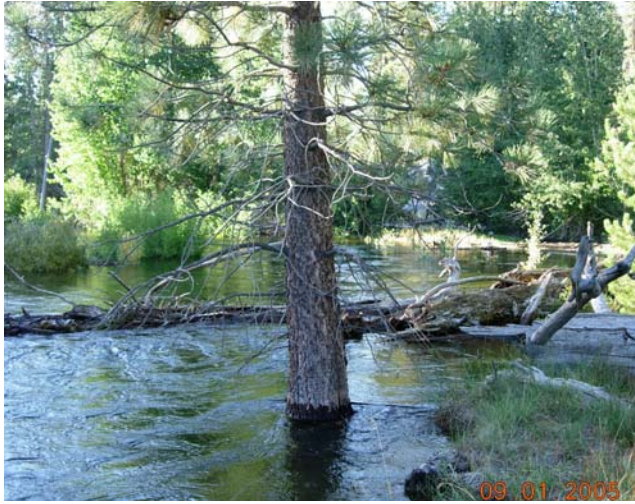
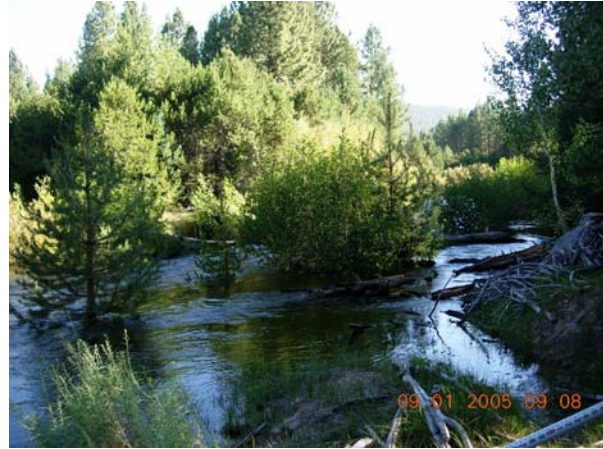
Portions of the floodplain and bars were connected at all three test flow releases as a result of flows entering into the floodplains at lower elevation points upstream and flowing within favored flow paths within the floodplain, and flow overbanking. As a result, wetted width and depths at the test flow releases were greater than predicted by the hydraulic modeling. In general, wetted width increased with greater flow magnitudes. However, comparatively minor changes in wetted width were noted in the lower reach as flows were increased from 580 cfs to 700 cfs due to the width of the valley bottom and local topography. Encroached vegetation was inundated at all three test flow releases.

**Figure 6. Mature Vegetation Inundated at the 580 cfs Test Flow Releases at the Lower (left photo) and Upper (right photo) Adjustable Reaches.**

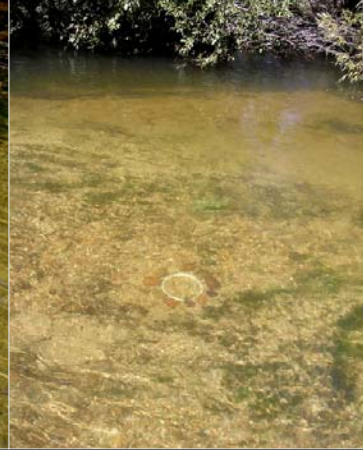
Run 1 - Lower monitoring site  
After 425 cfs  
Visible PT was uncovered; other one  
is still buried in the background.

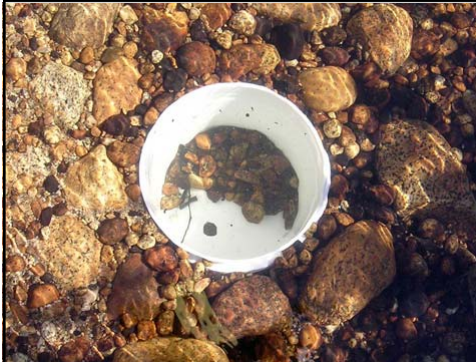
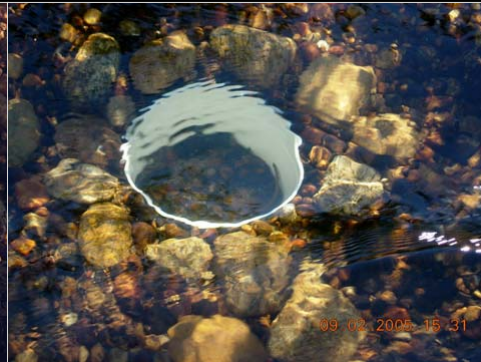
### Riff 2B, Upper Monitoring Site

After 425 cfs

After 700 cfs

Almost all the pit traps were completely full of sediment following each of the test flow releases (except site Riffle 2B in the upper reach, which was usually about ½ full or less) (Table 3). This indicates that bedload was moving at all test flows in both adjustable reaches. The dominant particle size captured by the pit traps was usually 4mm (very fine gravel), and maximum particle sizes were typically between 16 and 22mm, and up to 45mm in some instances. There was no discernable difference in the amount of sediment captured, or the particle sizes mobilized, at any of the three test flows based on the pit trap data.

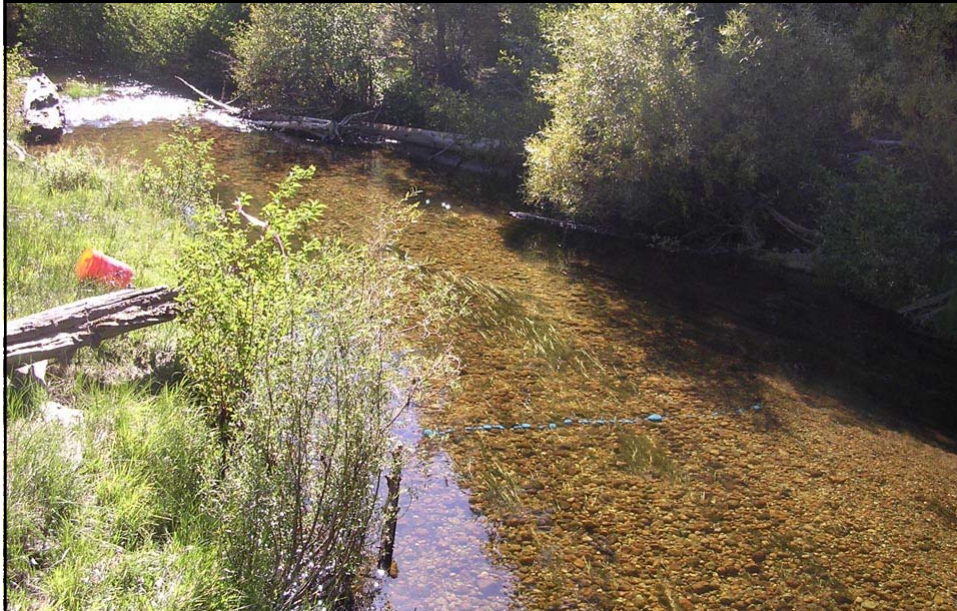
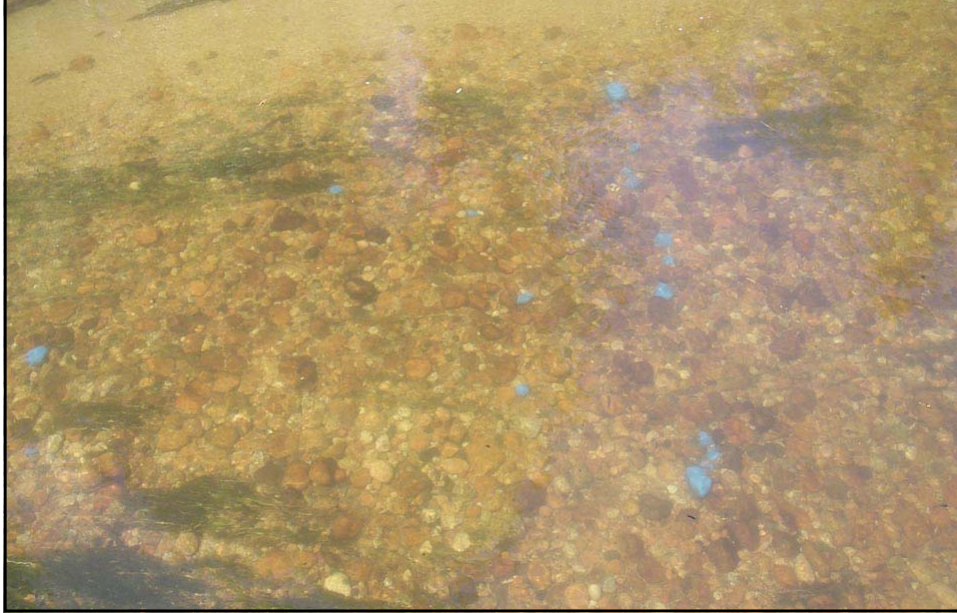
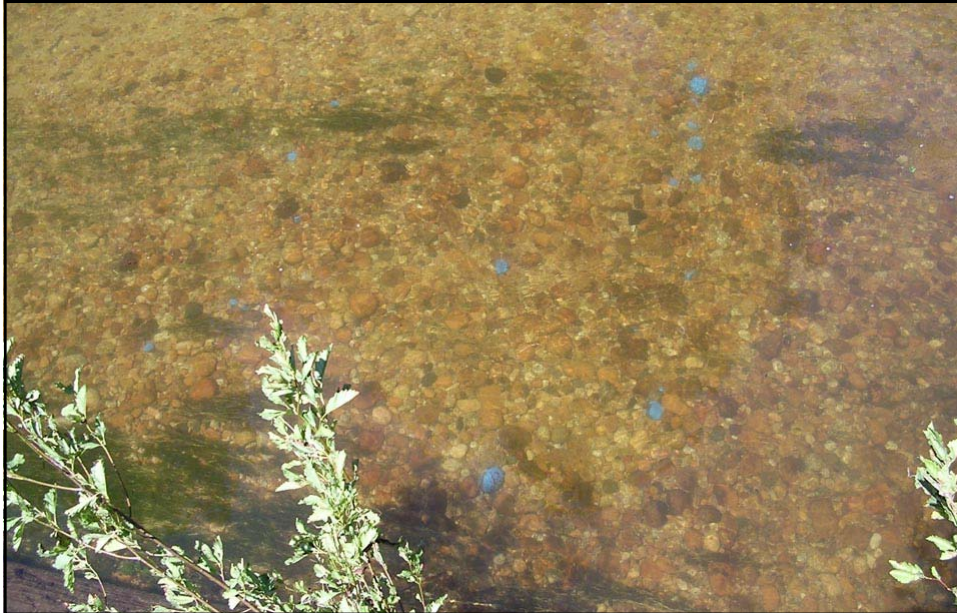
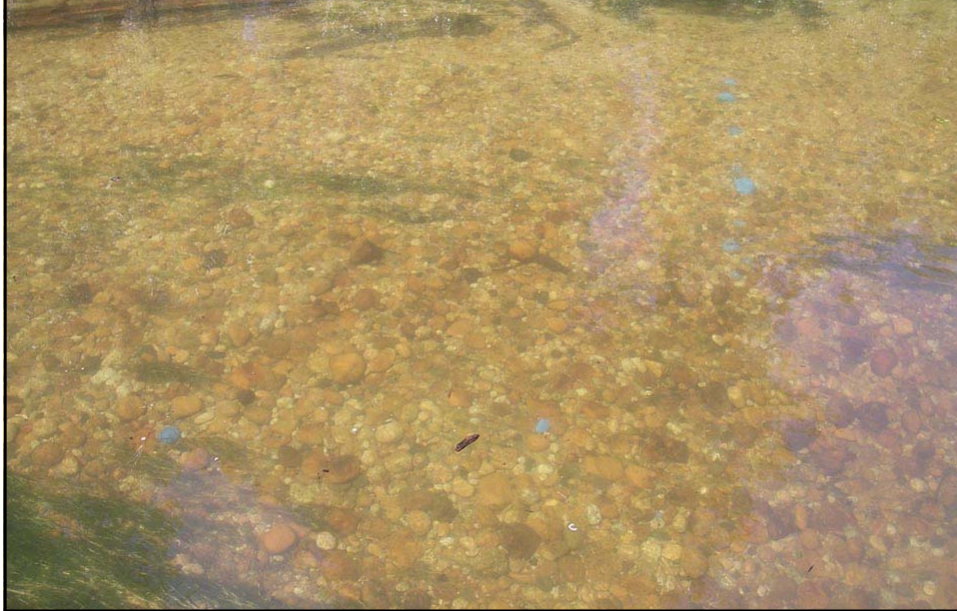
**Tracers after 425 cfs**  
Pool-0, Lower Monitoring Site

**Tracers after 580 cfs**  
Pool-0, Lower Monitoring Site

**Tracers after 700 cfs**  
Pool-0, Lower Monitoring Site

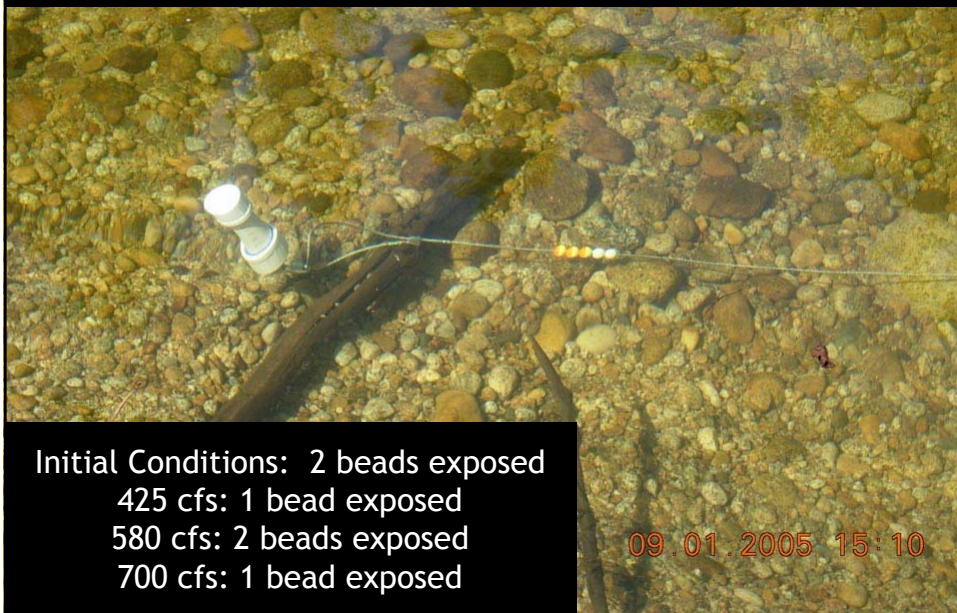
**Sliding Bead Monitor after 580 cfs**  
Pool Tail out 1, Upper Monitoring Site

Initial Conditions: 2 beads exposed  
425 cfs: 1 bead exposed  
580 cfs: 2 beads exposed  
700 cfs: 1 bead exposed

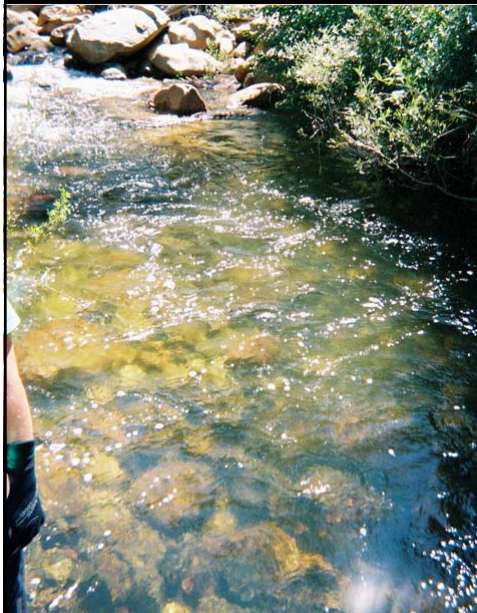
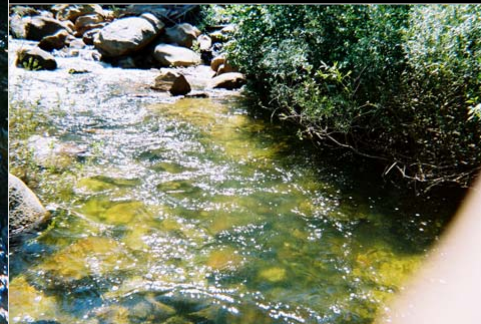
## Pool below Pocket 5

⇐ After 425 cfs release

⇓ After 580 cfs release

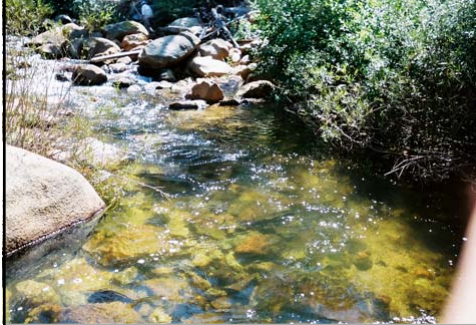
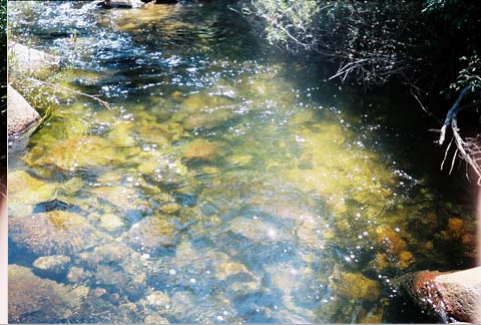
## Pool below Pocket 5

Upper part of pool  
after 700 cfs release

Lower part of pool  
after 700 cfs release
