GEO-1 EROSION AND SEDIMENTATION TECHNICAL MEMORANDUM

**KERN RIVER No. 3 HYDROELECTRIC PROJECT
*FERC PROJECT No. 2290***

October 2023

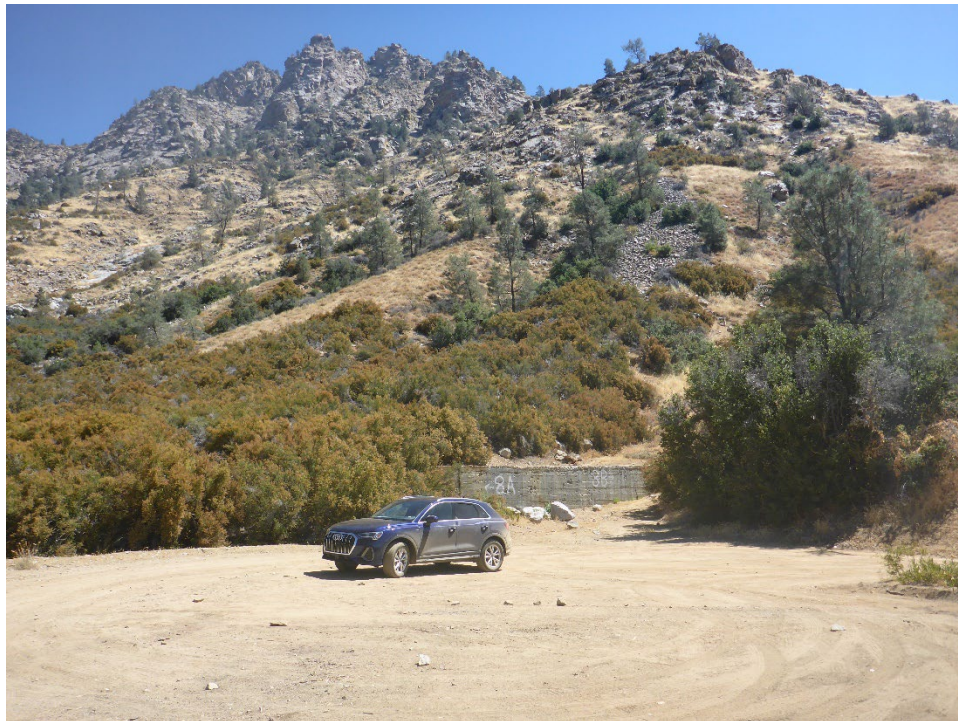
Figure A-16. Tunnel 8B Spoil Pile Site showing stable spoil pile pad surface.

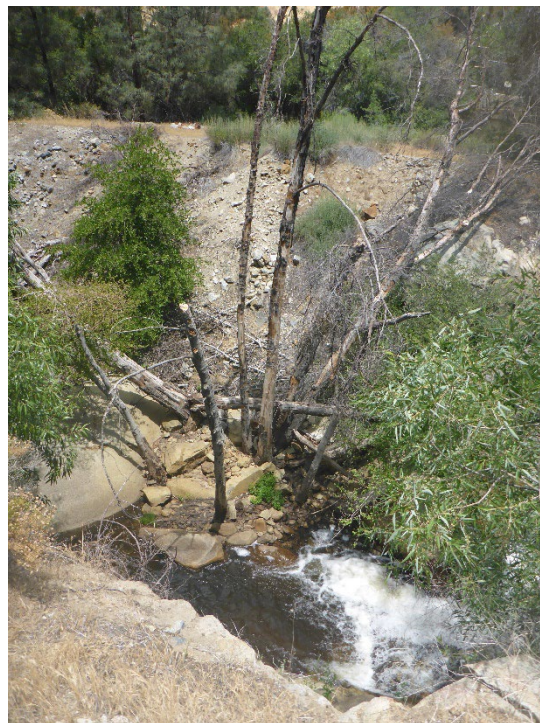
Figure A-20. Right Bank (north side) immediately downstream of the exposed flume crossing at Salmon Creek with little-to-no active erosion in historical spoil material.

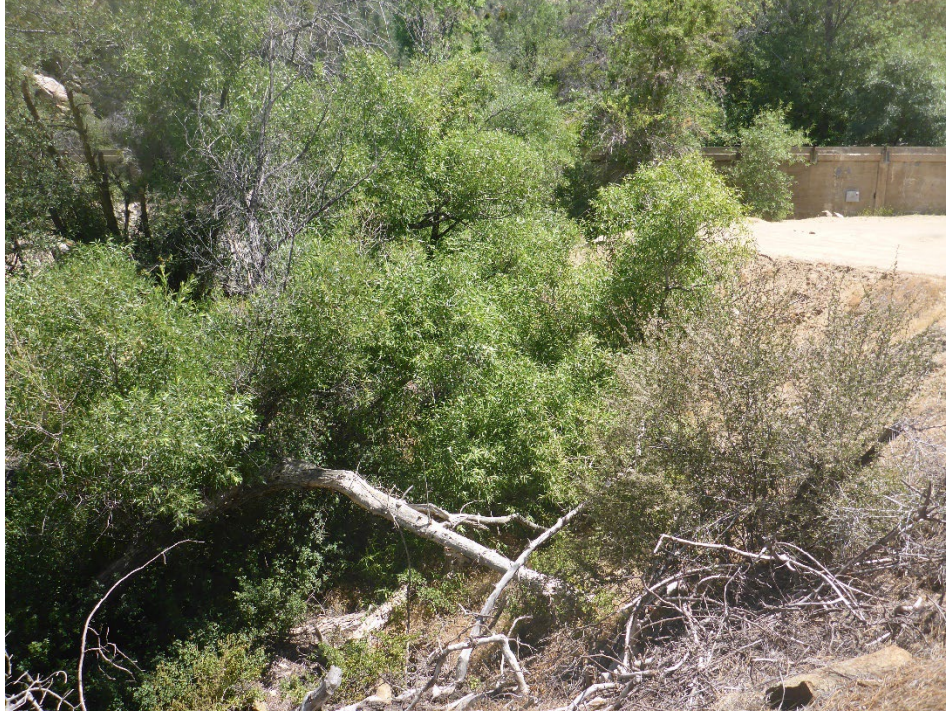
Figure A-20. Left bank (south side) immediately downstream of the exposed flume crossing at Salmon Creek with little-to-no active erosion in historical spoil material.

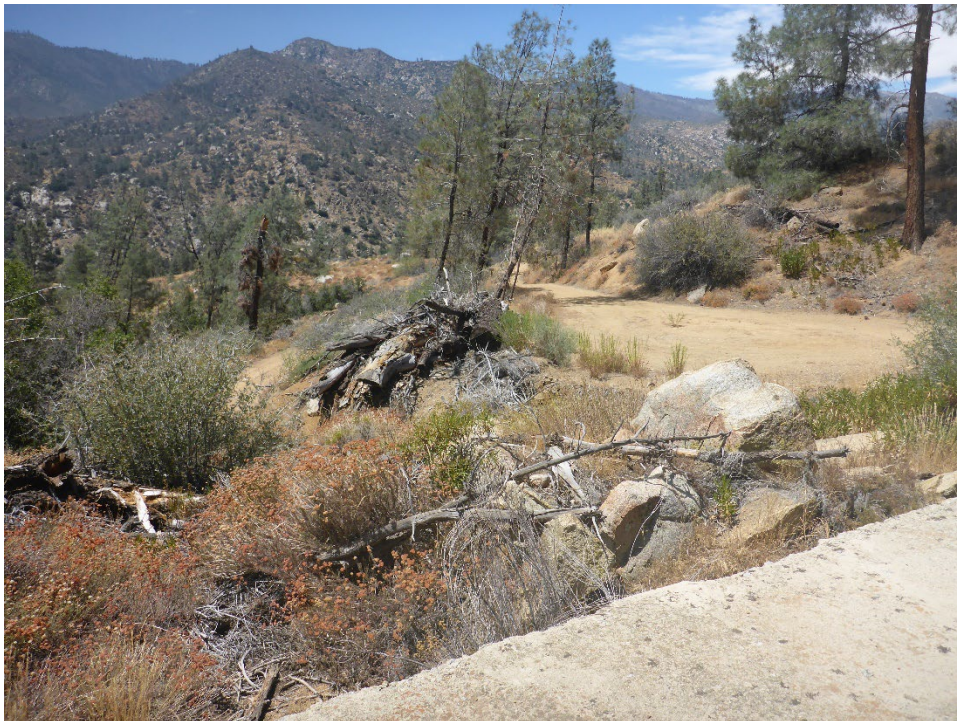
Figure A-26. Overview of Tunnel 10 Spoil Site (view looking downstream from top of exposed tunnel section).

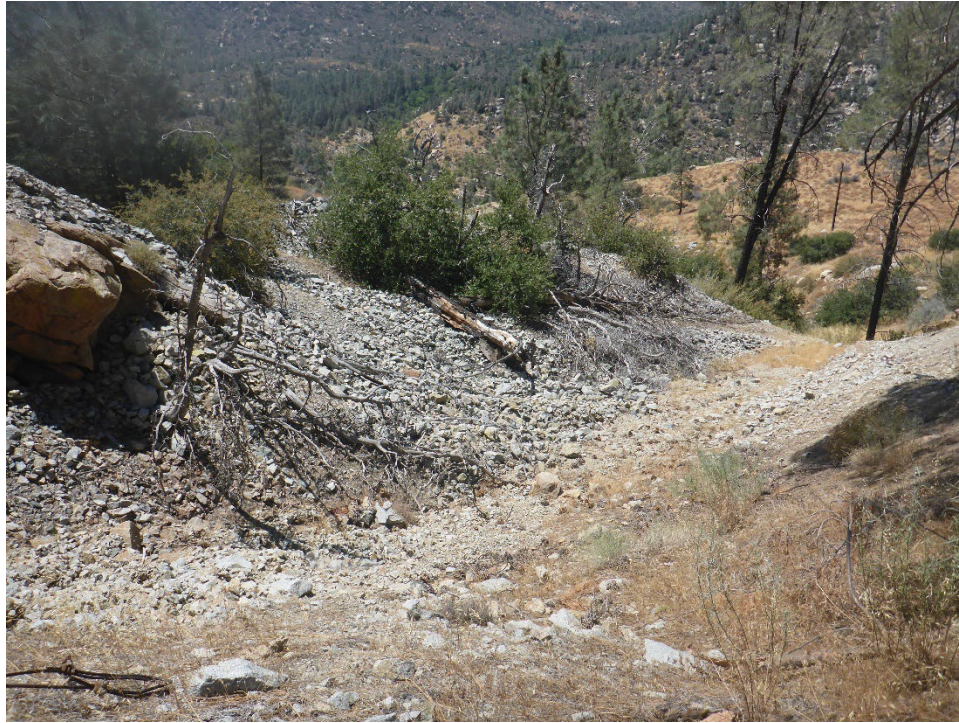
Figure A-31. Coarse Tunnel 11 spoil material with stable spoil edge with Little-to-no active erosion of spoil pile (view looking downslope).

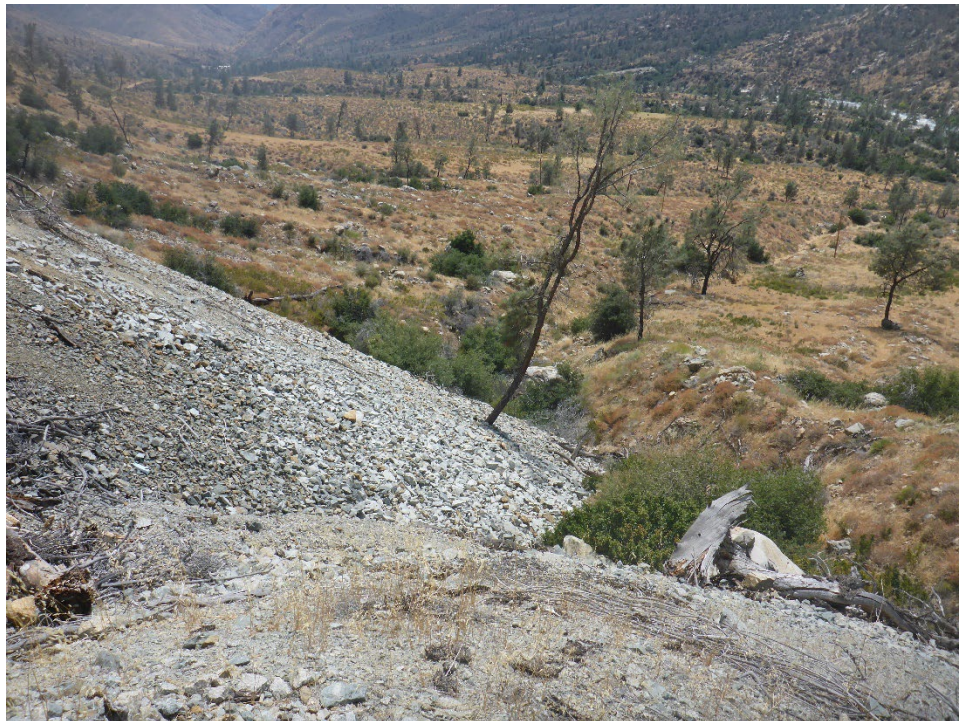
Figure A-32 Outer edge of Tunnel 12/13 Spoil Site with little-to-no active erosion (view looking downslope with Kern River in foreground).

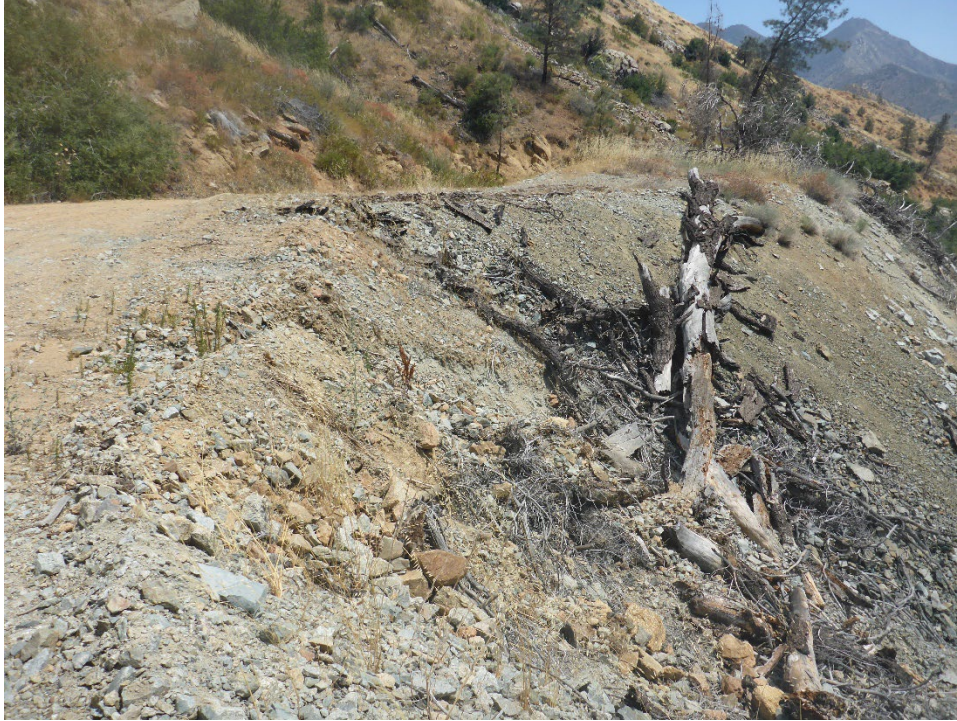
Figure A-33. Close-up view of access road built on top of Tunnel 12/13 spoil material (Figure A-32 image immediately adjacent to right side of Figure A-33 image).

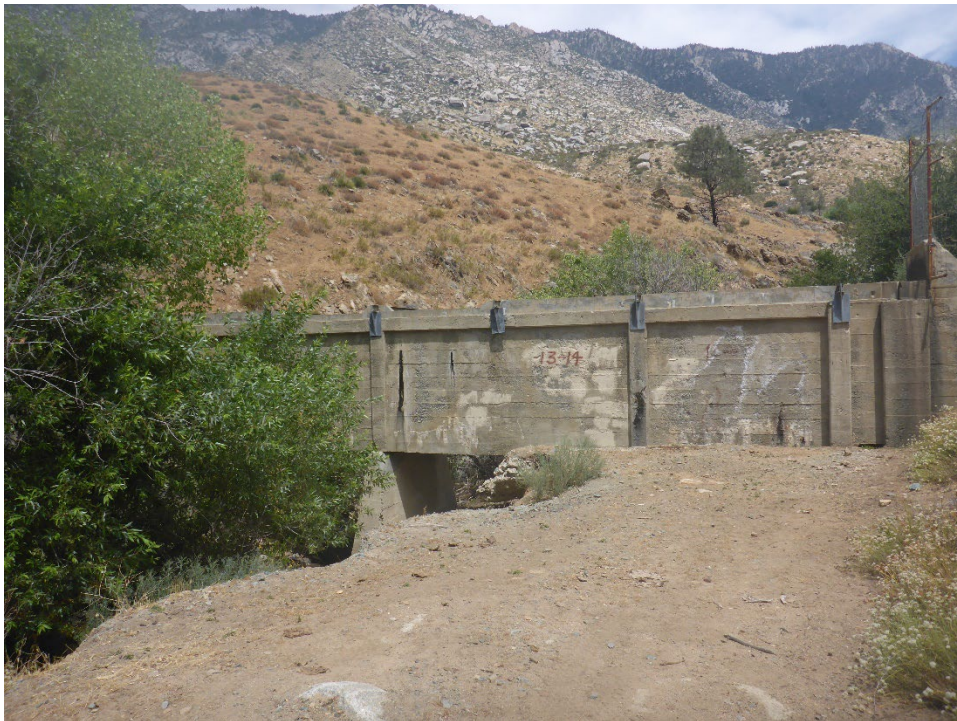
Figure A-34. Access road built on Tunnel 13/14 Spoil Site at Gold Ledge Creek (view looking upstream and showing left bank [south side] of spoil material).

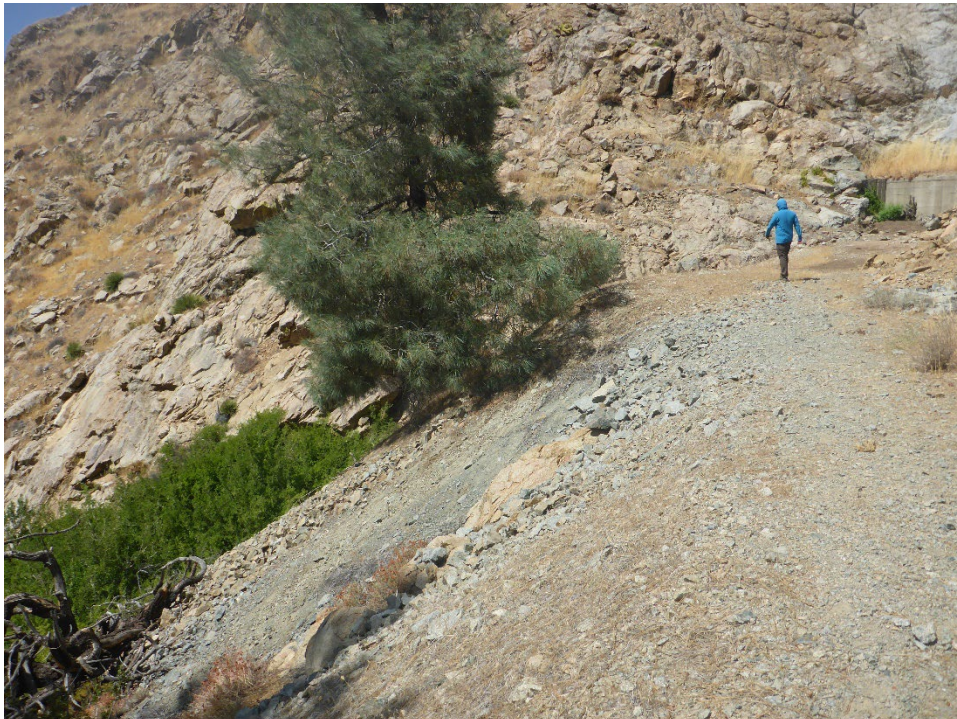
Figure A-38. Tunnel 15 Spoil Site (view looking upslope from access road).

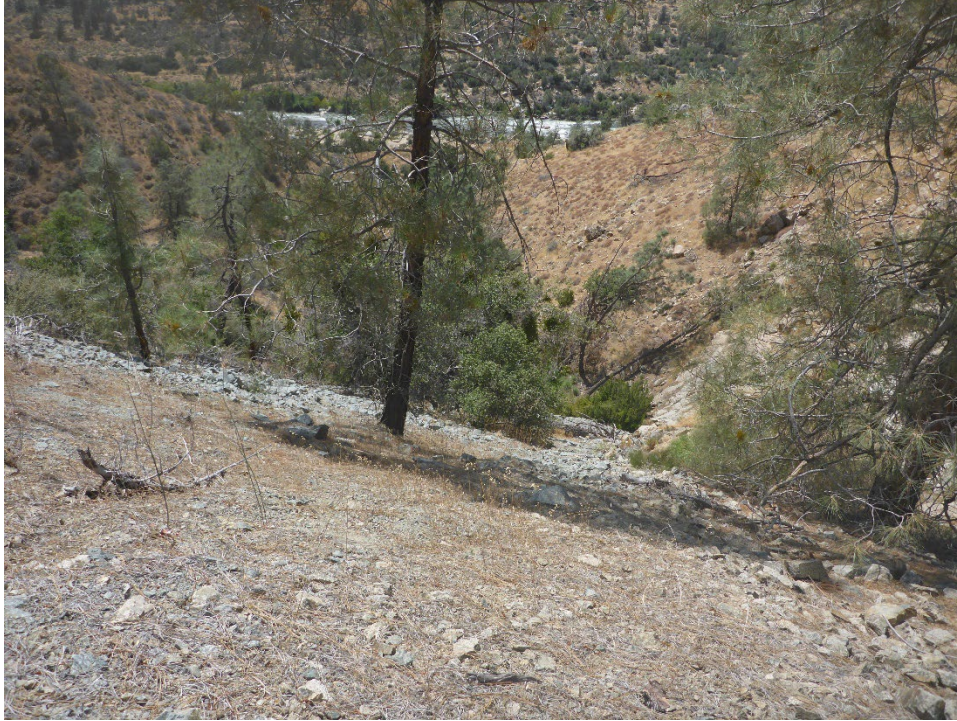
Figure A-39. Stable outboard edge of Tunnel 15 spoil pile with little-to-no active erosion; Kern River visible in background (view looking downslope).

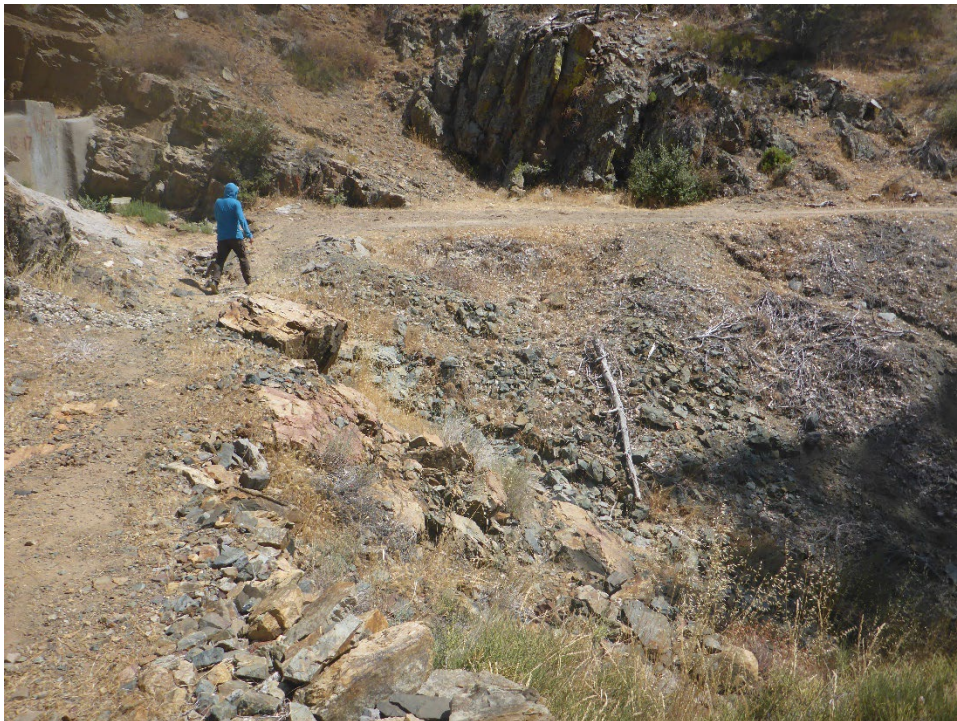
Figure A-40. Spoil material and access road at Tunnel 16/17 Spoil Site with little-to-no active erosion.

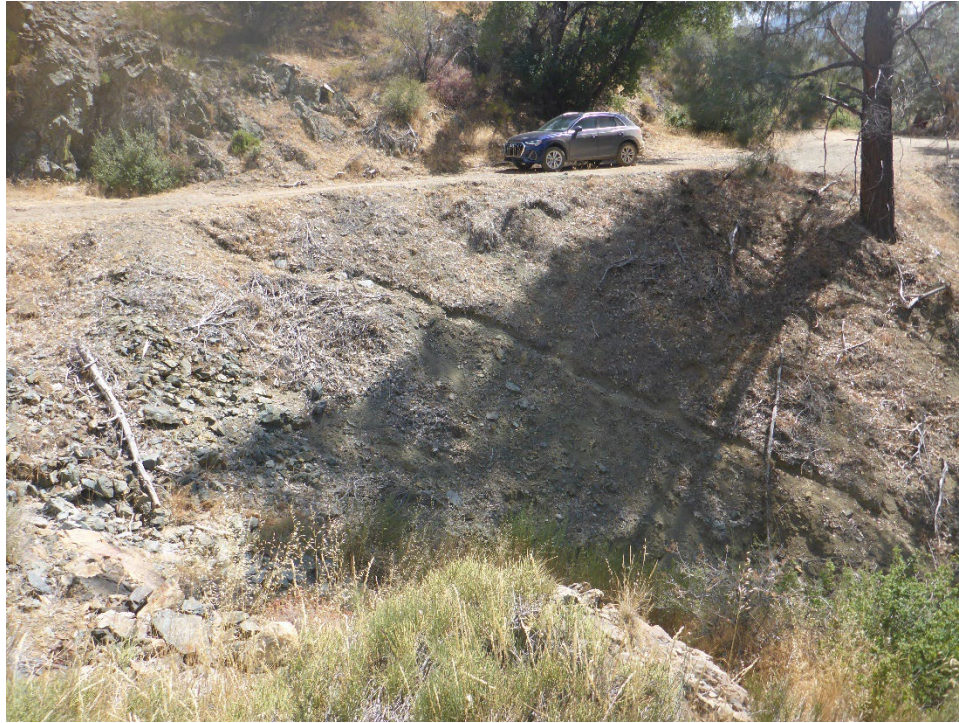
Figure A-41. Spoil material and access road at Tunnel 16/17 Spoil Site (view from immediately adjacent to right side of Figure A-40).

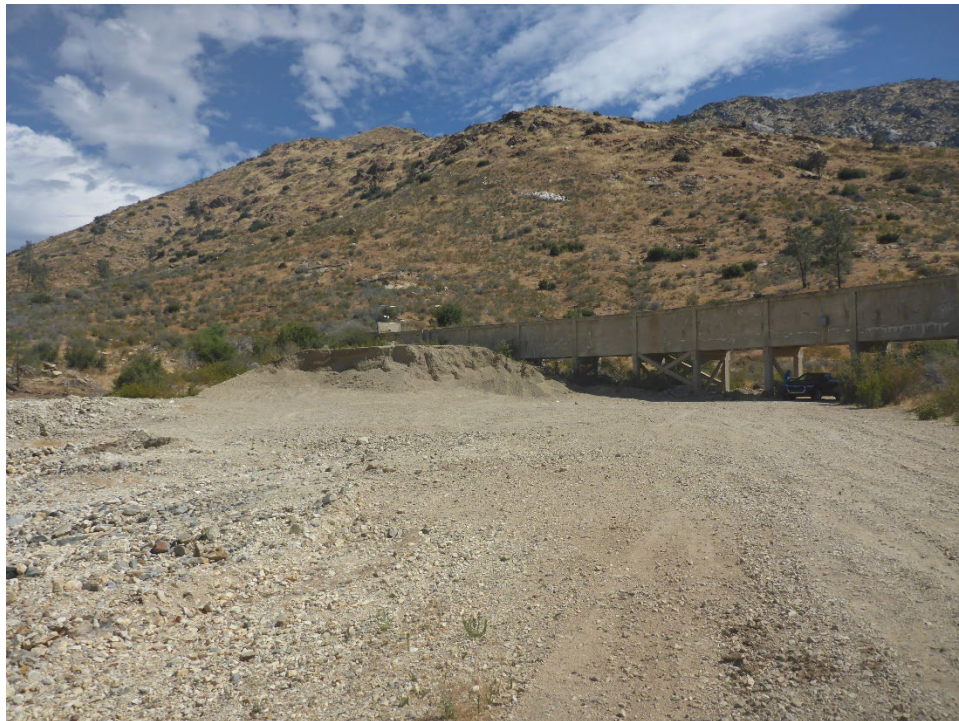
Figure A-42. Spoil material and large pad at Corral North Tunnel 17 Spoil Site. Aggregate stockpile adjacent to exposed tunnel structure in foreground likely imported material for road maintenance.

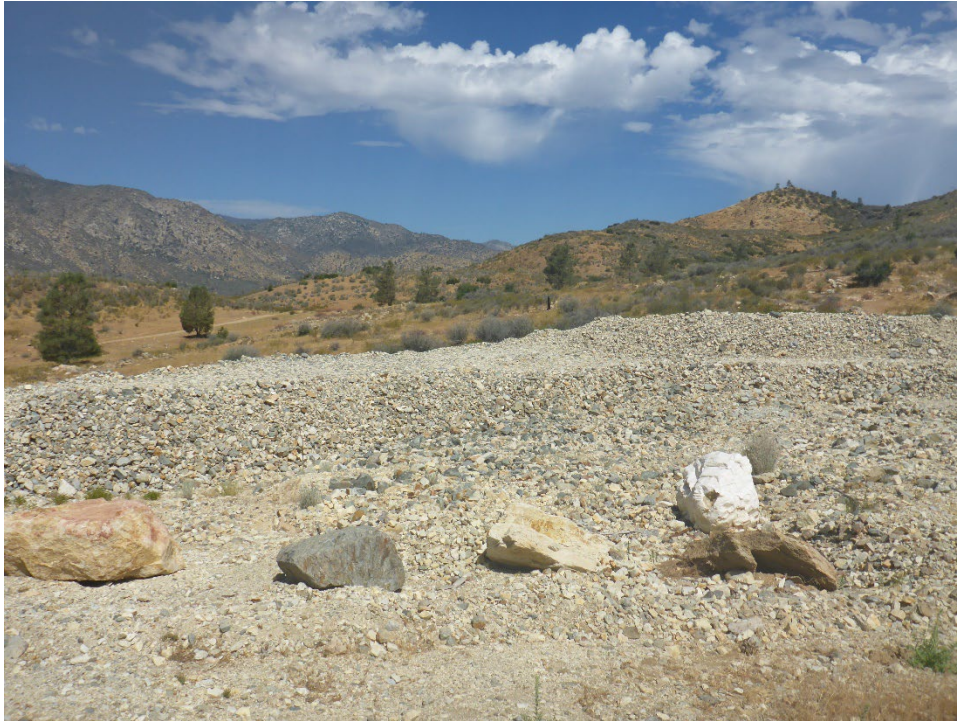
Figure A-43. Coarse spoil material at Corral North Tunnel 17 Spoil Site, located at head of broad, low-gradient upland valley swale, little-to-no active erosion.

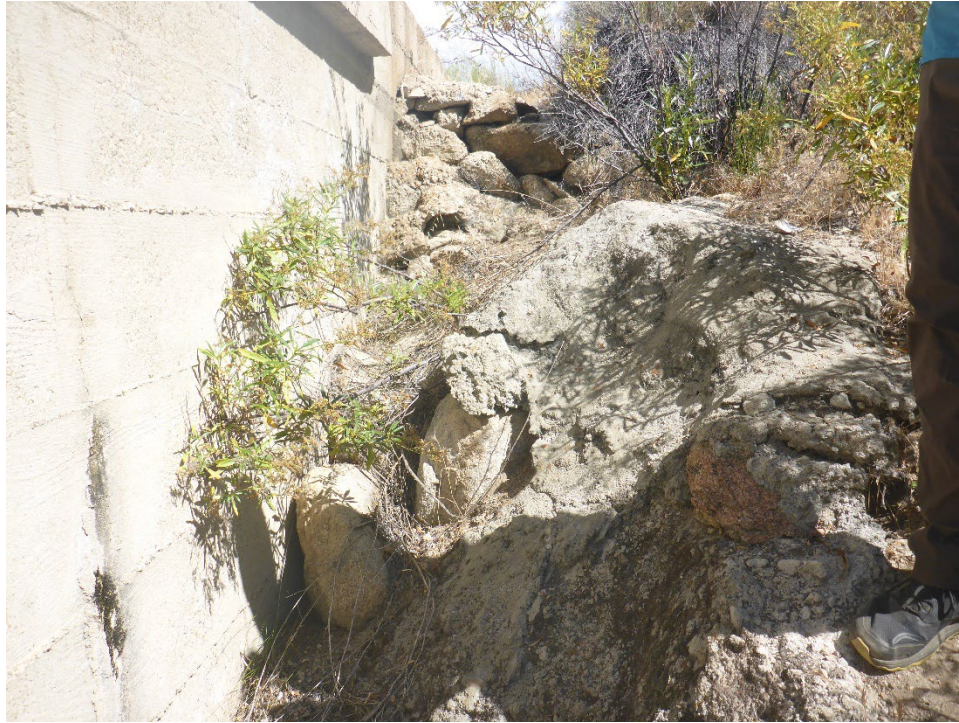
Figure A-45. Gunite erosion control/bank stabilization along upstream edge of Corral Creek crossing flume.

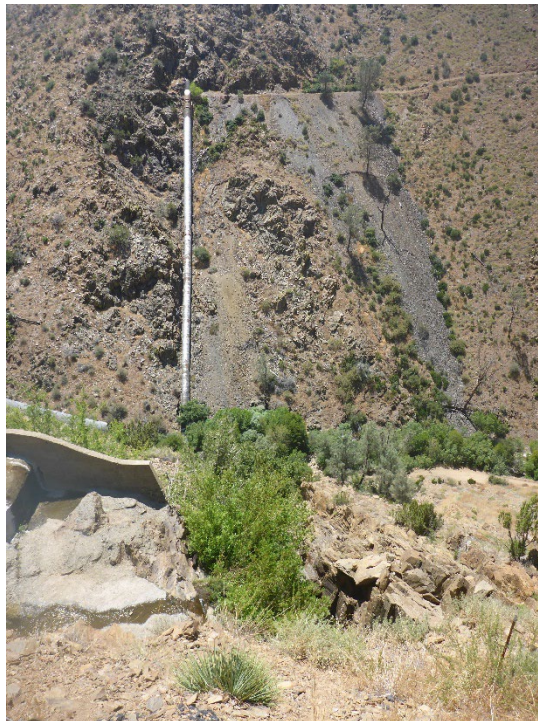
Figure A-54. Cannel Creek Siphon Spillway (view looking downslope).

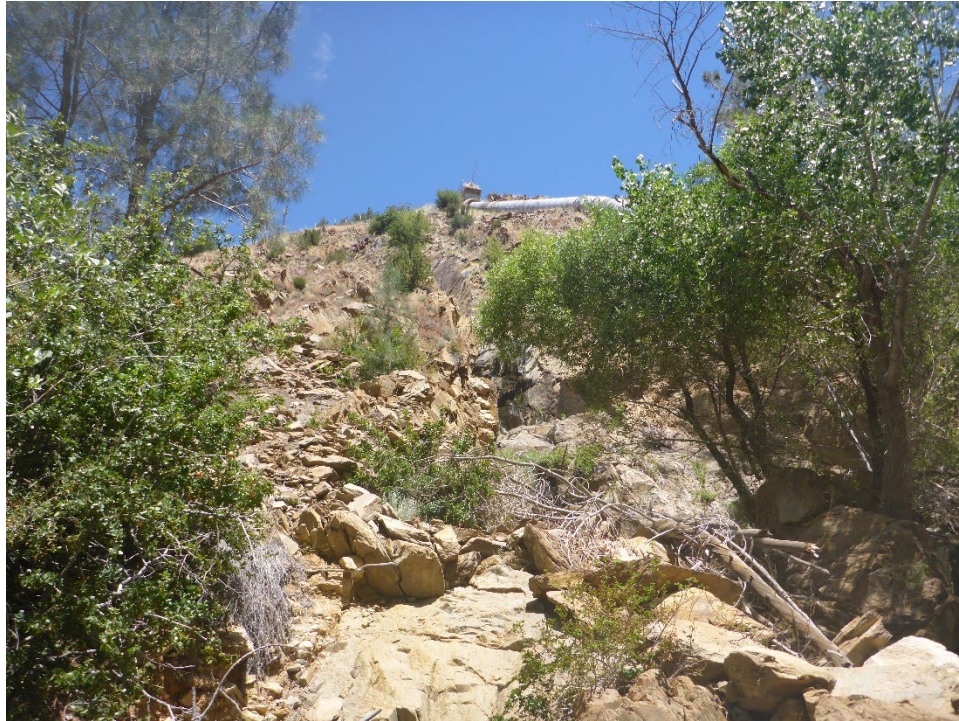
Figure A-55. Cannel Creek Siphon Spillway Channel (view looking upslope).

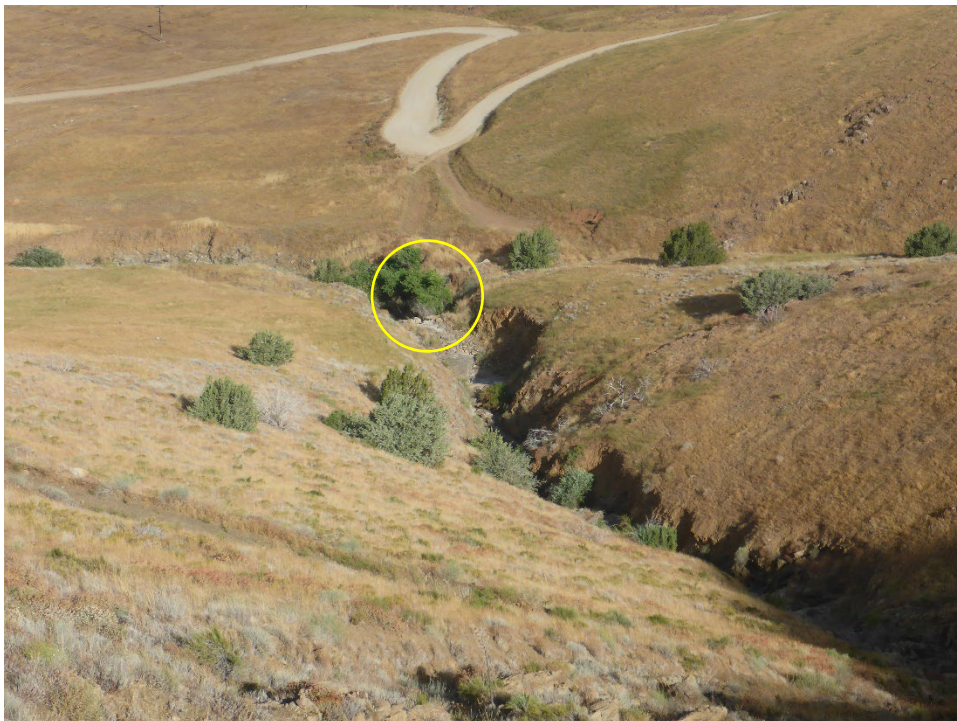
The KR3 Powerhouse Forebay Spillway channel was identified as an area of concern for potential active erosion and sedimentation based on communication with Stakeholders. The KR3 Powerhouse Forebay Spillway channel is formed in native hillslope soils and colluvium from direct surface discharge released at the end of the KR3 Conveyance Flowline immediately before the flowline enters the KR3 Powerhouse penstock (Figure 3-1). Over time, water released into the spillway has carved a distinct channel through the hillslope colluvial mantle down to underlying bedrock (Figures A-56 to A-63). The channel averages 40 to 50 feet wide and 10 to 15 feet deep over the entire length of the spillway channel, based on LiDAR measurements. KR3 Powerhouse Forebay Spillway channel enters the Kern River floodplain approximately 1,300 feet upstream of the KR3 Powerhouse. The channel planform pattern and degree of incision appears largely unchanged from 2005 to 2022, based on aerial imagery analysis.

Figure A-60. Top of KR3 Powerhouse Forebay Spillway channel (looking downstream; location of knickpoint in Figure A-59 image indicated by yellow circle).

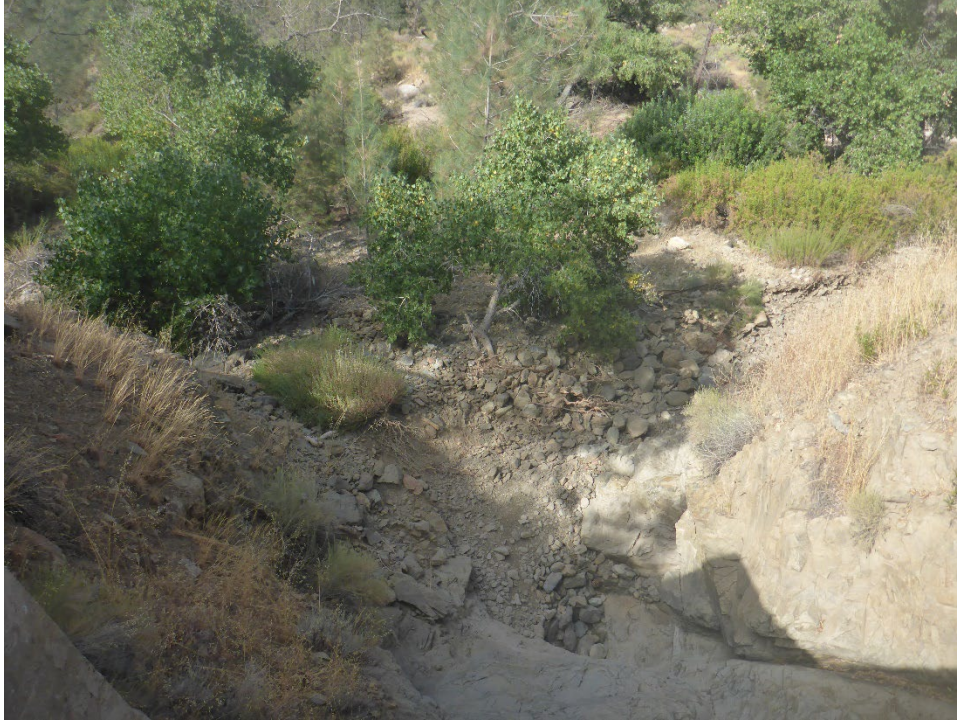
Figure A-61. KR3 Powerhouse Forebay Spillway channel where it empties into the Kern River floodplain (looking downstream).

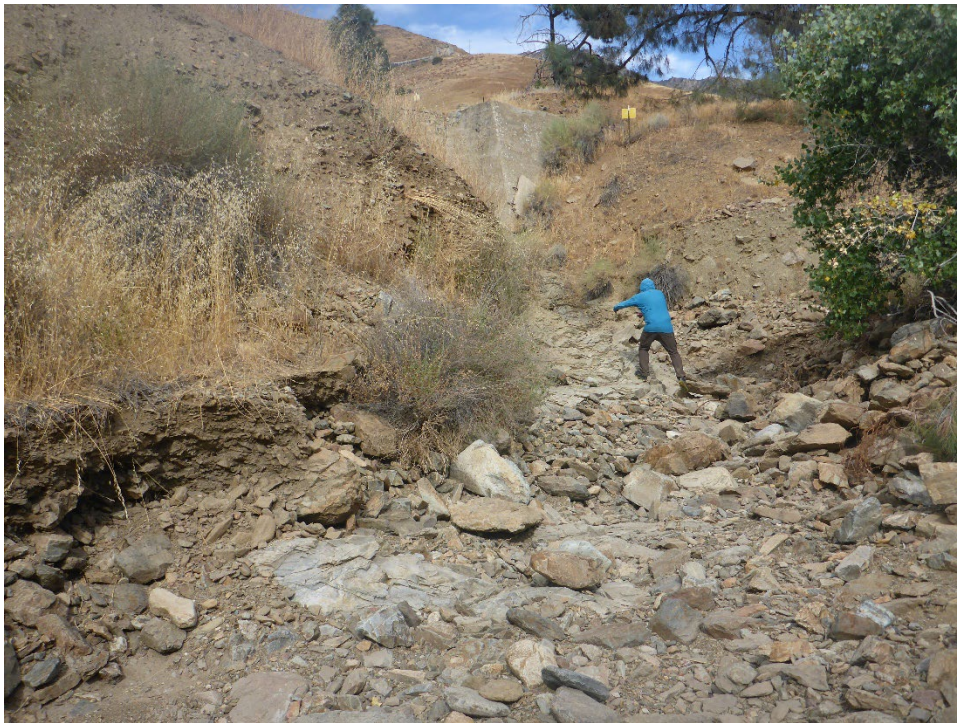
Figure A-62. KR3 Powerhouse Forebay Spillway channel where it empties into the Kern River floodplain (looking upstream).

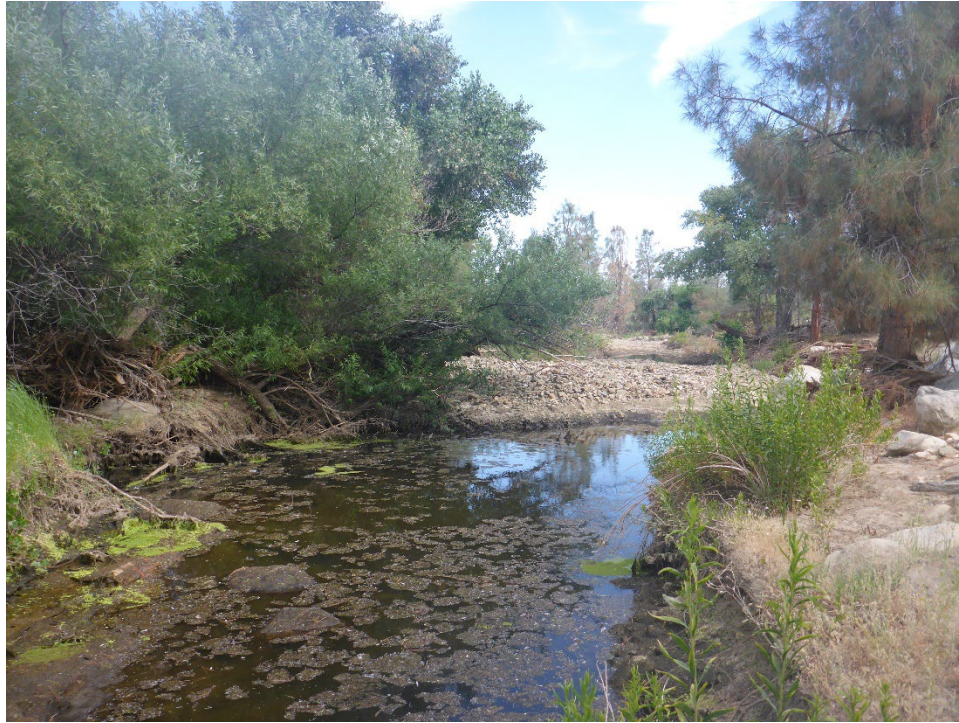
Figure A-63. KR3 Powerhouse Forebay Spillway channel where it empties into the Kern River floodplain (looking upstream).
