Rush Creek Project, FERC Project No. 1389

LAND 1 – Aesthetics
Draft Technical Study Report

August 2024

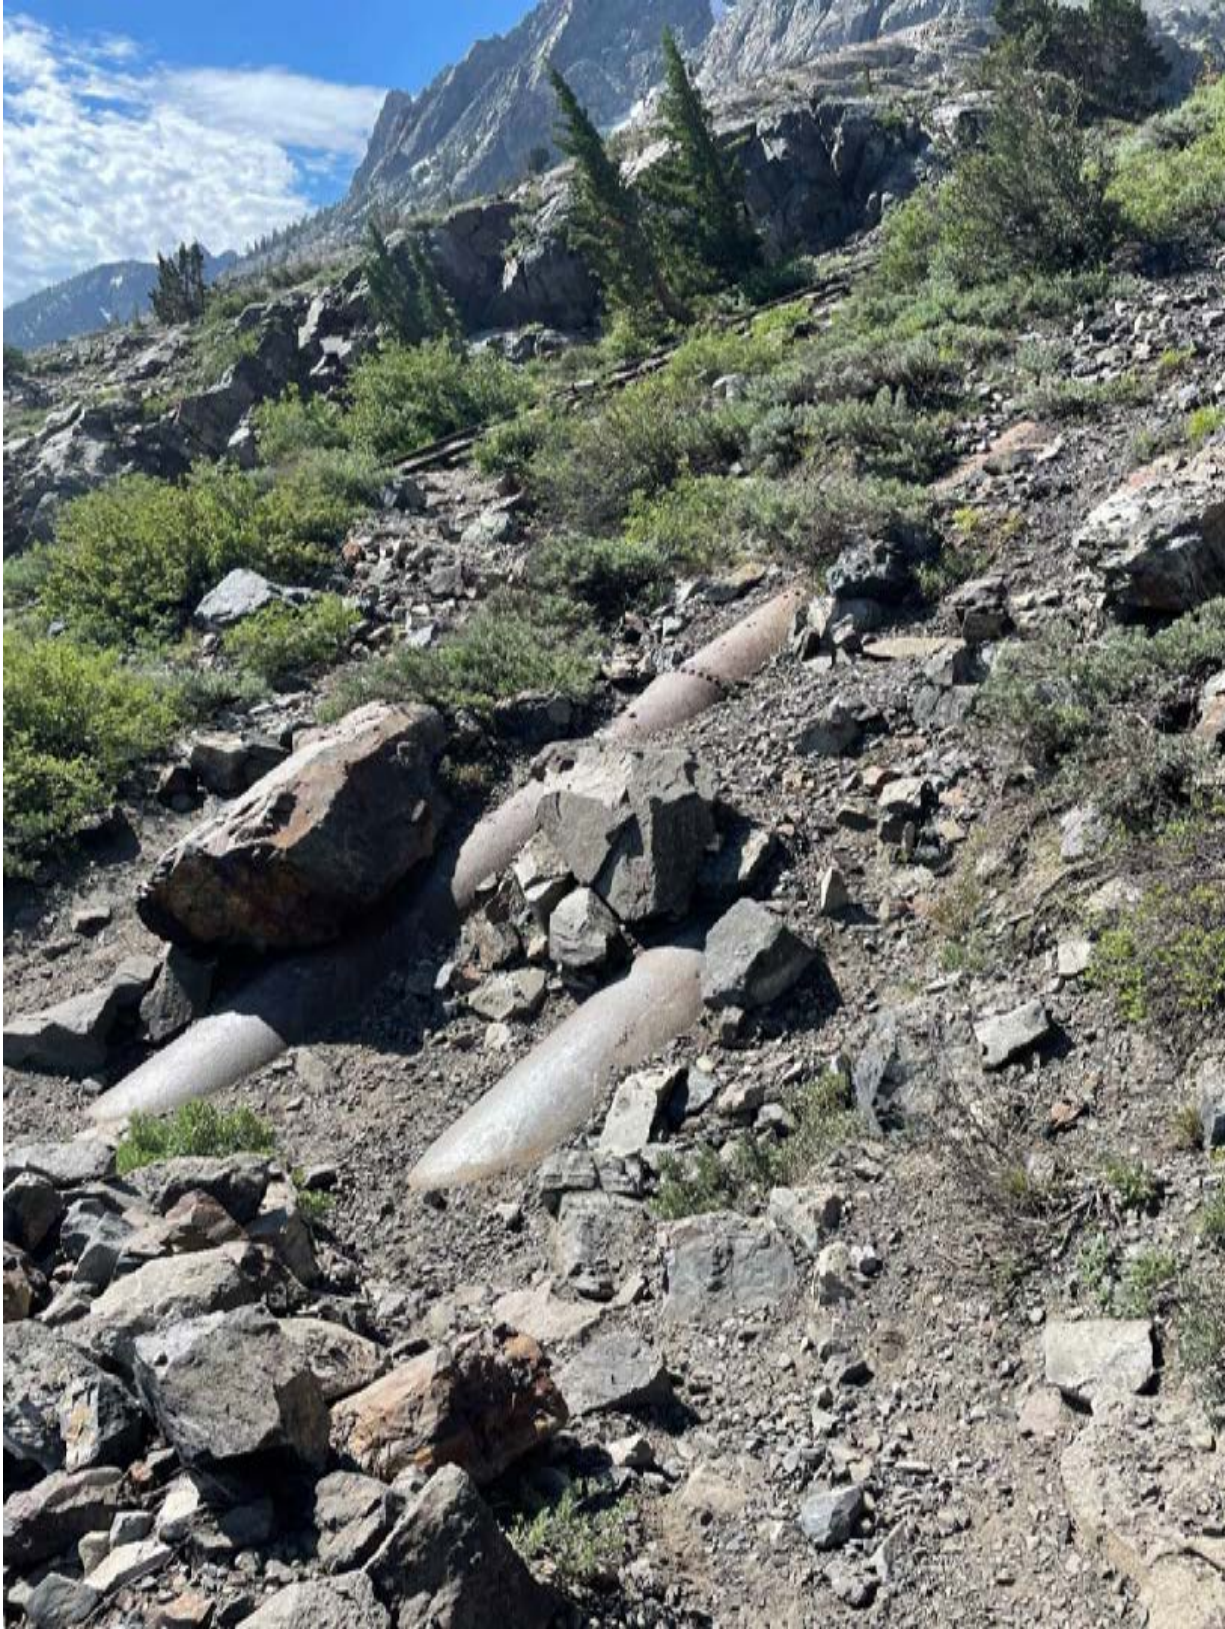
Photo 1. Key Observation Point 1, Penstock and Tram Tracks

Note: July 17, 2023 (37.7655, -119.13)

- GPS Coordinates: 37.7655, -119.13
- Location Description: Rush Creek Trail heading toward Horsetail Falls
- Viewshed Description: Horsetail Falls is the prominent view heading up the trail. Obviously visible Project facilities include the tram tracks, Agnew 4-kilovolt (kV) line, and penstock/flowline. The Agnew 4-kV line and associated poles are a component of the middleground view. Looking east from the trail into the valley, the developed areas of the June Lake Loop are visible to the south of Silver Lake. The tram tracks and partial views of the penstock/flowline are among the elements in the foreground while walking. Project facilities, while contrasting in line and form with the natural landscape are generally consistent with other landscape colors (not contrasting).

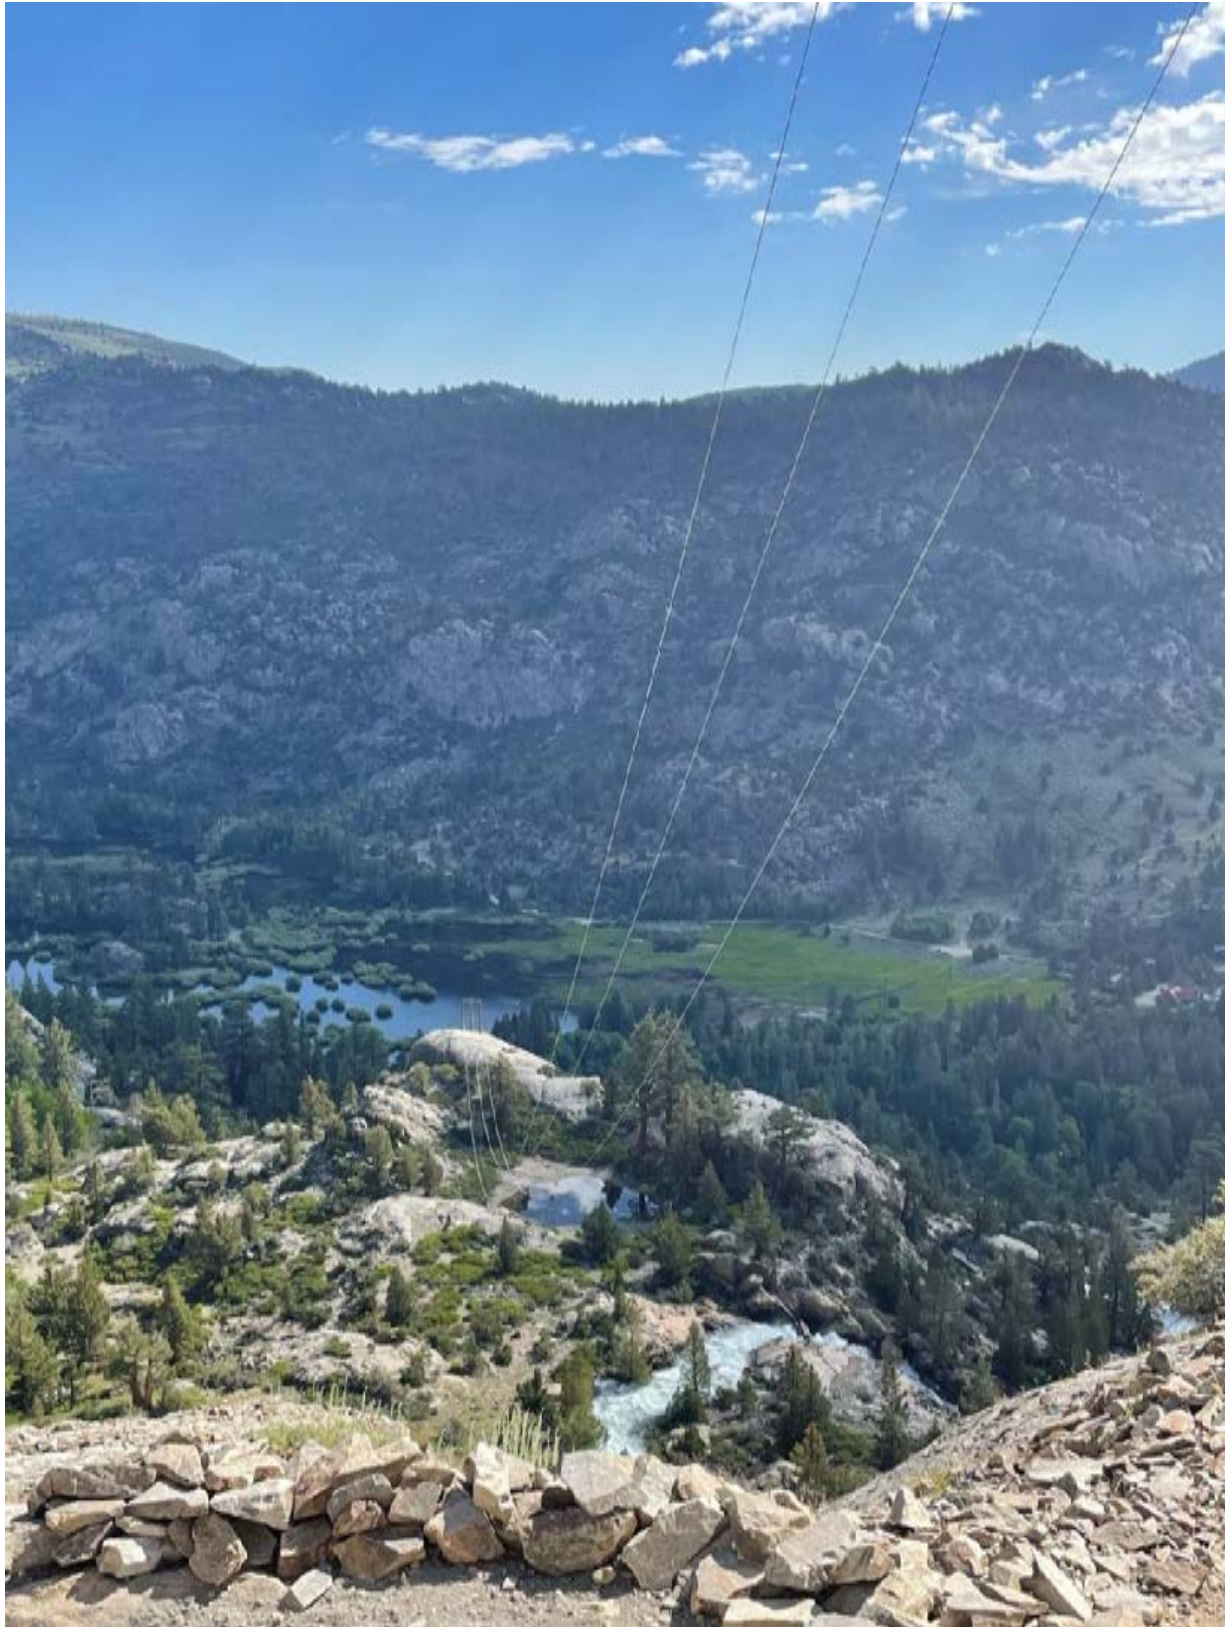
Photo 2. Key Observation Point 2, Agnew 4-kV Line

Note: July 17, 2023 (37.7628, -119.129)

- GPS Coordinates: 37.7628, -119.129
- Location Description: Viewpoint along the Rush Creek Trail with views directly down the Agnew 4-kV line east into the valley.
- Viewshed Description: Steep slope of the mountain to the west and views over the valley to the east as the trail climbs toward Horsetail Falls. The slope is rocky talus with large granite outcroppings and occasional shrubby vegetation, though there are few trees along the trail. The developed background of the valley limits visual awareness of facility infrastructure, though the tram tracks and Agnew 4-kV line are present at the viewpoint and all along the trail.

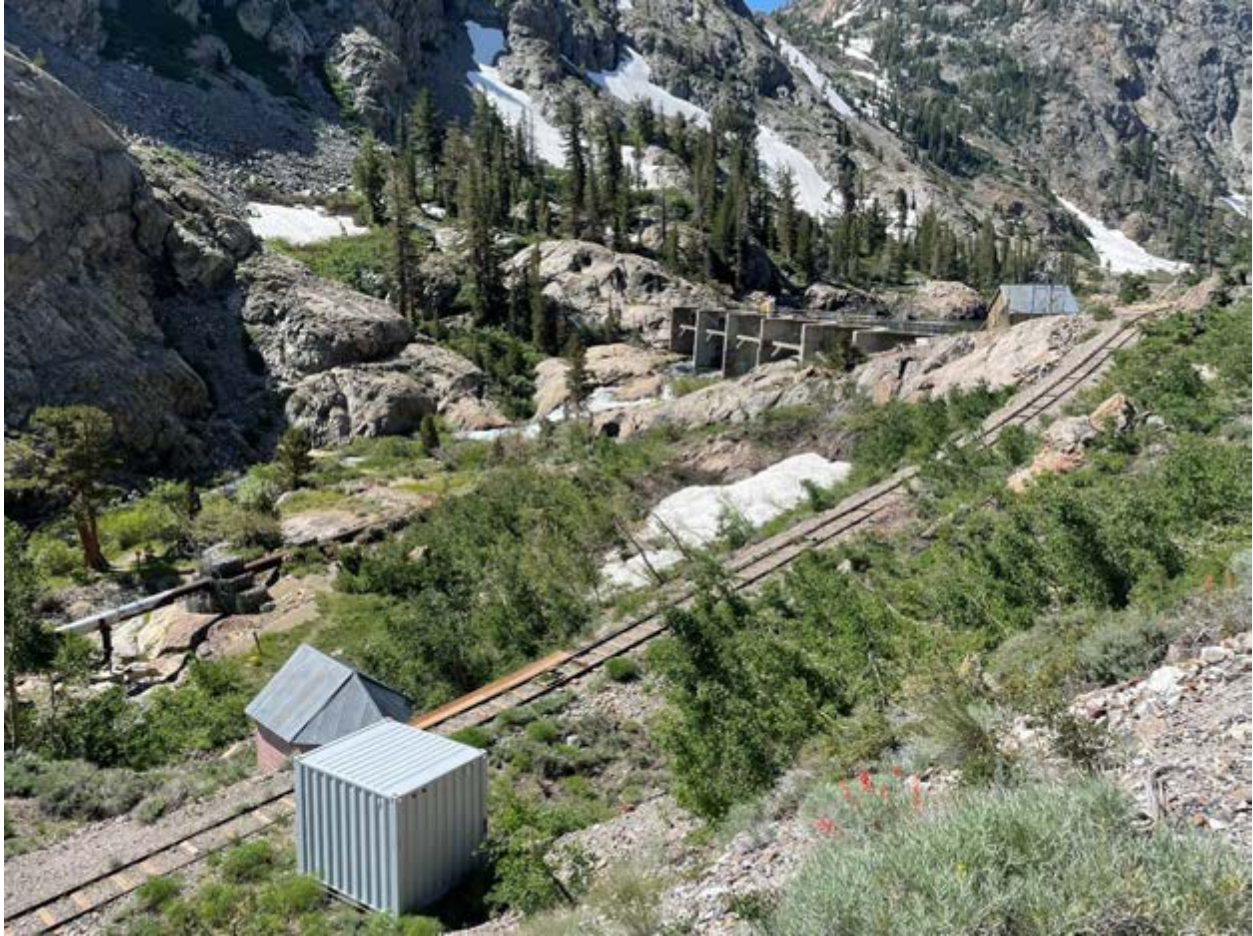
Photo 3. Key Observation Point 3, Agnew Dam and Ancillary Facilities—View from Downstream

Note: July 17, 2023. (37.7593, -119.132)

- GPS Coordinates: 37.7593, -119.132
- Location Description: Along the Rush Creek Trail above Rush Creek just east and above Agnew Junction.
- Viewshed Description: From this location perched along the trail above Rush Creek multiple Project facilities are visually prominent within the foreground and middleground, including the flowline, and tram tracks (below the trail), the downstream view of Agnew Dam, stand pipe, valve house, Agnew flume, and various other buildings and infrastructure. While contrasting in line, form and texture with the natural landscape, the weathered historical feel of buildings and of the tram tracks lessen their contrast with the natural setting – a backdrop of high Sierra rocks and mountains.

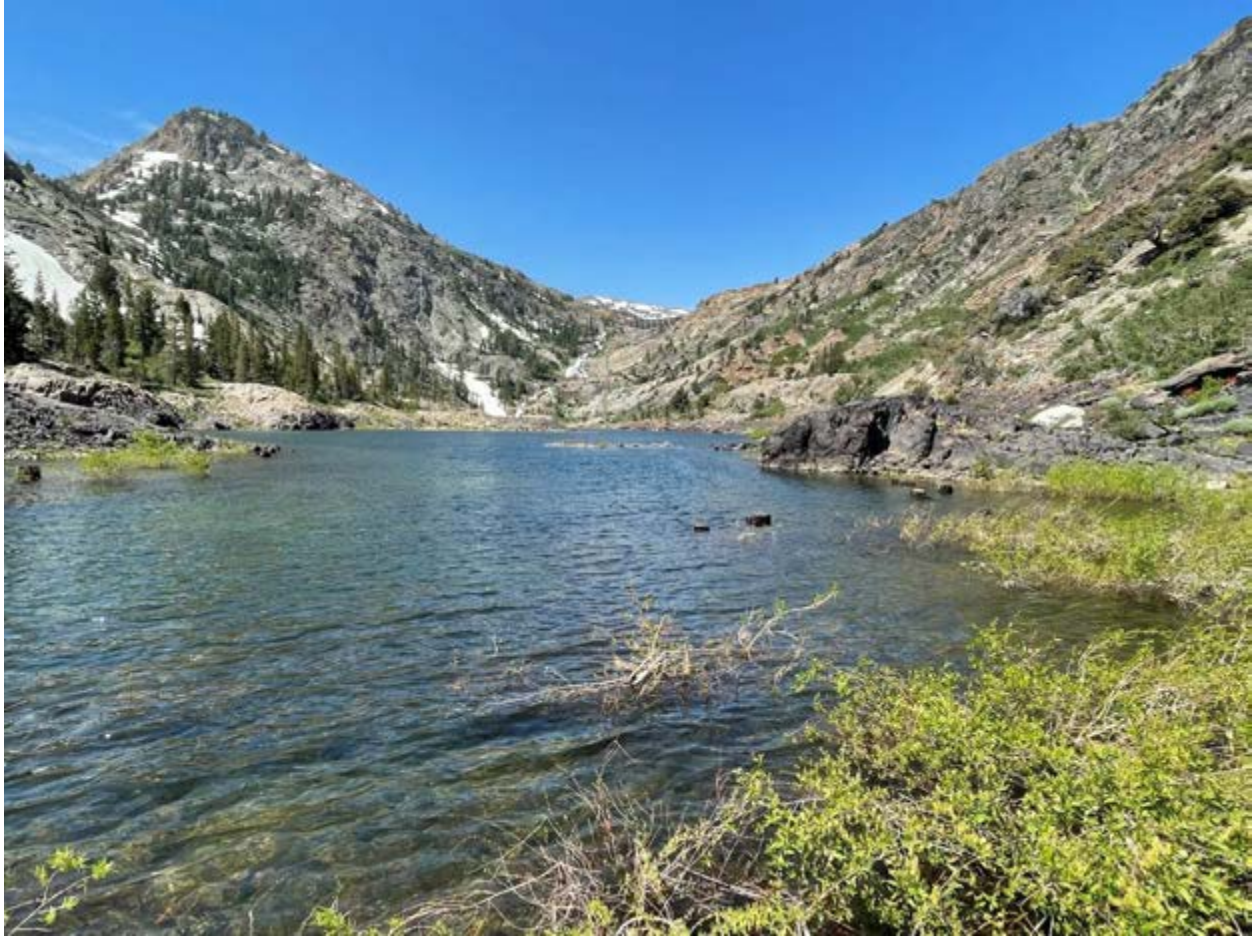
Photo 4. Key Observation Point 4, Agnew Lake and Dam at Shoreline—(looking upstream toward Gem Dam)

Note: July 17, 2023 (37.7579, -119.132)

- GPS Coordinates: 37.7579, -119.132
- Location Description: Directly adjacent to the upstream end of Agnew Dam along the shoreline of the lake.
- Viewshed Description: Views upstream (southwest) are across Agnew Lake toward Gem Dam which is just visible at the top of the drainage (a uniform gray against the red/tan rock and green vegetation). Downstream views are dominated by the foreground of the Agnew Dam, while the boathouse and other ancillary facilities take up most of the visual foreground space when looking toward the Rush Creek Trail. The Agnew Lake motor barge is a prominent visual element when standing at the shoreline looking out across the lake and contrasts sharply in form, line, shape, and color (the barge is red) with the surrounding lake and granite rock. Surrounding mountains rise steeply several thousand feet above the facilities. Shoreline vegetation includes minimal grasses and some shrubs.

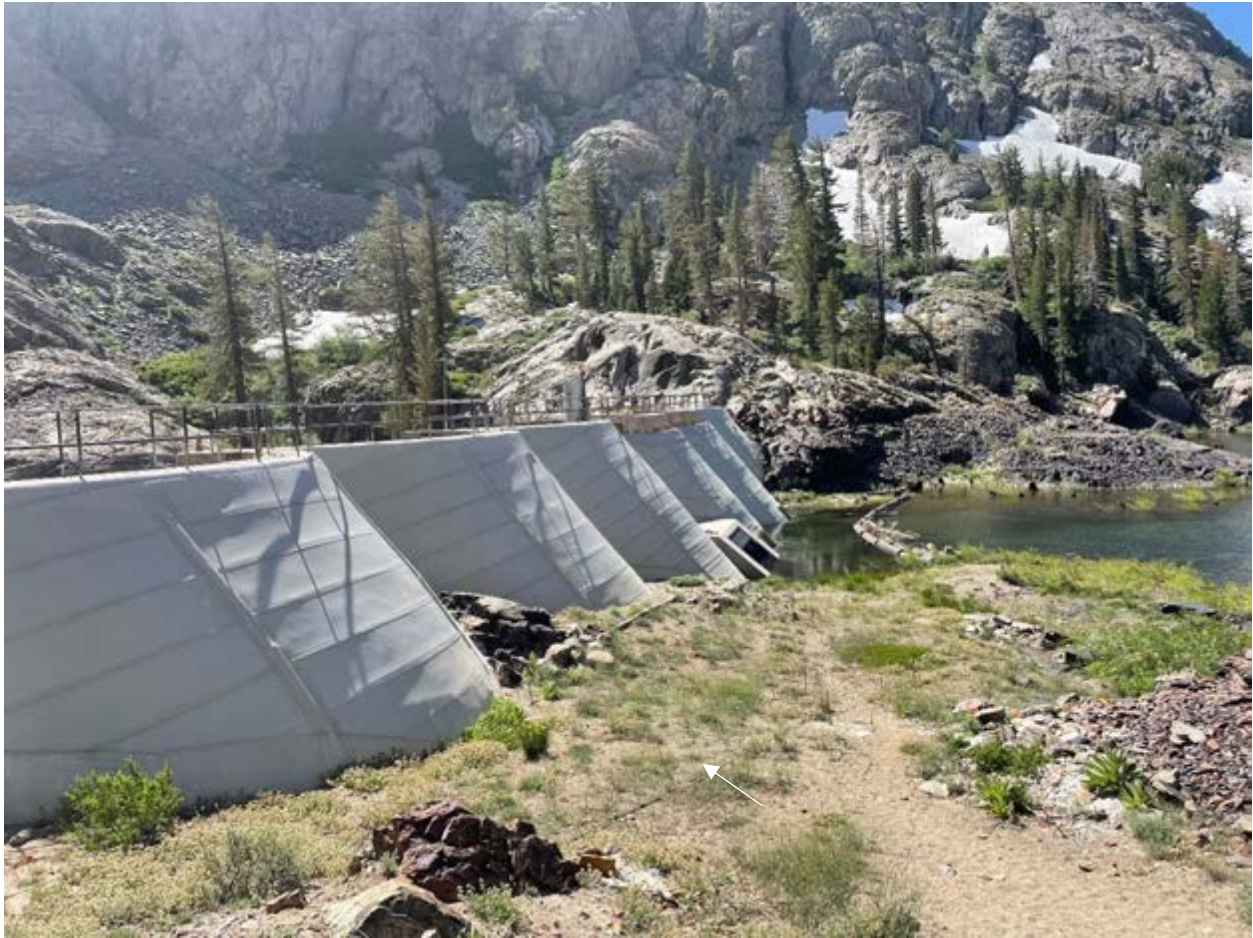
Photo 5. Key Observation Point 4, Agnew Dam at Shoreline

Note: July 17, 2023 (37.7579, -119.132)

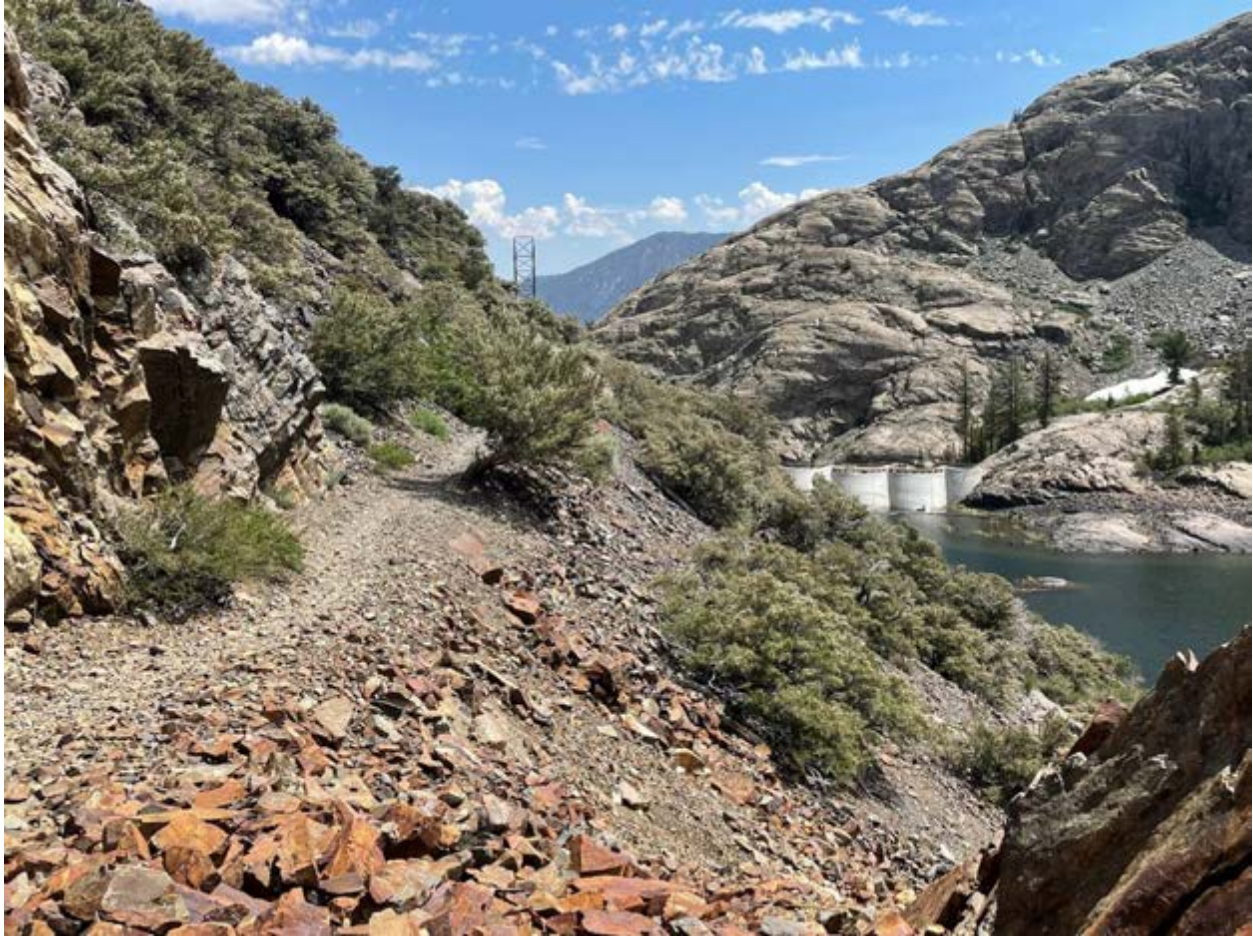
Photo 6. Key Observation Point 5, Agnew Lake—View from Upstream

Note: July 17, 2023 (37.7574, -119.135)

- GPS Coordinates: 37.7574, -119.135
- Location Description: Along the Rush Creek Trail above Agnew Lake looking towards the upstream face of Agnew Dam.
- Viewshed Description: The Rush Creek Trail runs mid-slope along the rocky talus of the mountain that climbs above Agnew Lake on its northeast shoreline. Vegetation is sparse. The white geomembrane of Agnew Dam contrasts sharply against the grey and tan of the surrounding rocky environment. A powerline tower is visible in the skyline to the north of the dam.

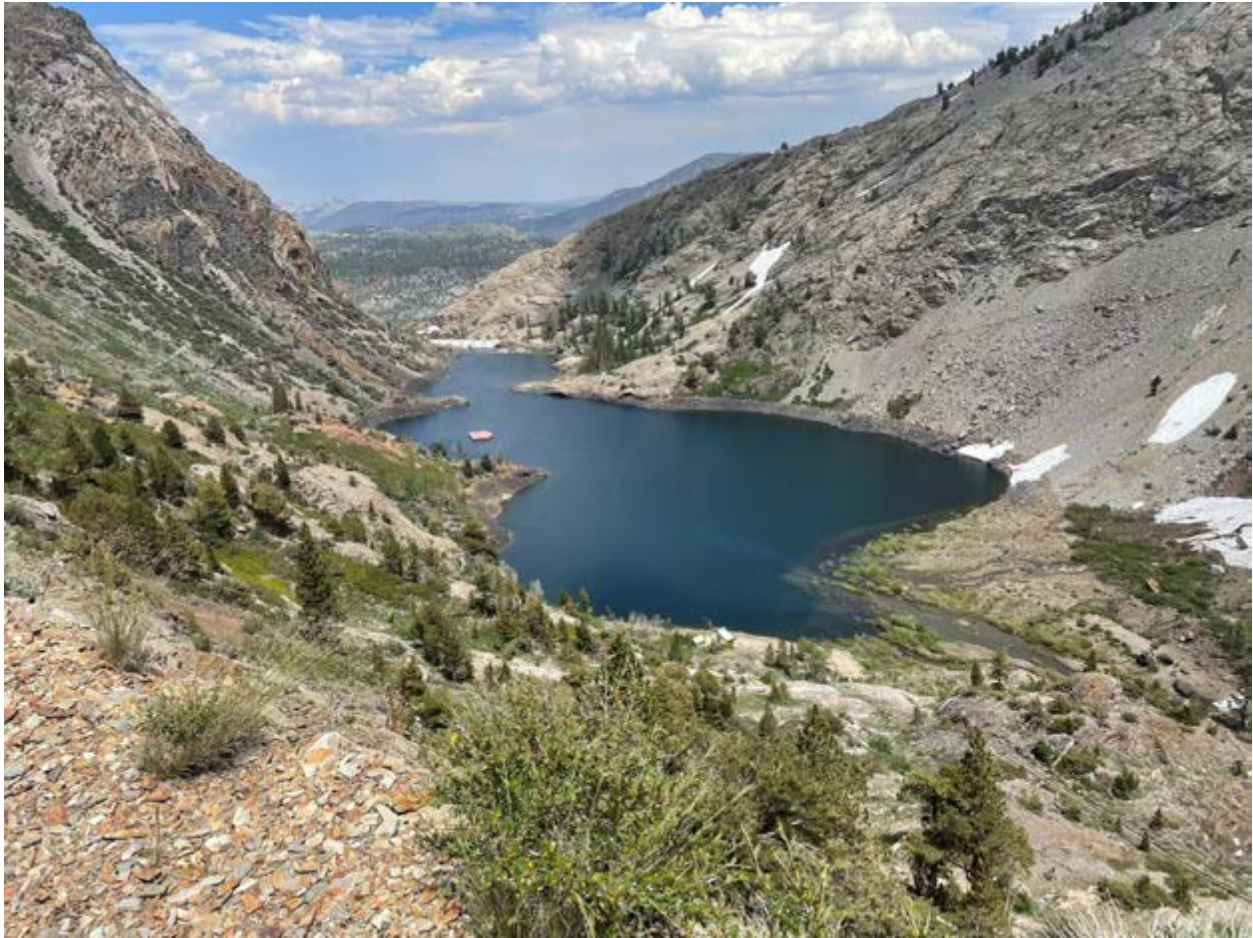
Photo 7. Key Observation Point 6, Agnew Lake and Dam—View from Above

Note: July 17, 2023 (37.7528, -119.141)

- GPS Coordinates: 37.7528, -119.141
- Location Description: Rush Creek Trail at the top of the drainage immediately north of Gem Dam (Gem Dam not visible).
- Viewshed description: Exposed ridgetop with expansive view encompassing all of Agnew Lake to the east. Agnew Dam's white geomembrane is visible at the eastern end of the lake and the red motor barge is a prominent visual element in the lake itself. Swimmers are visible below along the western shoreline of Agnew Lake. Rush Creek Trail and Spooky Meadows Trail are linear features that rise away from the lake to the west along the talus slopes that create the lake basin. Topography and vegetation obstruct any views of Gem Dam to the west.

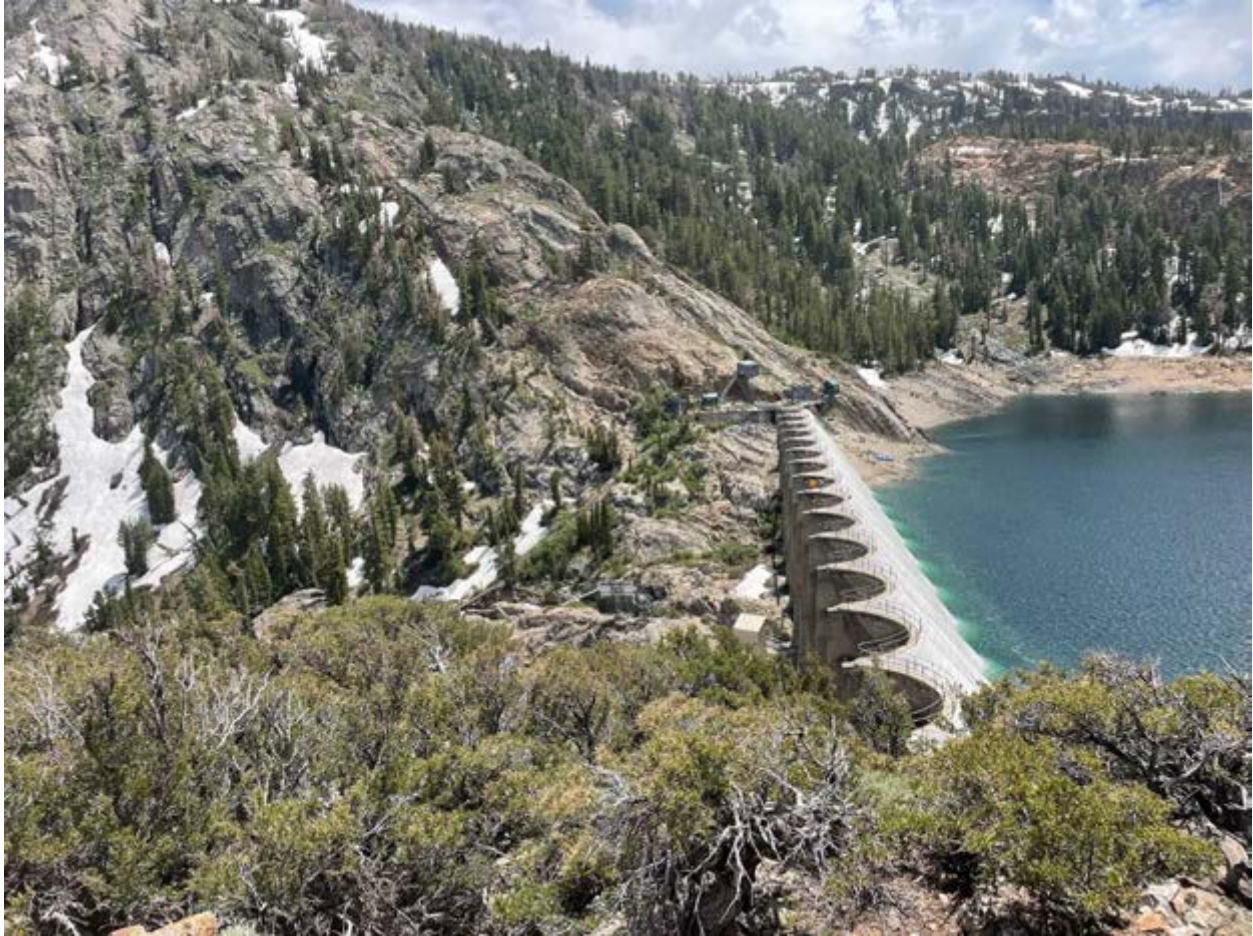
Photo 8. Key Observation Point 7, Gem Dam

Note: July 17, 2023 (37.7525, -119.141)

- GPS Coordinates: 37.7525, -119.141
- Location Description: Top of the ridge between Gem Lake and Agnew Lake south of Rush Creek Trail.
- Viewshed Description: View from a rocky exposed ridge above Gem Dam approximately one hundred yards south and above the Rush Creek Trail. The entirety of Gem's Dam crest is visible from the ridge as is Rush Creek and many of the ancillary facilities on the downstream side of the dam. The generation facilities are weathered, like the landscape, though the angular forms of the buildings and some of the equipment, especially at the landing area across the other side of the dam, create an industrial sense of place. Dominant landscape elements in the foreground include red and tan rocks, and shrubby vegetation, while the backdrop includes towering mountains to the west. Gem Lake appears as an obvious reservoir with a clear gap of several feet in elevation between the edge of the water and the line of vegetation around its shore.

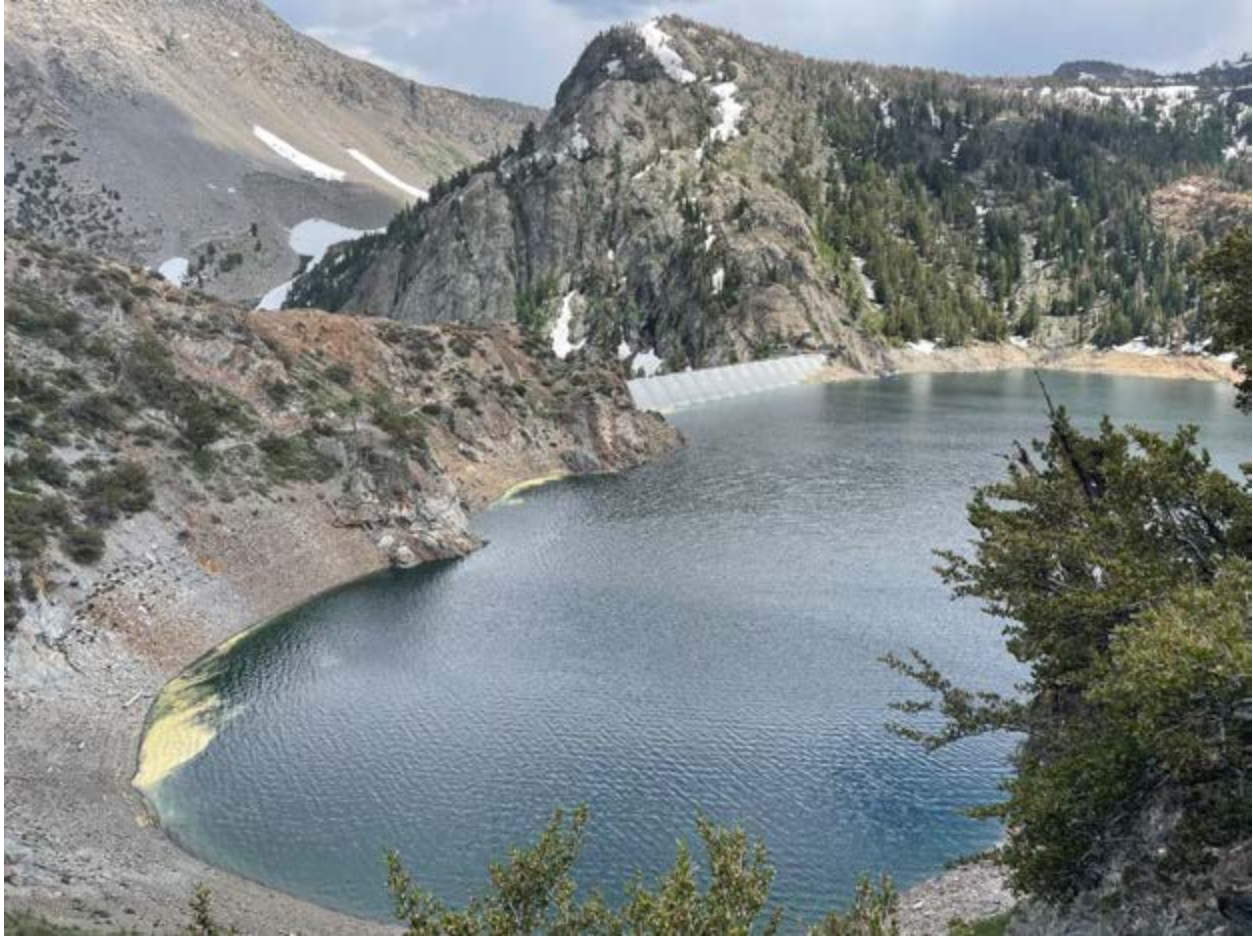
Photo 9. Key Observation Point 8, Gem Dam—View from Upstream (looking east)

Note: July 19, 2023 (37.7546, -119.144)

- GPS Coordinates: 37.7546, -119.144
- Location Description: Rush Creek Trail along the north side of Gem Dam just west of the dam itself.
- Viewshed Description: Facing west along the trail Gem Dam's white geomembrane is a dominant element of the foreground and middleground spanning the narrow mouth of the lake basin. Gem Lake is an obvious reservoir with a defined "bathtub ring" even with the water at high elevation. There is no access to the lake itself as steep rocky slopes and cliffs scarce of vegetation separate the trail from the shoreline.

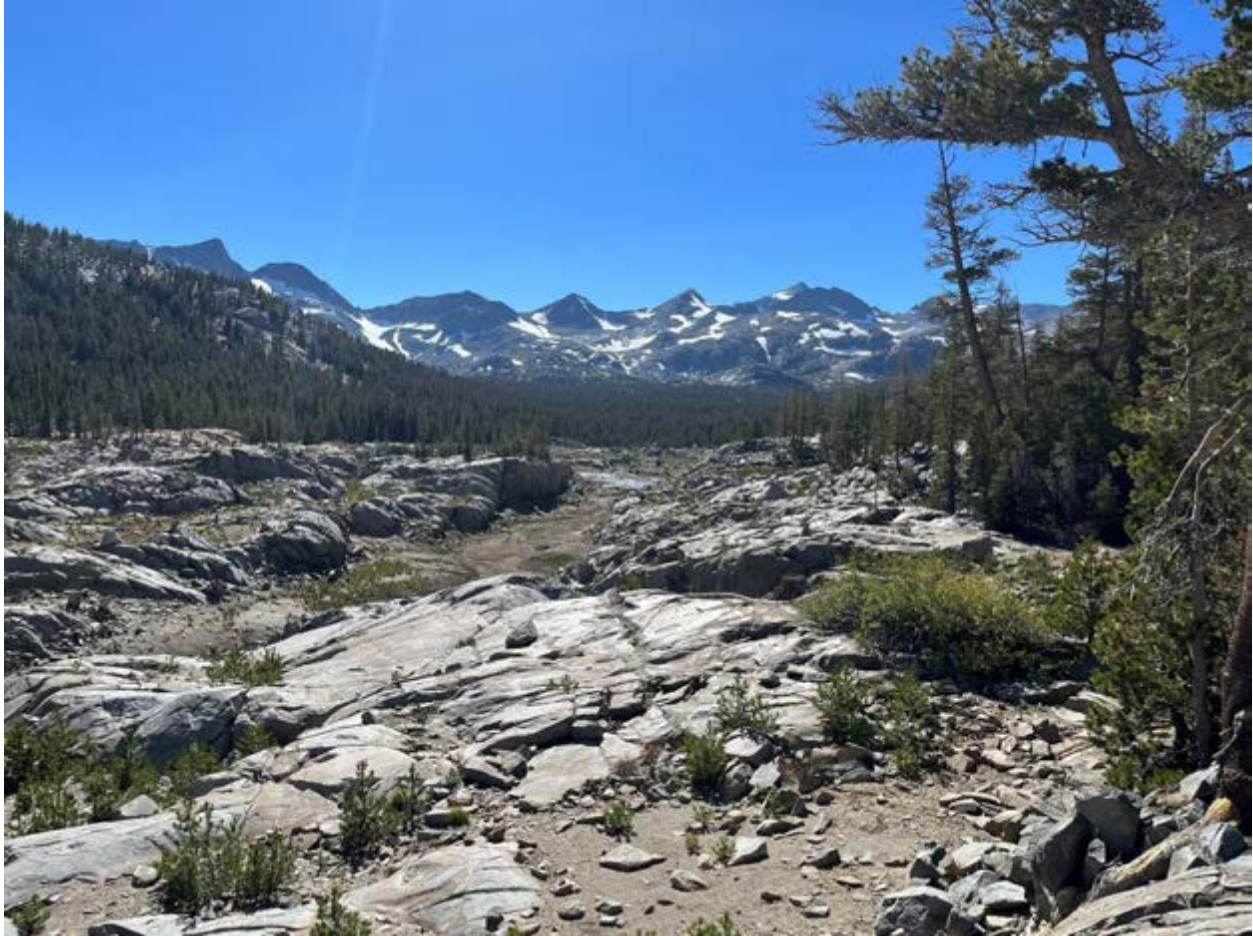
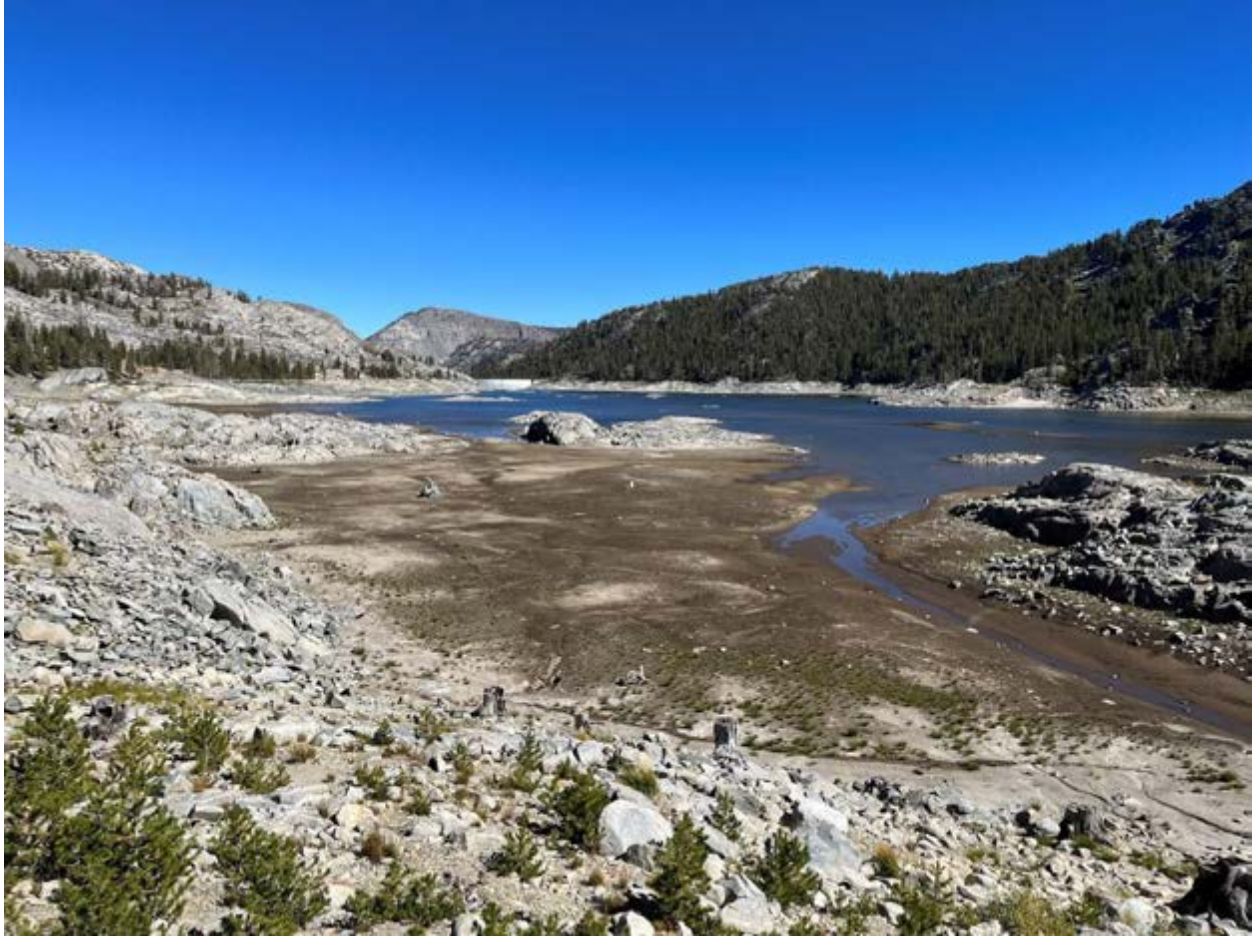
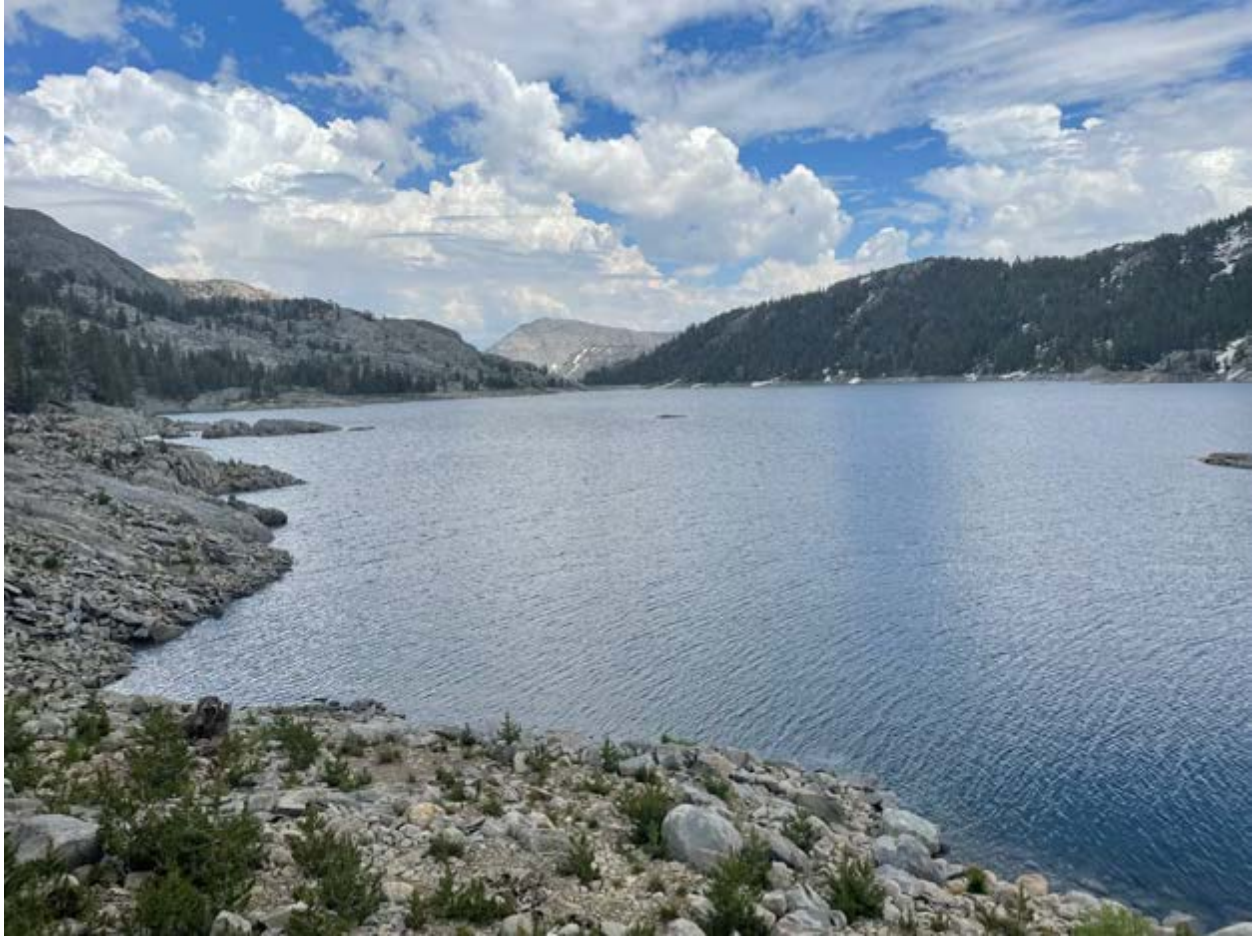
Photo 16. Key Observation Point 15, Waugh Lake—Northern Shoreline (looking upstream)

Photo 17. Key Observation Point 15, Waugh Lake—Northern Shoreline (looking downstream)

Photo 18. Key Observation Point 15, Waugh Lake—Northern Shoreline (looking downstream)

- Viewshed Description: Looking upstream, the silty lakebed of Waugh Lake is replaced by granite slabs of rock and a defined creek channel (mostly dry in September 2023). The high peaks of the Sierra crest dominate the upstream backdrop. Vegetation at the shoreline consists of scattered conifers (mostly lodgepole pine). Downstream the view during early summer (peak runoff) varies dramatically compared to later in the season after most of the snow has melted. During the early season, the lake appears nearly full with no lakebed visible and the crest of the dam just visible as a linear flat feature, distinctive compared to the rounded mountainous terrain on either side of the drainage. Later in the season the brown silt of the lakebed dominates the foreground and the whole of Rush Meadows Dam is visible at the eastern end, its white geomembrane contrasting starkly with the blue and brown of the lakebed and the rocky gray mountains beyond.
