Rush Creek Project, FERC Project No. 1389

LAND 1 – Aesthetics
Draft Technical Study Report

August 2024

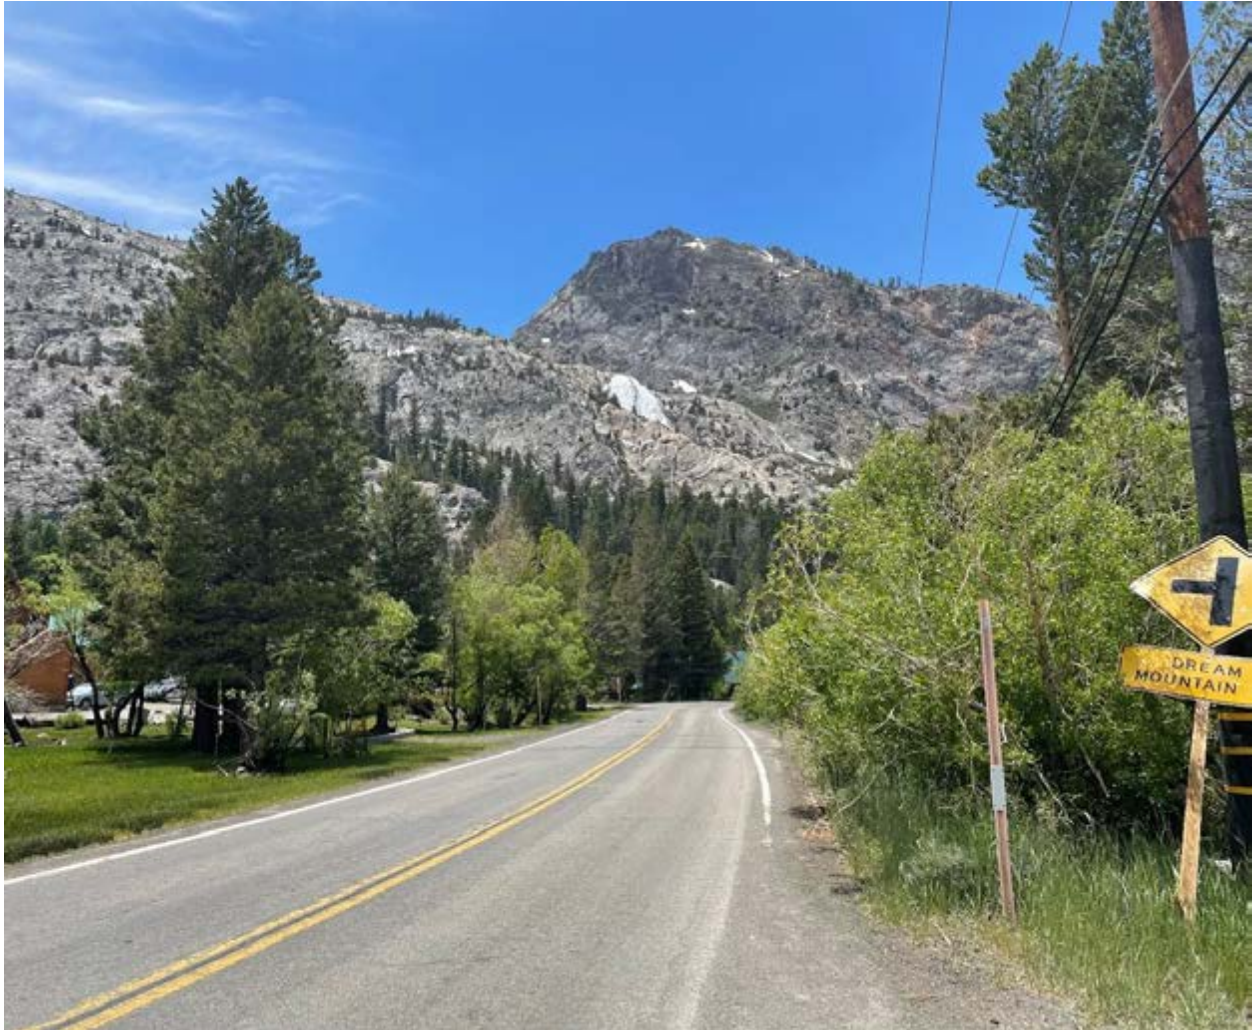
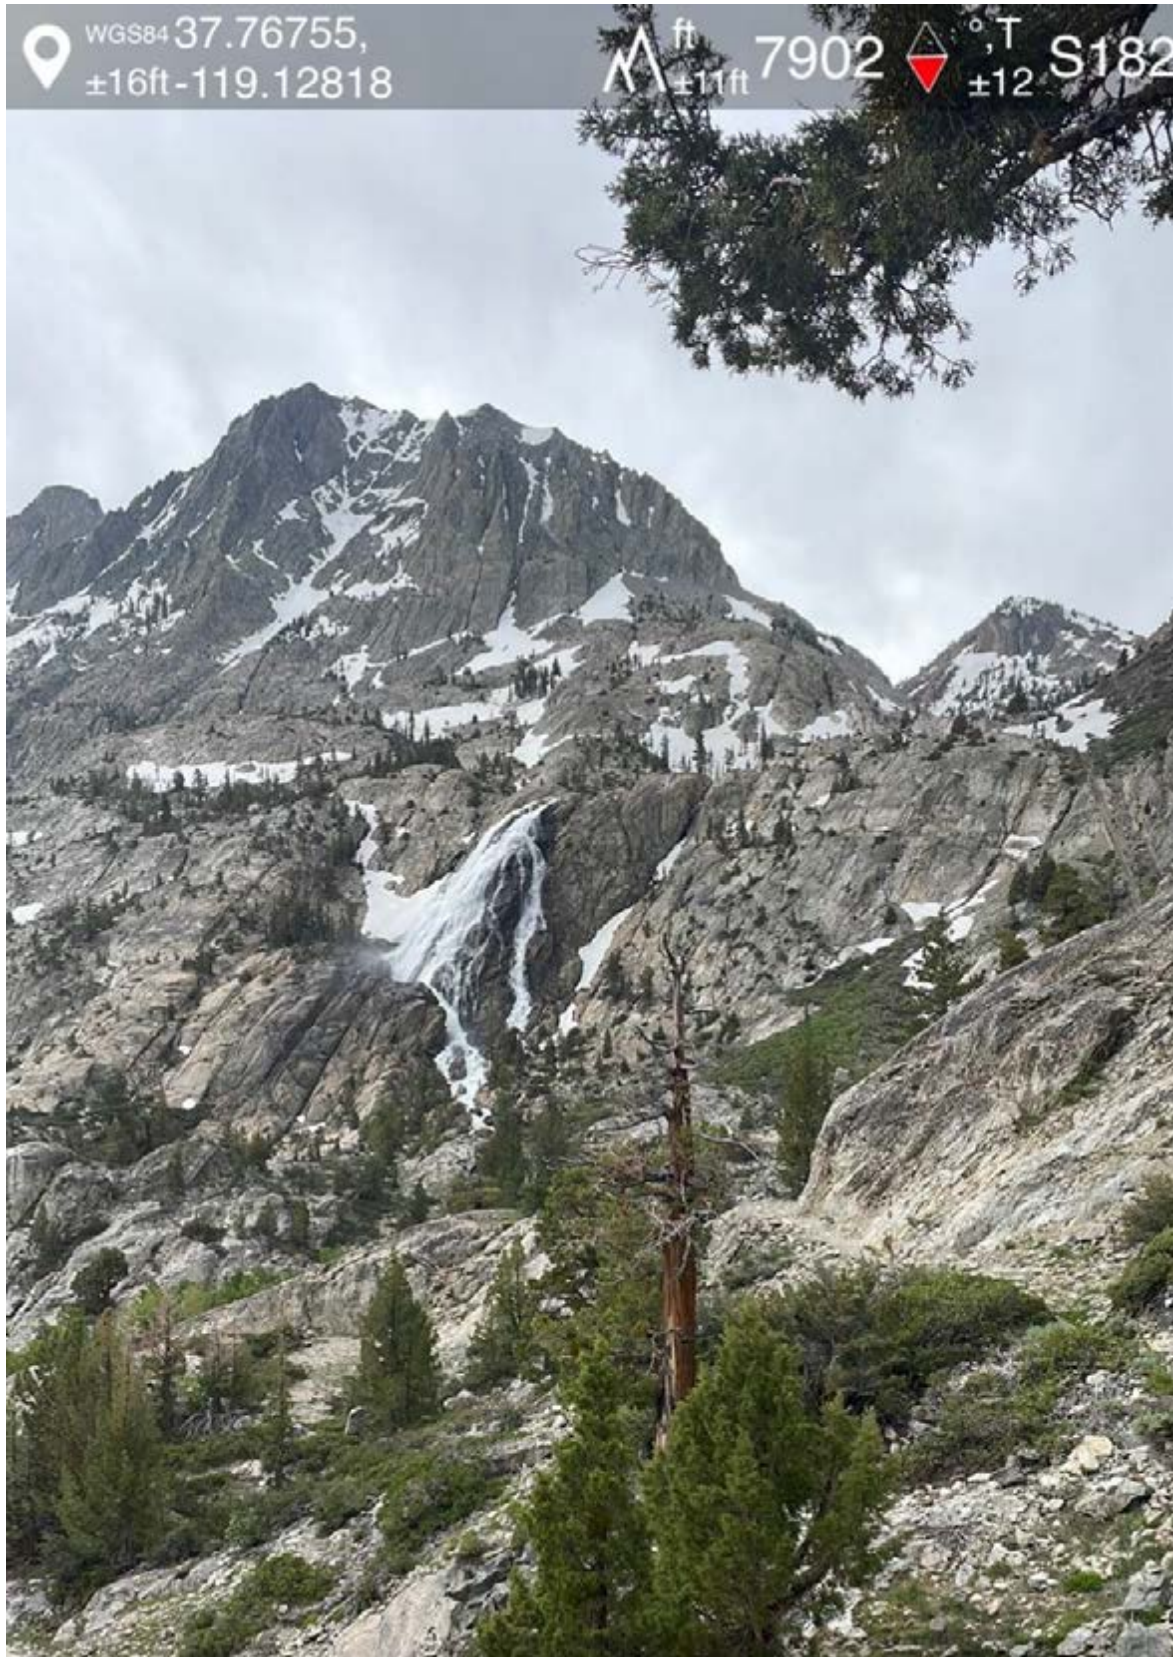
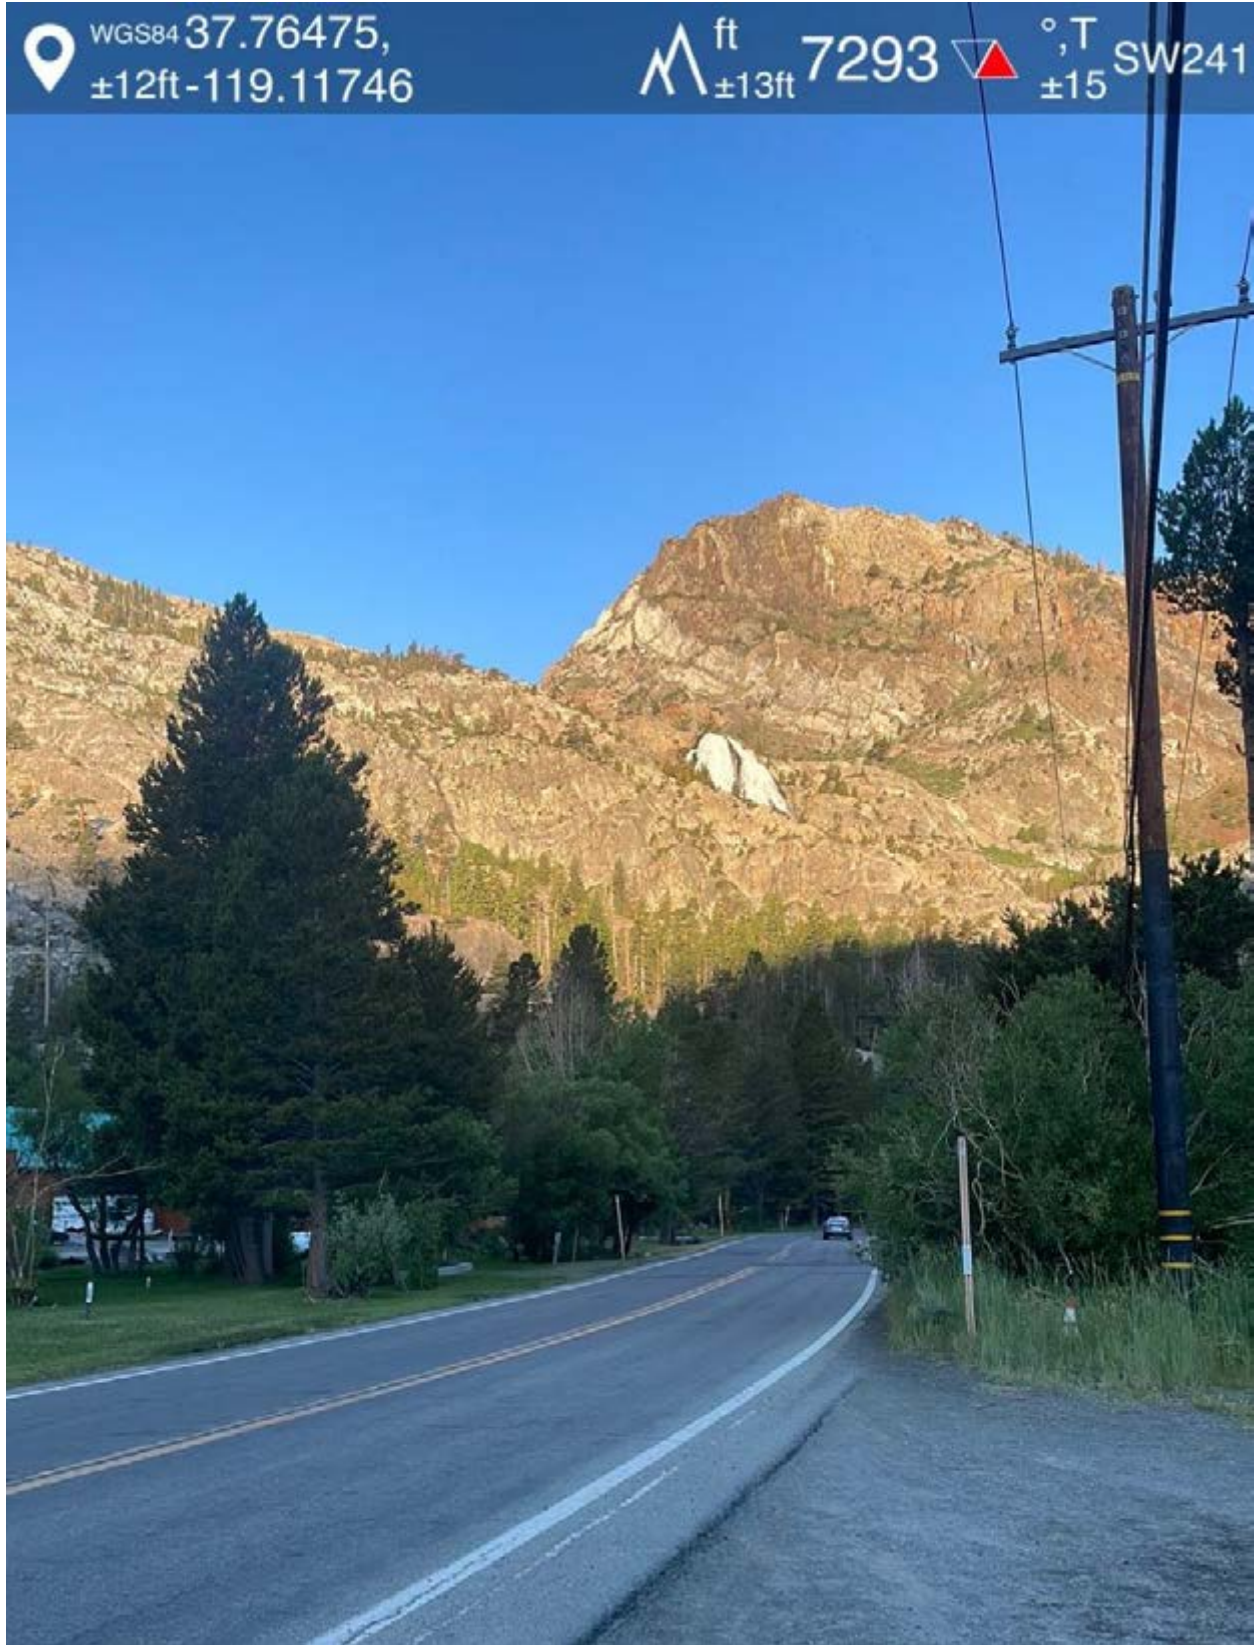
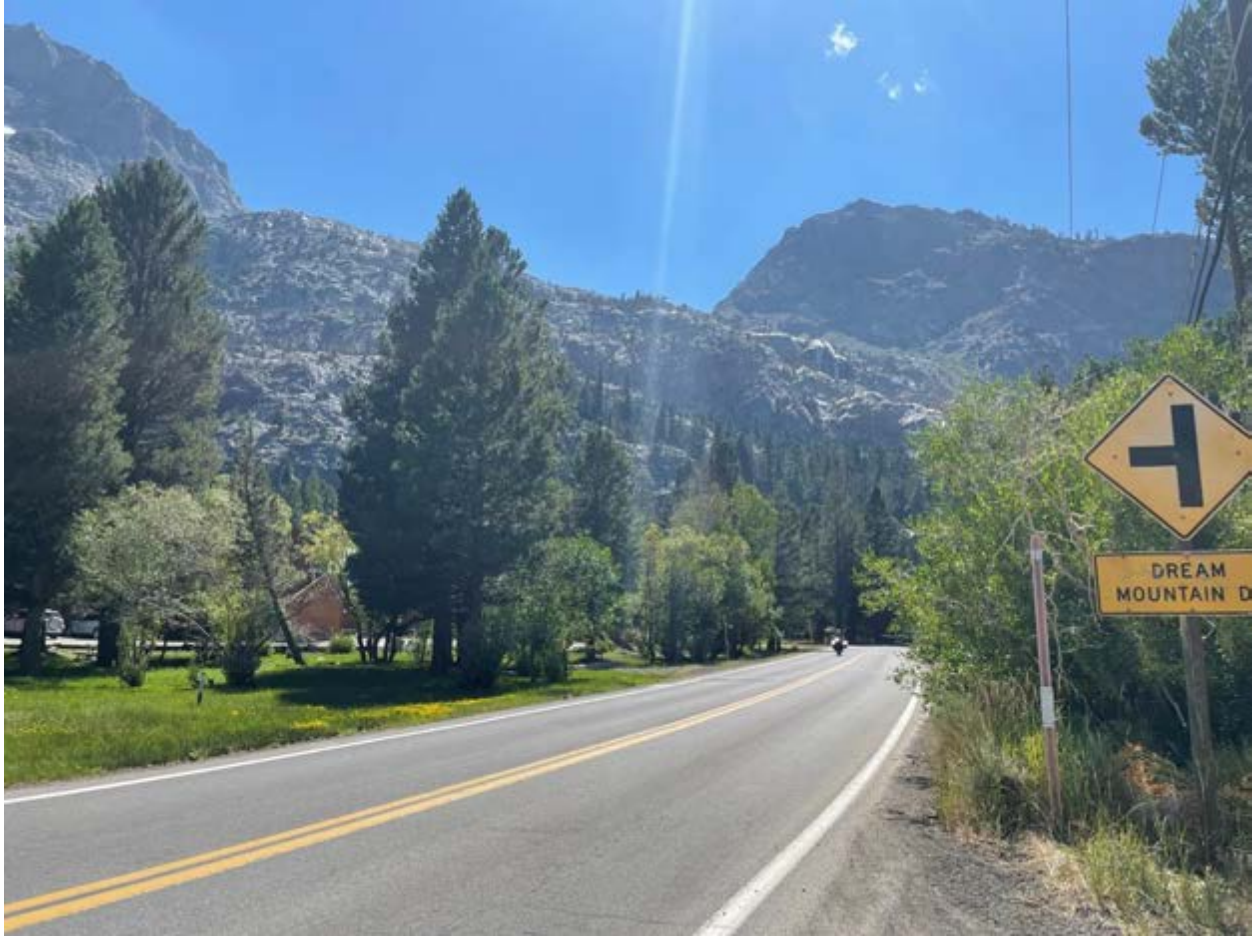
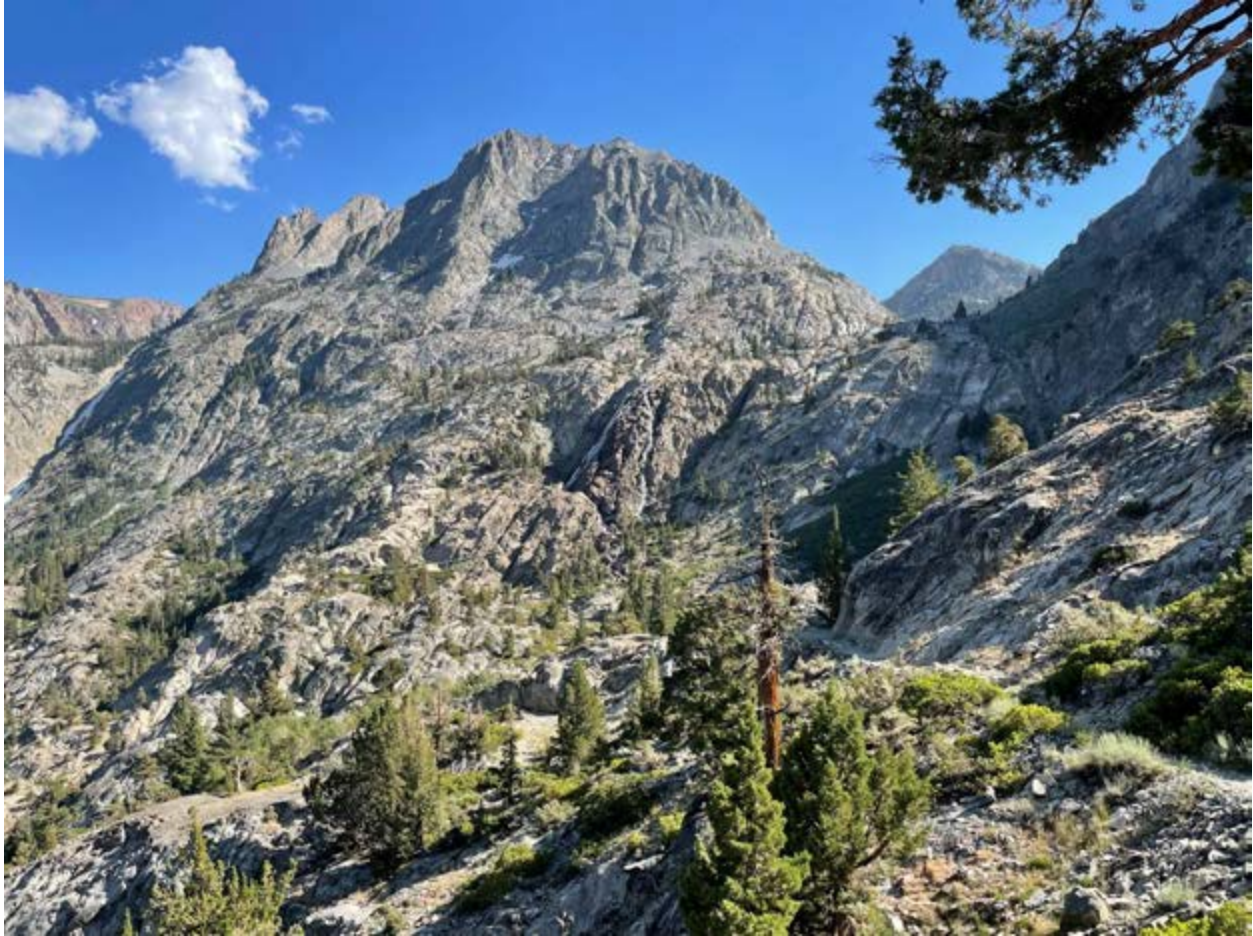
Photo 1. Key Observation Point 1. Date: June 24, 2023. cfs: 327

Photo 2. Key Observation Point 2. Date: June 24, 2023. cfs: 327

Photo 3. Key Observation Point 1. Date: July 17, 2023. cfs: 284

Photo 4. Key Observation Point 2. Date: July 17, 2023. cfs: 284

Photo 5. Key Observation Point 1. Date: August 6, 2023. cfs: 9.10

Photo 6. Key Observation Point 2. Date: August 6, 2023. cfs: 9.10

Horsetail Falls is a water feature along Rush Creek downstream of Agnew Dam where the creek falls and cascades approximately 500 vertical feet. Horsetail Falls is a dramatic and eye-catching component of the middleground view from SR 158 at high flows and an eye-catching, though less dramatic, visual phenomena at lower flows. At lower flows, time-of-day, and weather conditions (e.g., overcast or clear) may reduce or enhance the view of the falls from the highway. As an example, the falls at around 9 cfs while visible in the photo taken on August 6, 2023, are not as visually prominent against the landscape backdrop as they are from the same location in mid-October when flow conditions were also approximately 9 cfs but when the sun was lower in the sky. From the Rush Creek Trail, the falls constitute a more significant component of the overall viewshed. While spectacular at high flows, they are an outstanding feature of the landscape from the trail even at 2 cfs.

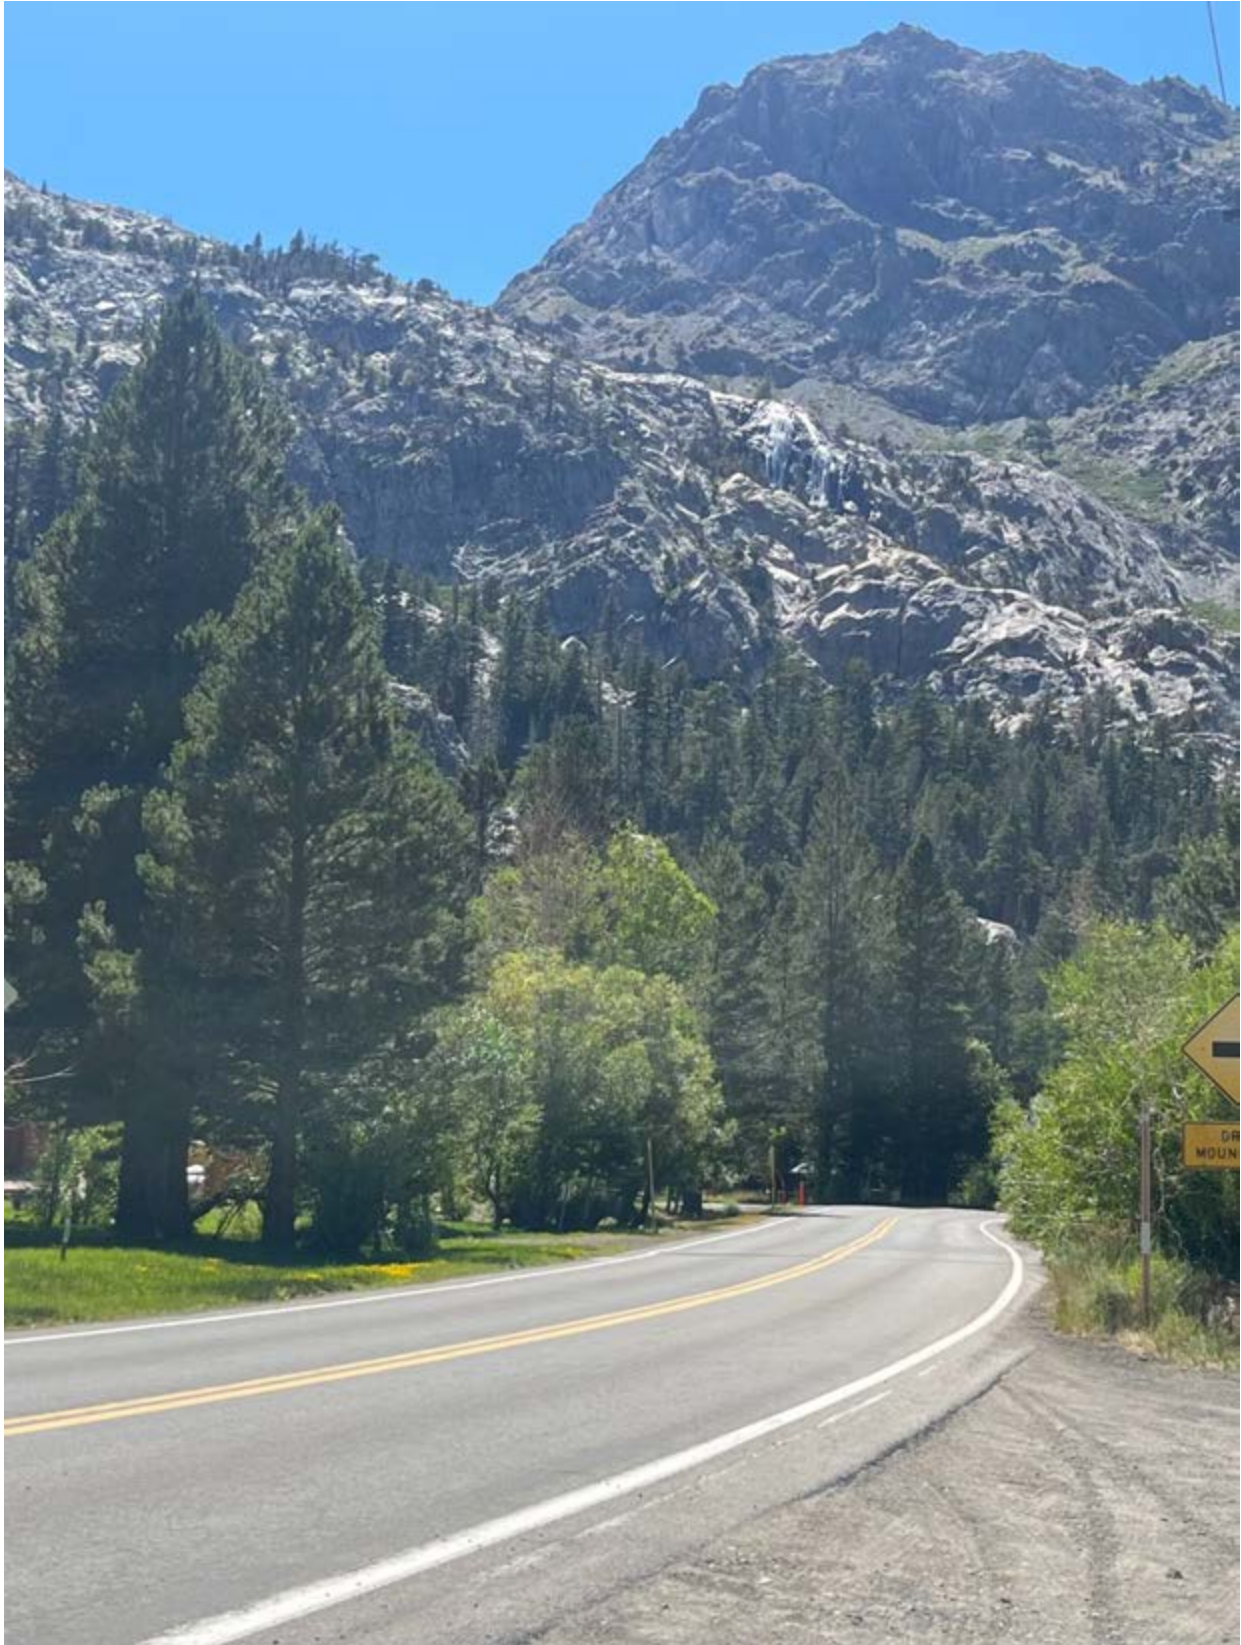
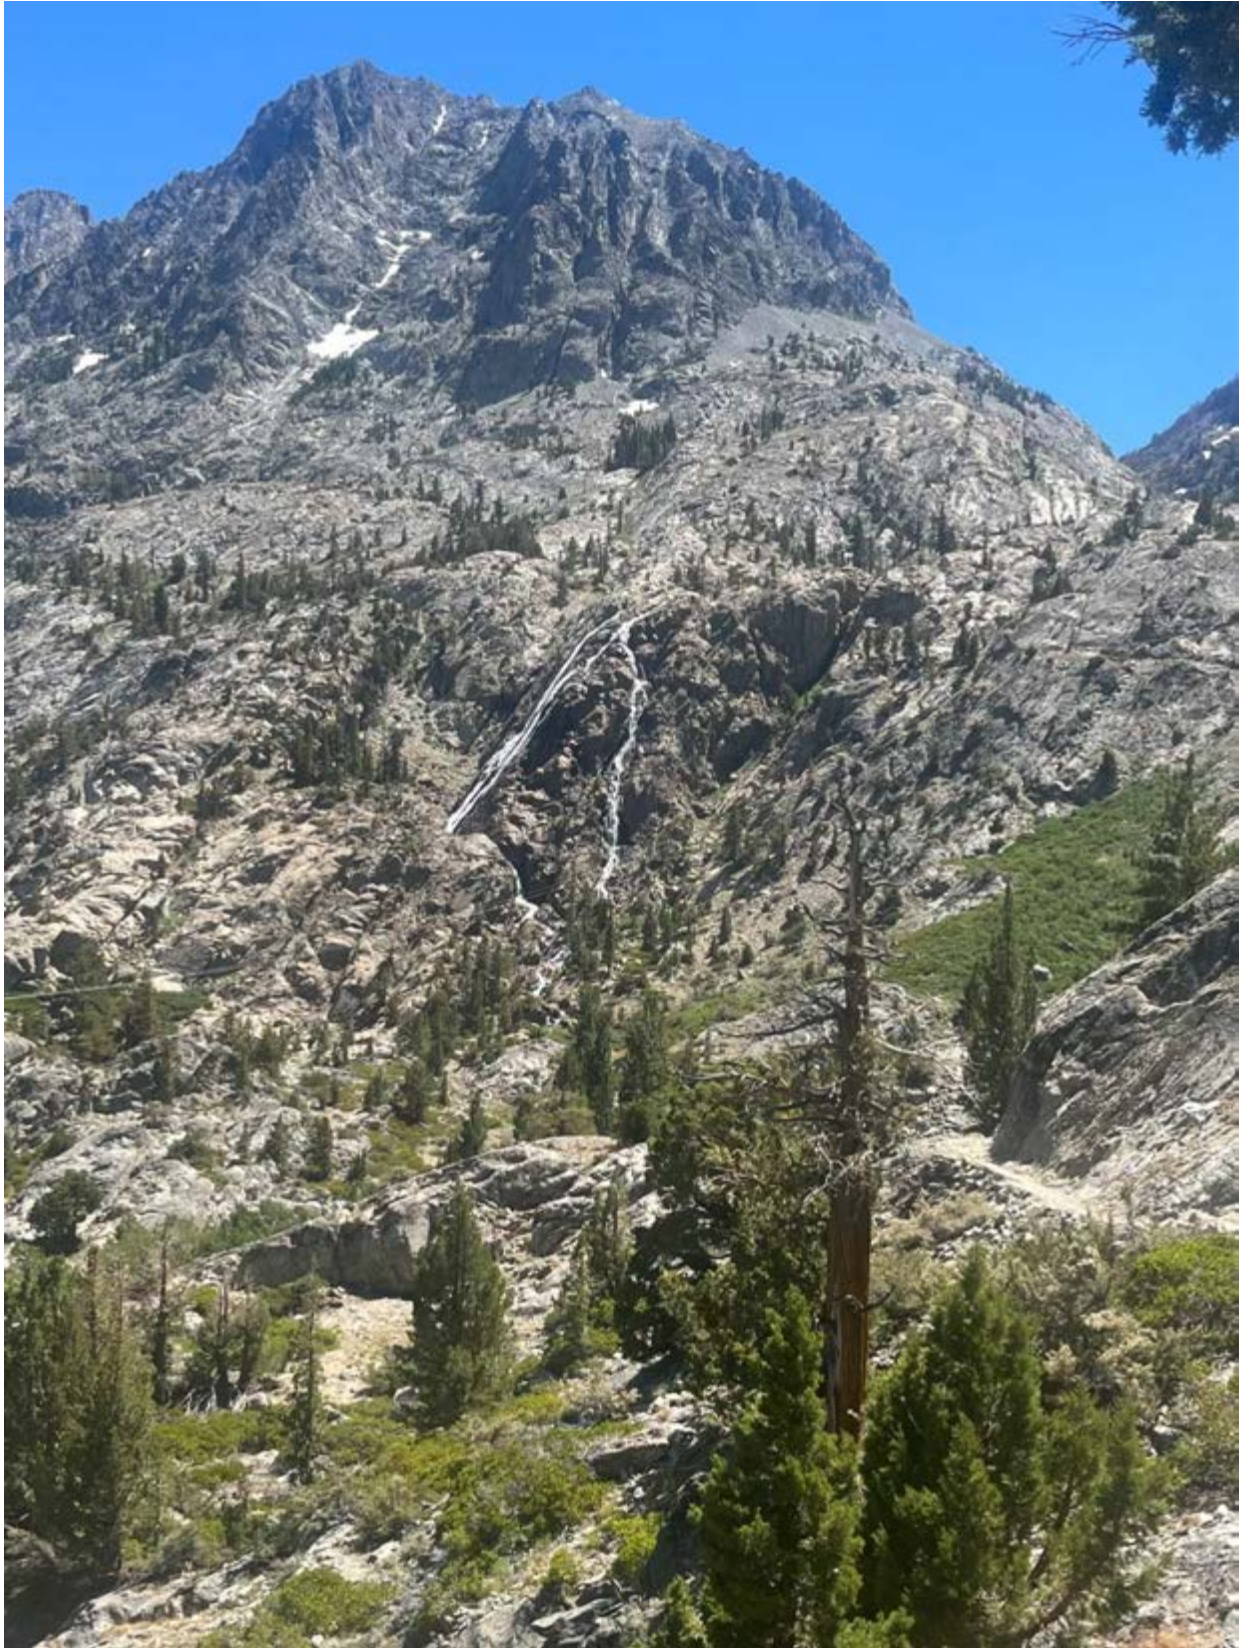
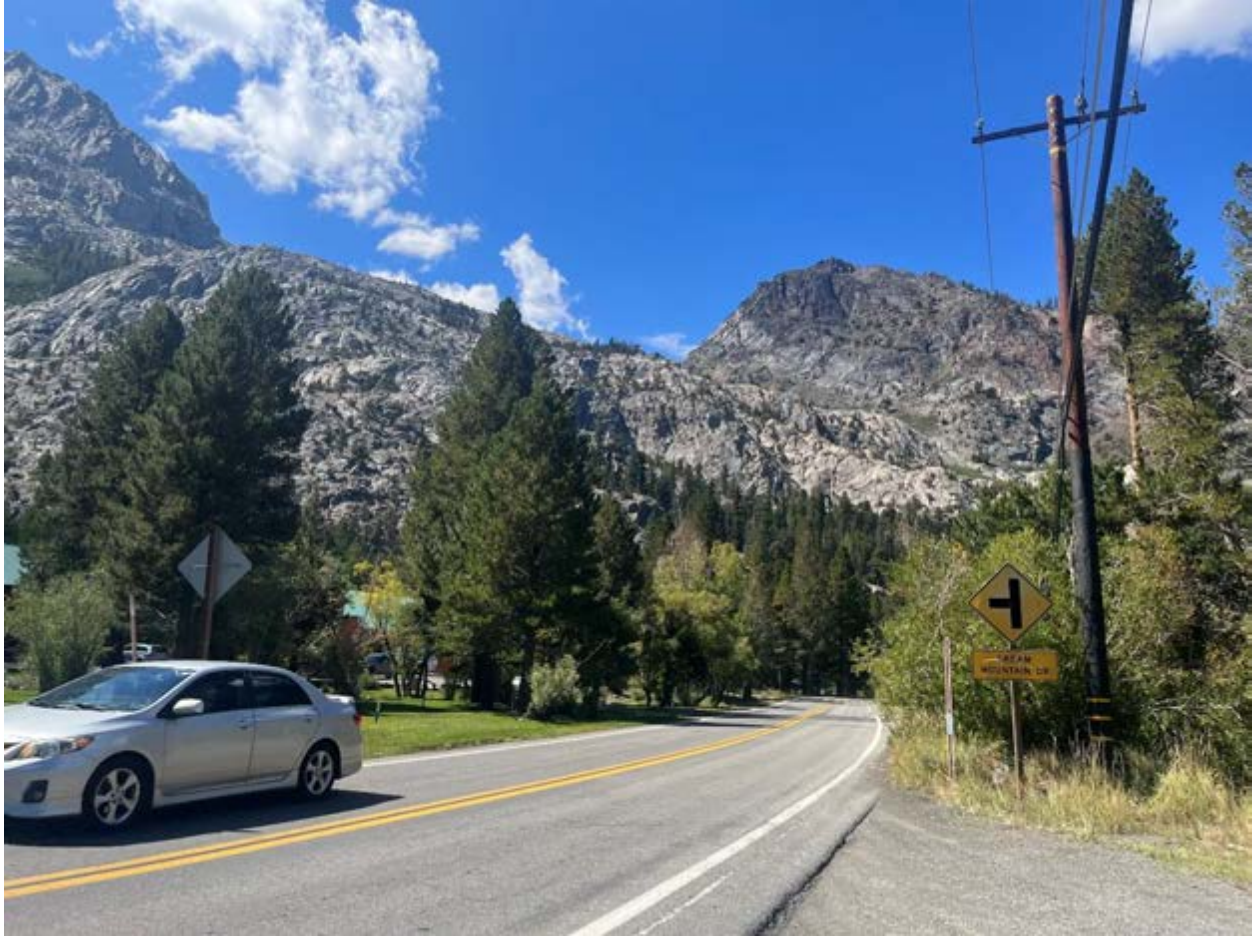
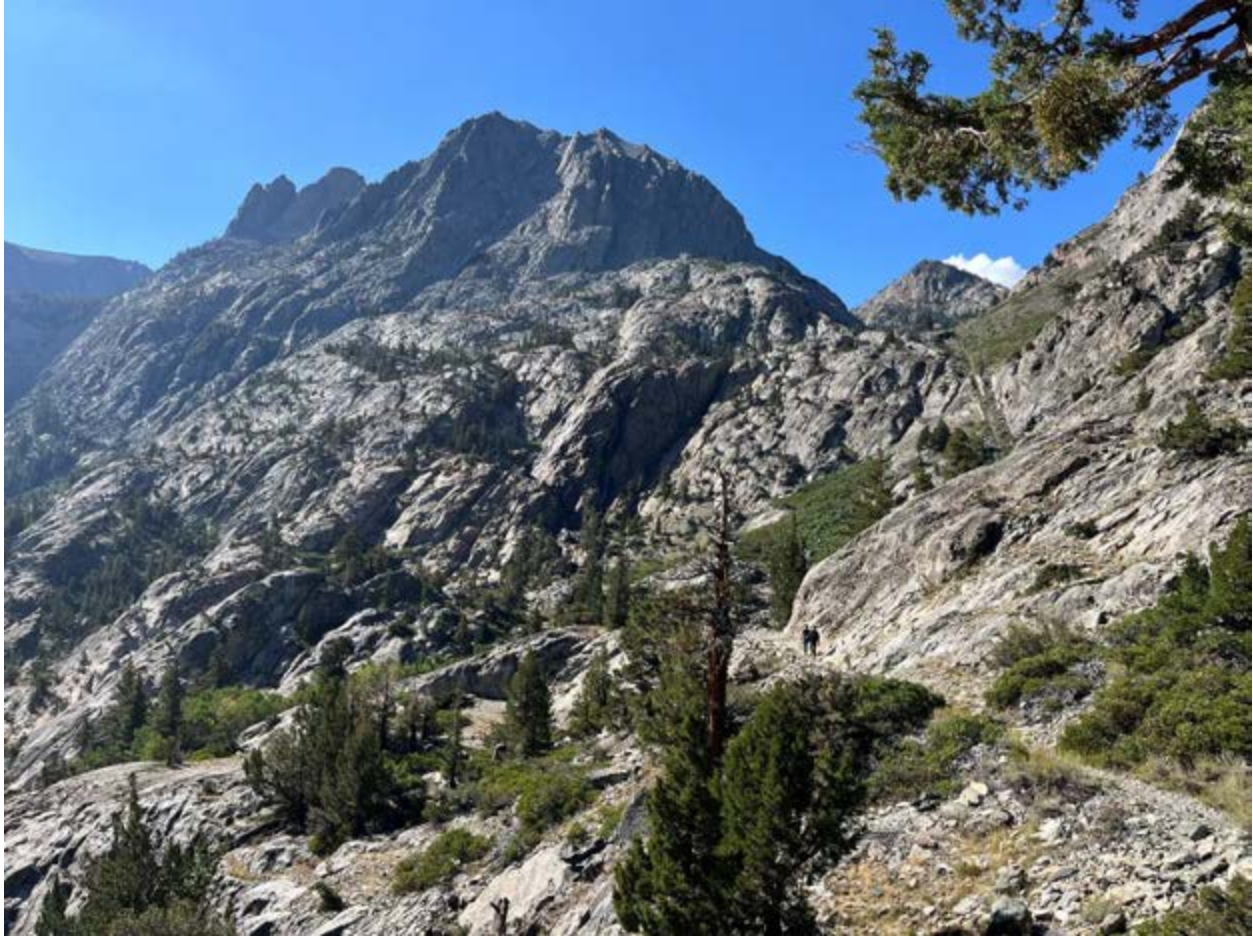
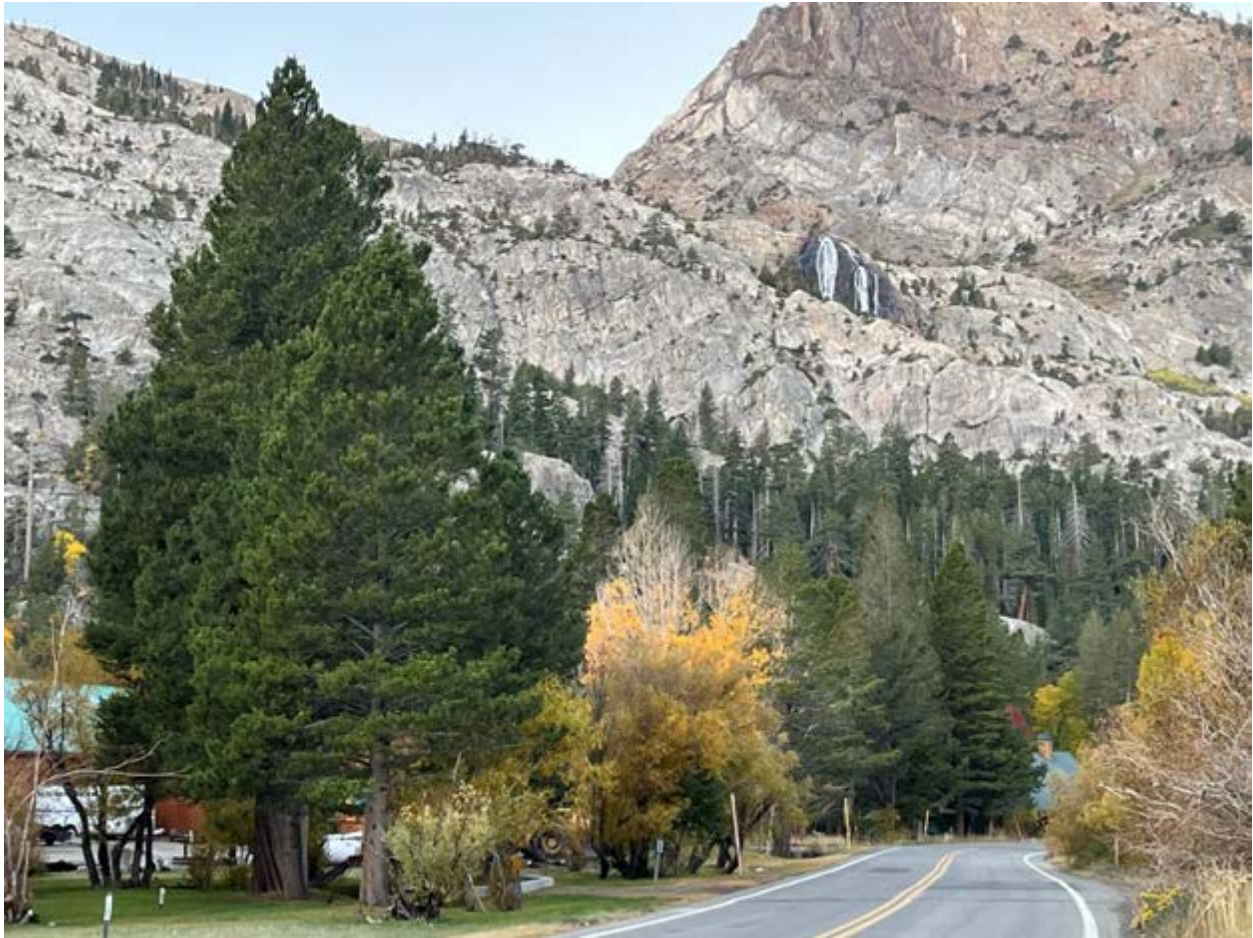
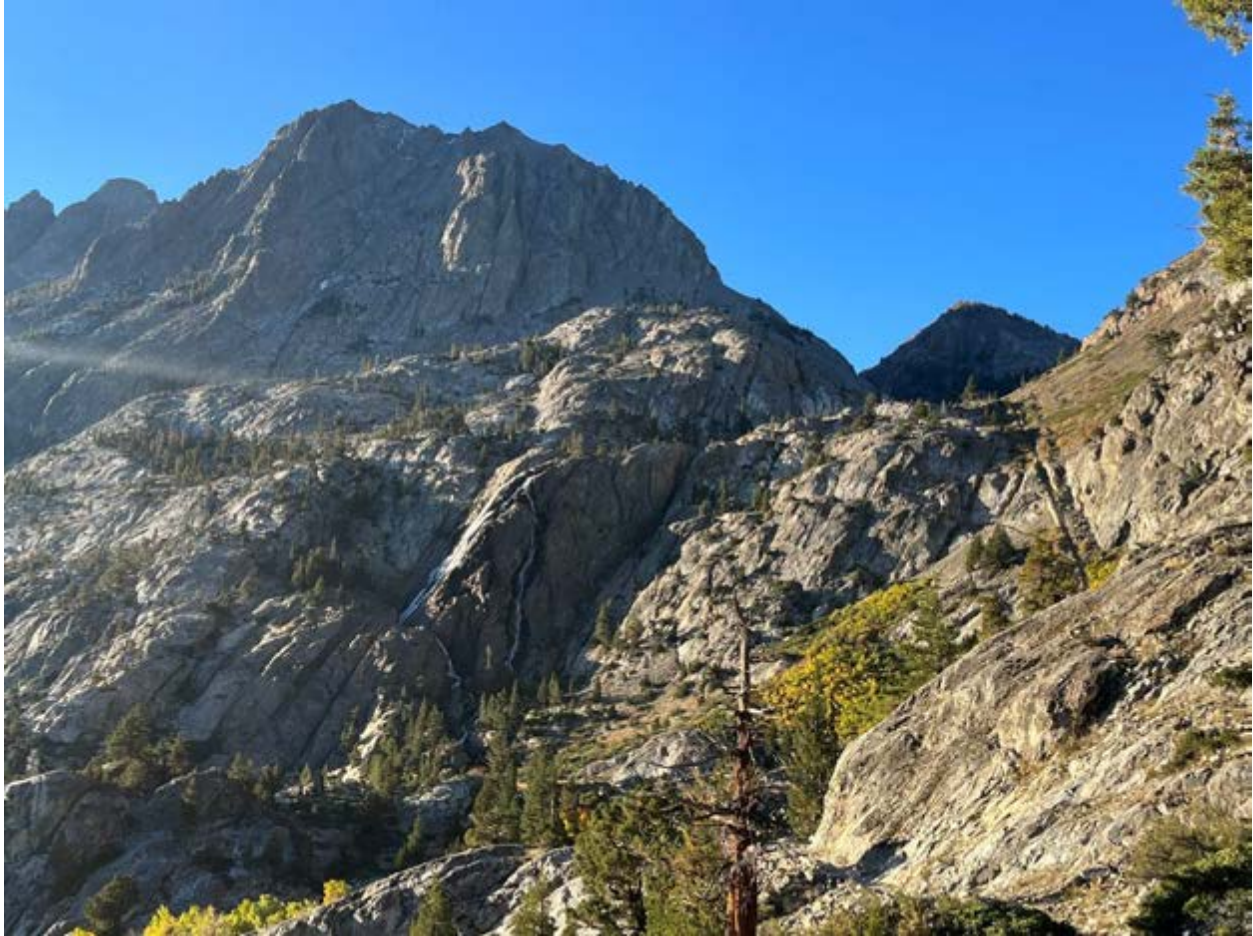
Photo 7. Key Observation Point 1. Date: August 4, 2023. cfs 9.6

Photo 8. Key Observation Point 2. Date: August 4, 2023. cfs 9.6

Photo 9. Key Observation Point 1. Date: September 16, 2023. cfs: 2.10

Photo 10. Key Observation Point 2. Date: September 16, 2023. cfs: 2.10

Photo 11. Key Observation Point 1. Date: October 18, 2023. cfs: 10.8

Photo 12. Key Observation Point 2. Date: October 18, 2023. cfs: 10.8

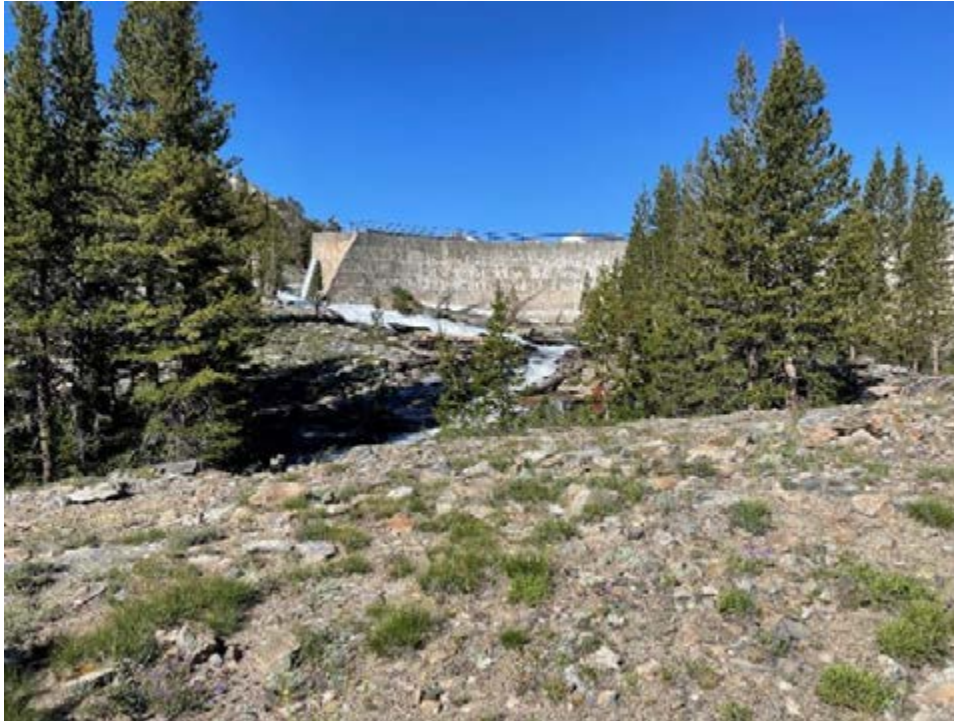
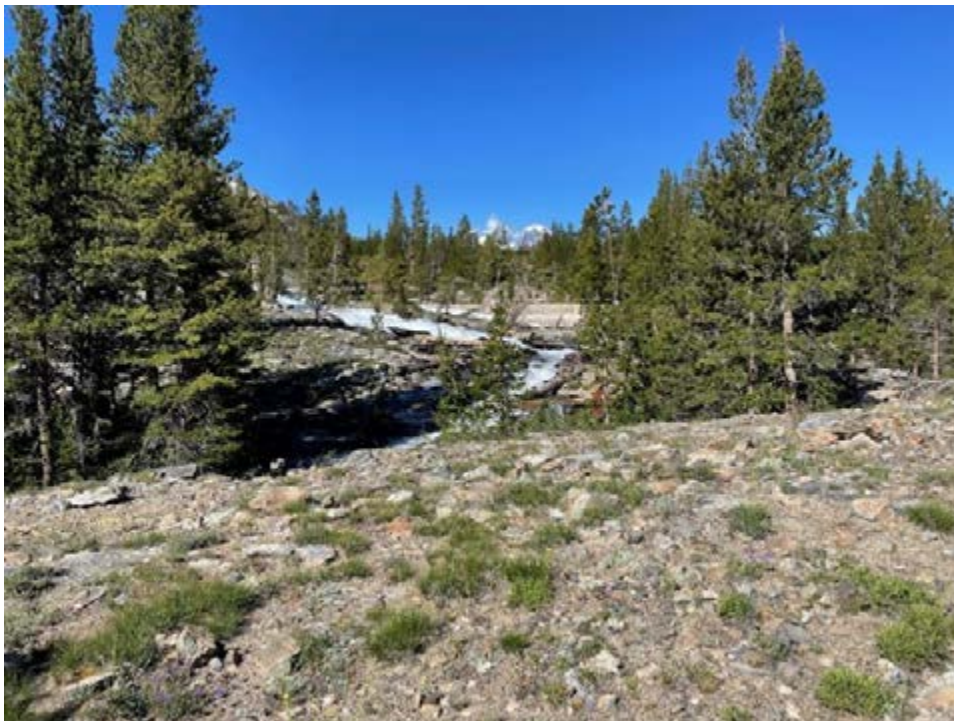
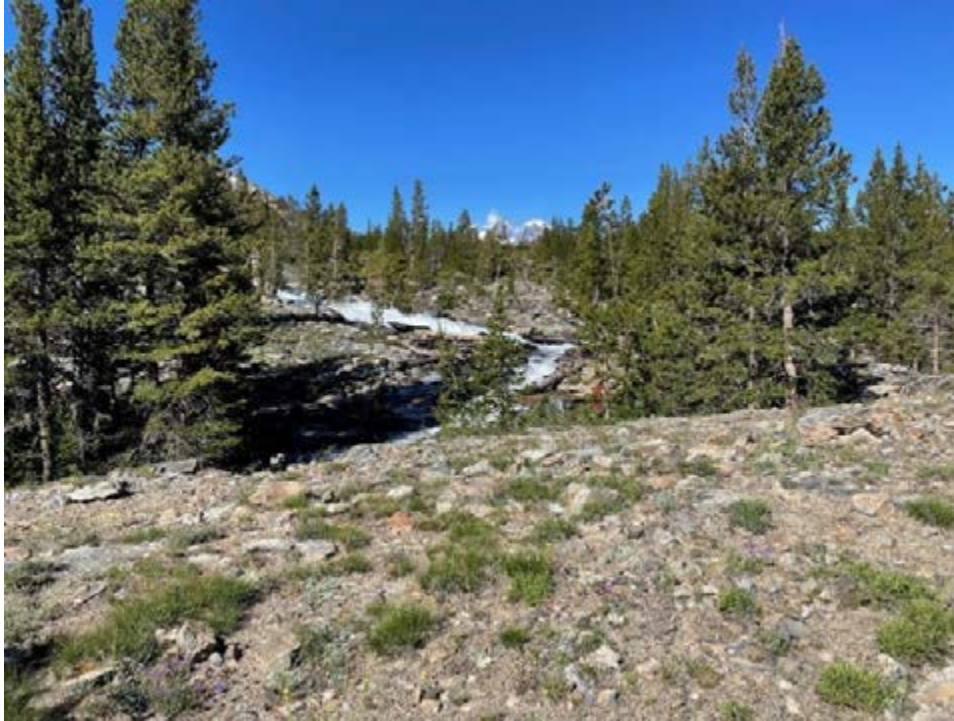
RUSH MEADOWS DAM – KOP 10

Original

Simulation – Partial Removal

Simulation – Full Removal

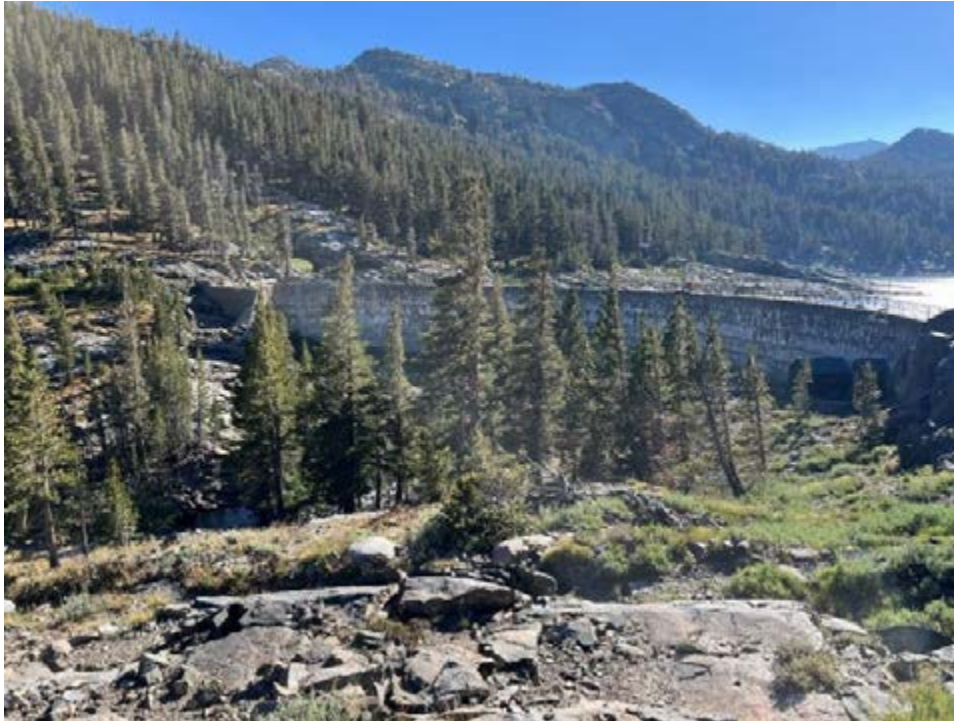
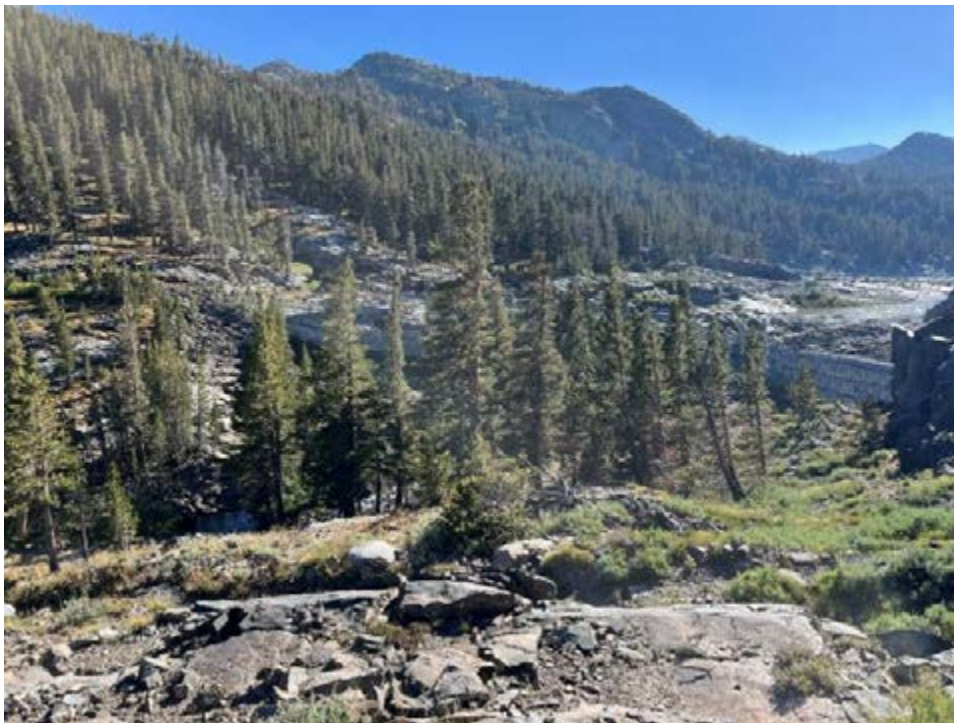
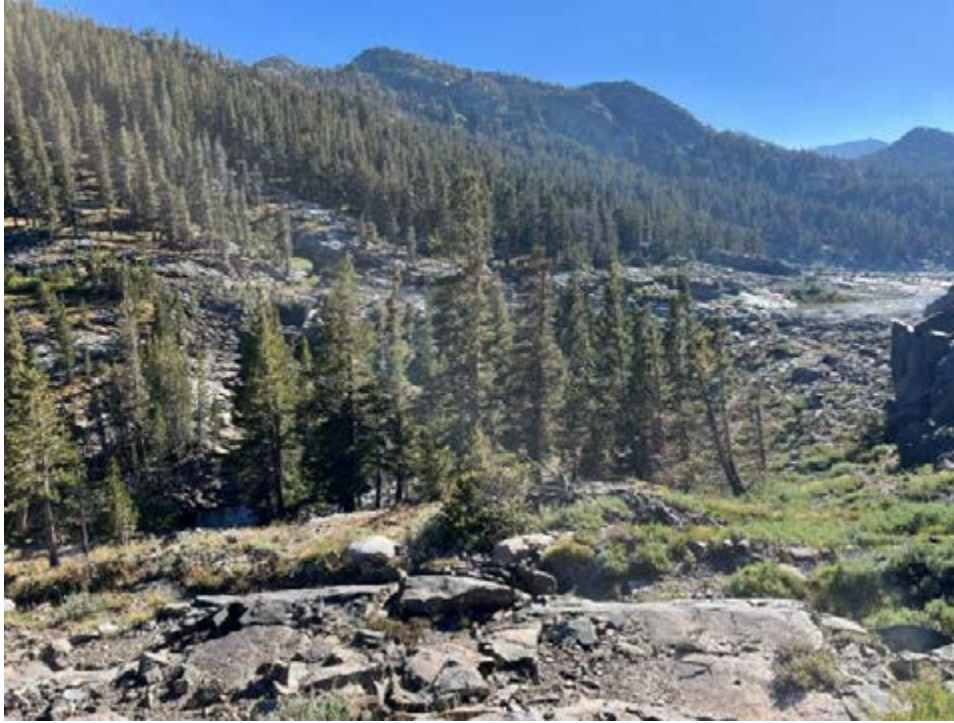
RUSH MEADOWS DAM – KOP 12

Original

Simulation – Partial Removal

Simulation – Full Removal

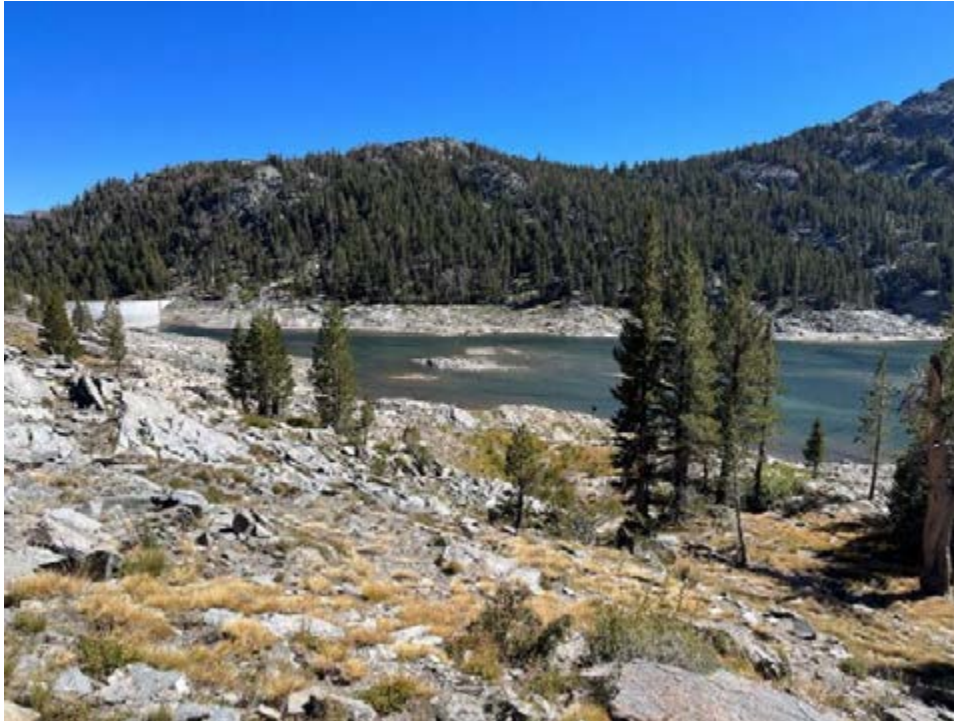
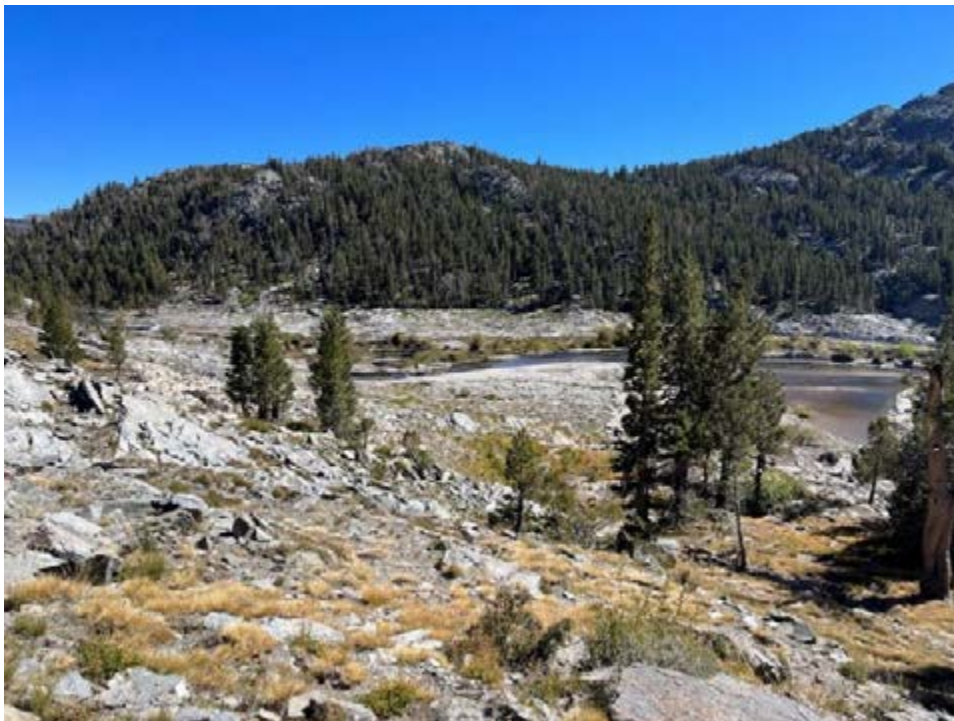
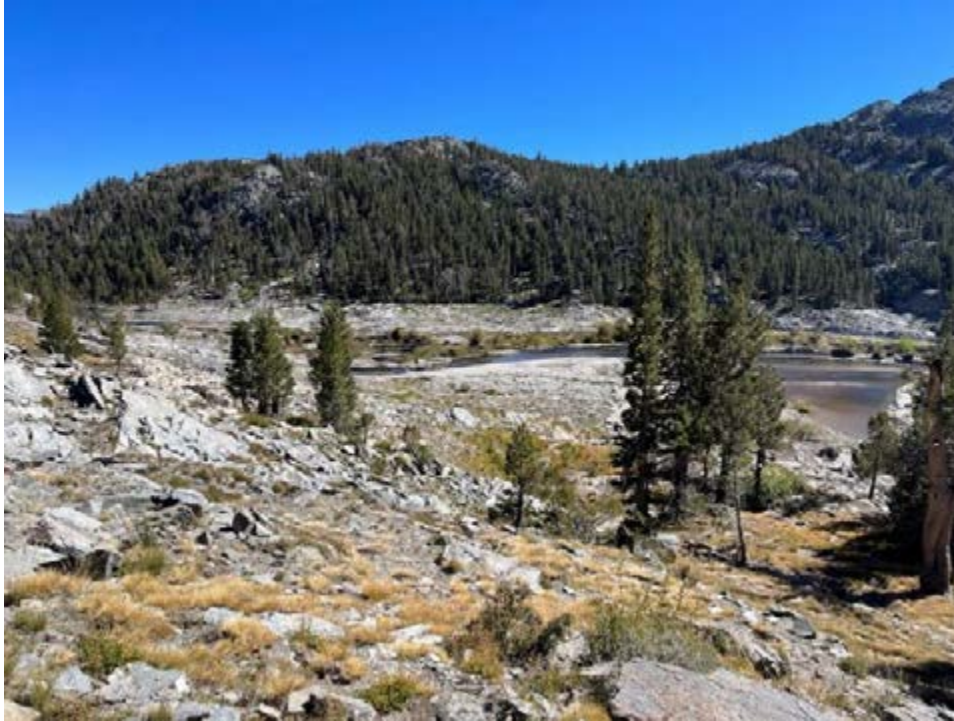
RUSH MEADOWS DAM – KOP 14

Original

Simulation – Partial Removal

Simulation – Full Removal
