Rush Creek Project, FERC Project No. 1389

LAND 1 – Aesthetics
Draft Technical Study Report

August 2024

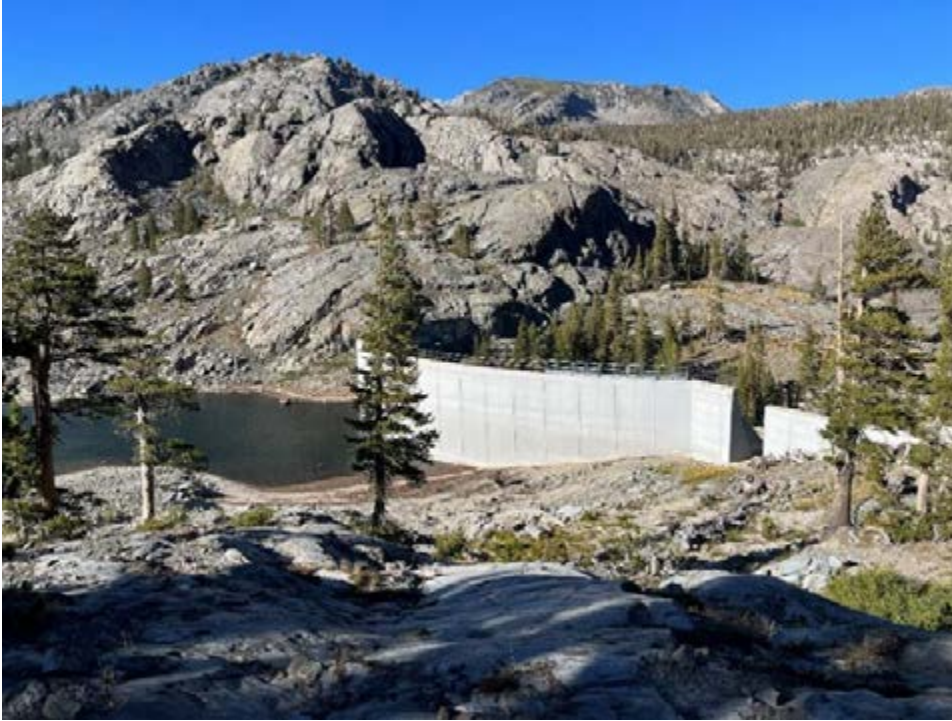
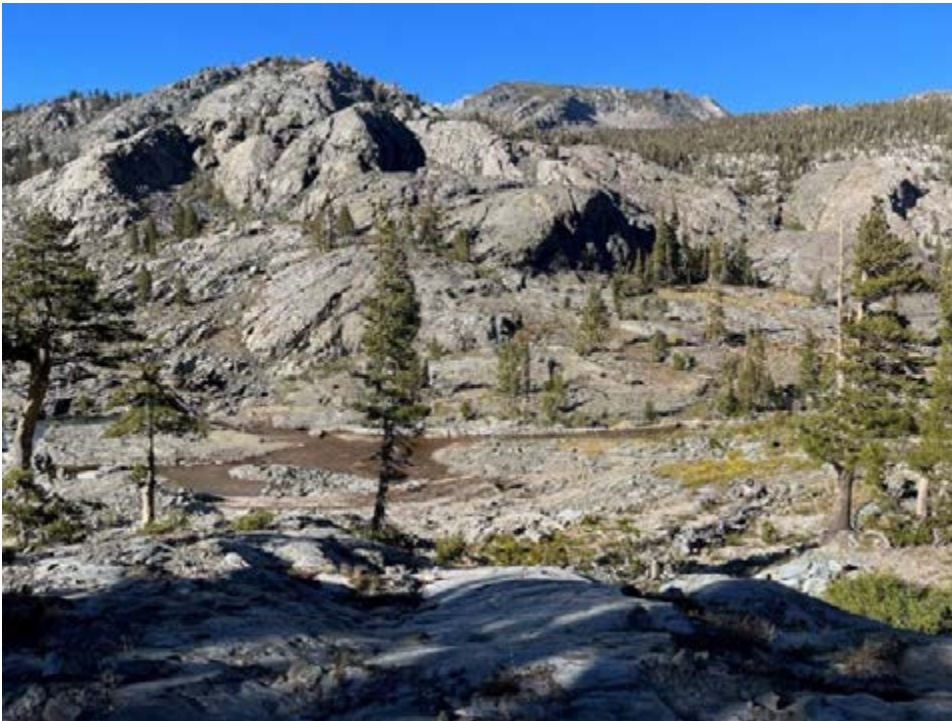
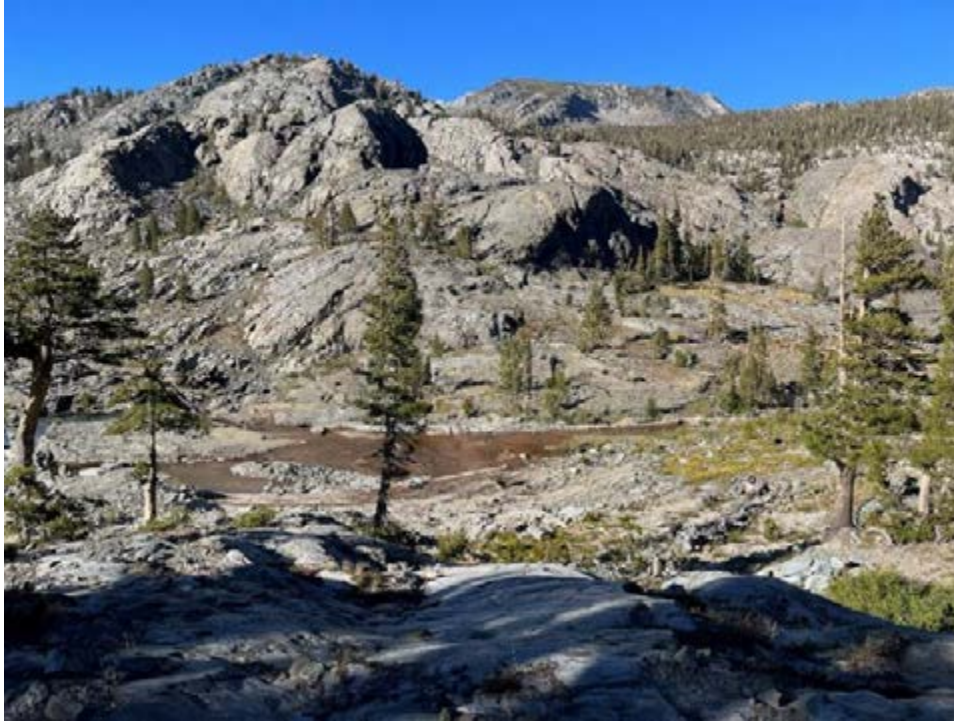
RUSH MEADOWS DAM – KOP 11

Original

Simulation - Partial Removal

Simulation – Full Removal

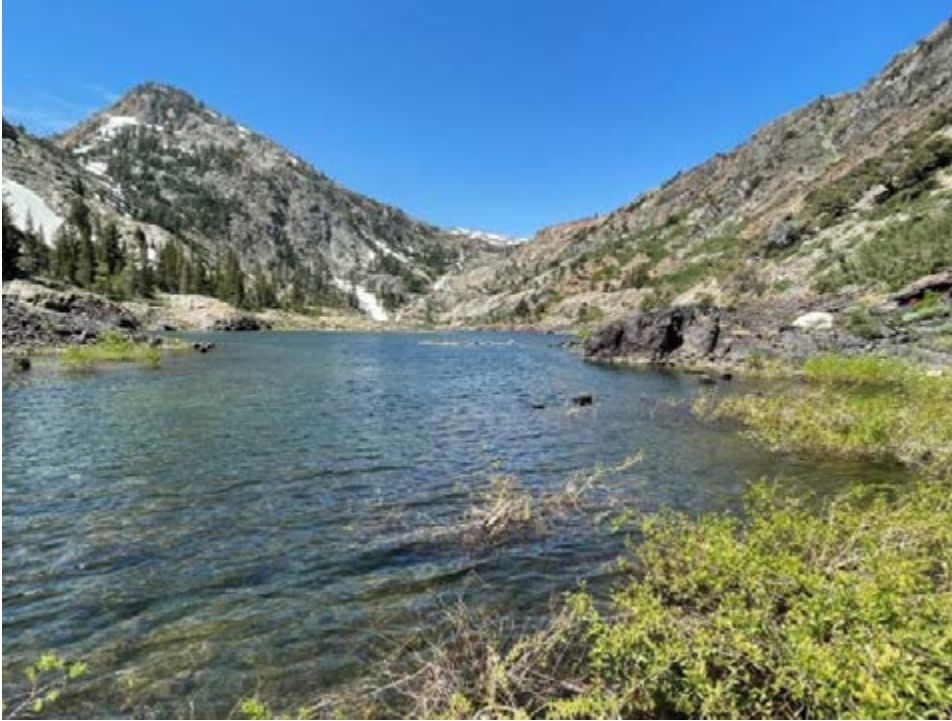
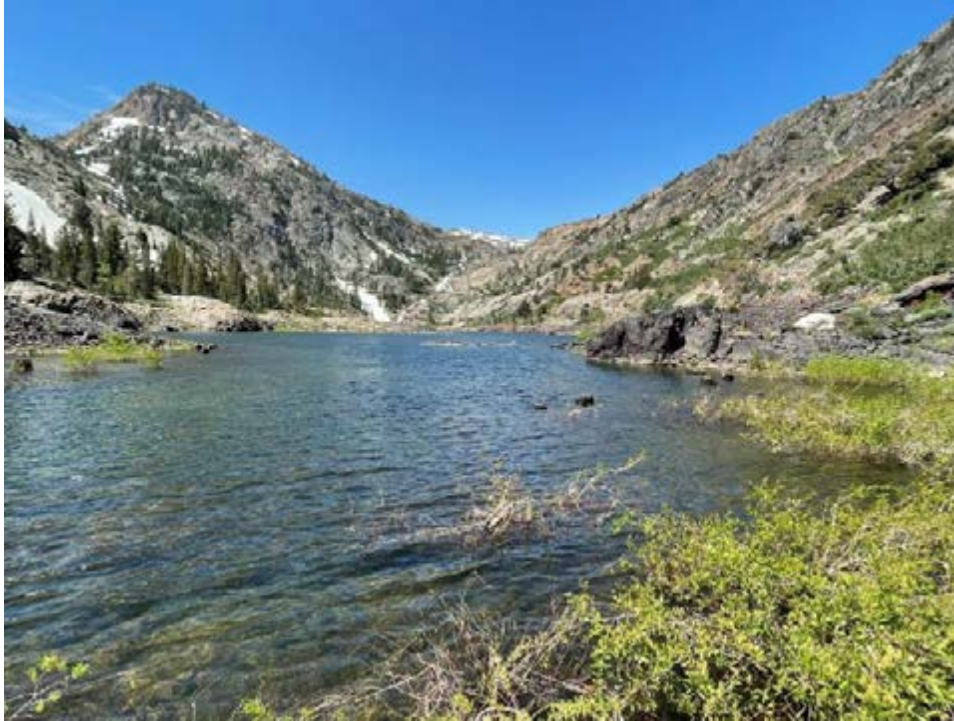
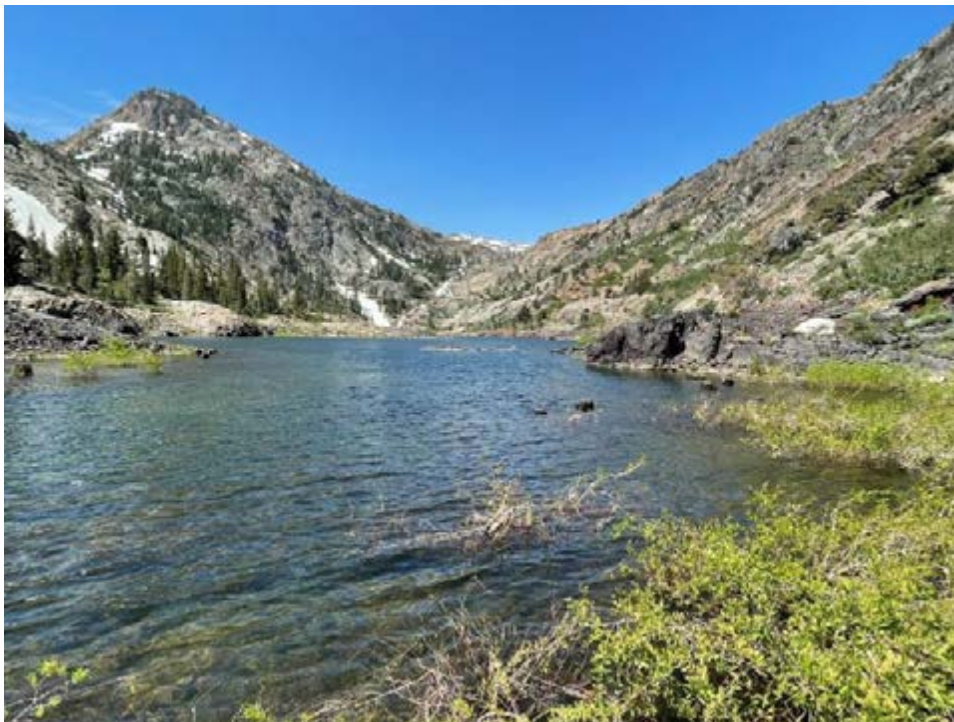
GEM DAM – KOP 4

Original

Simulation - Partial Removal

Simulation – Full Removal

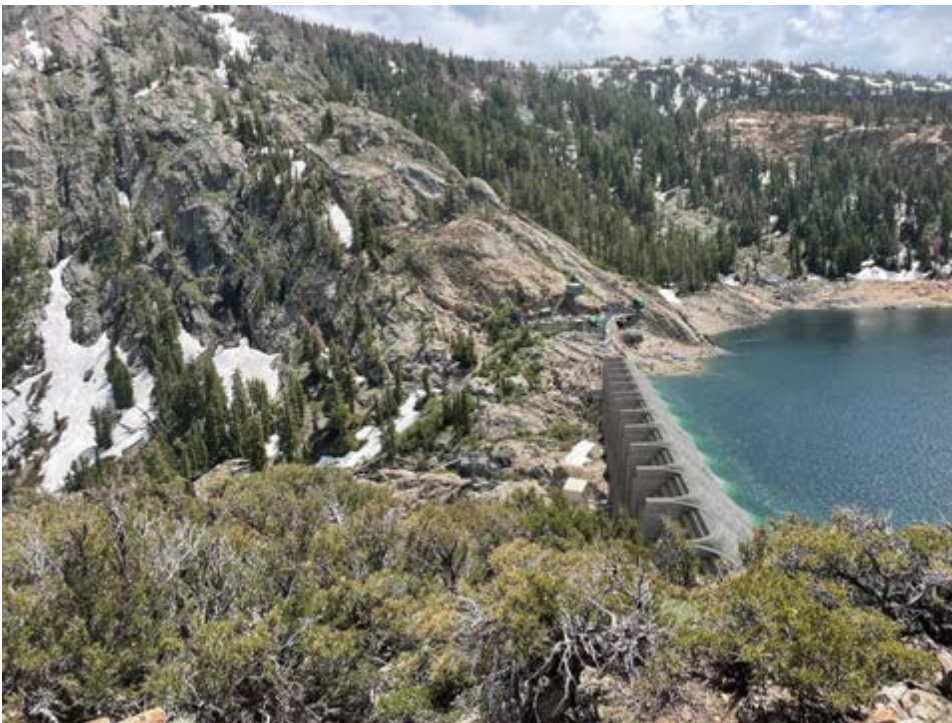
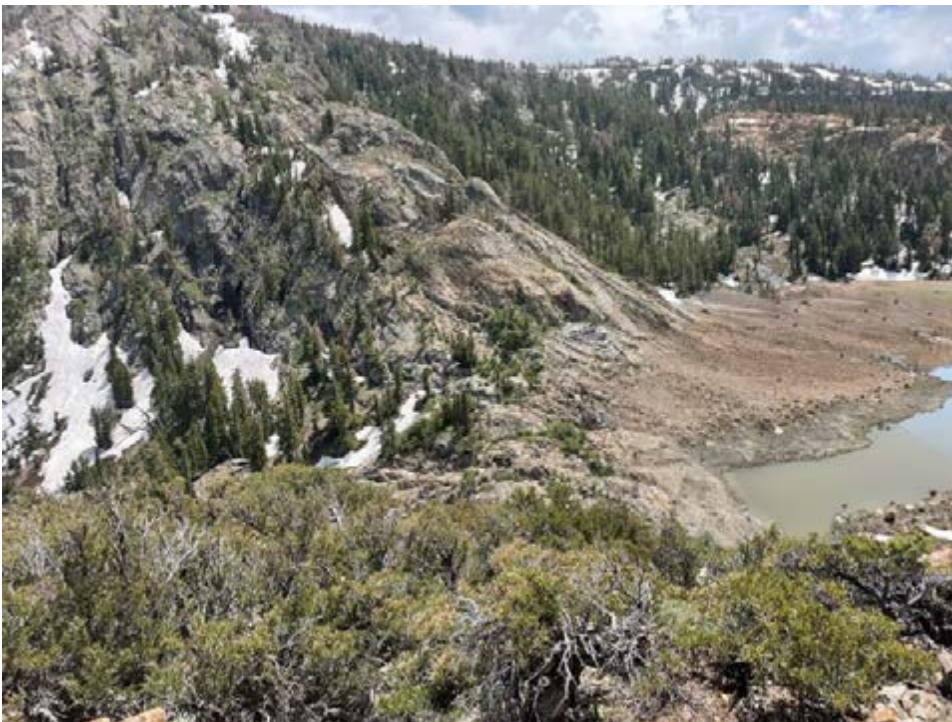
GEM DAM – KOP 7

Simulation - Retrofit

Simulation – Full Removal

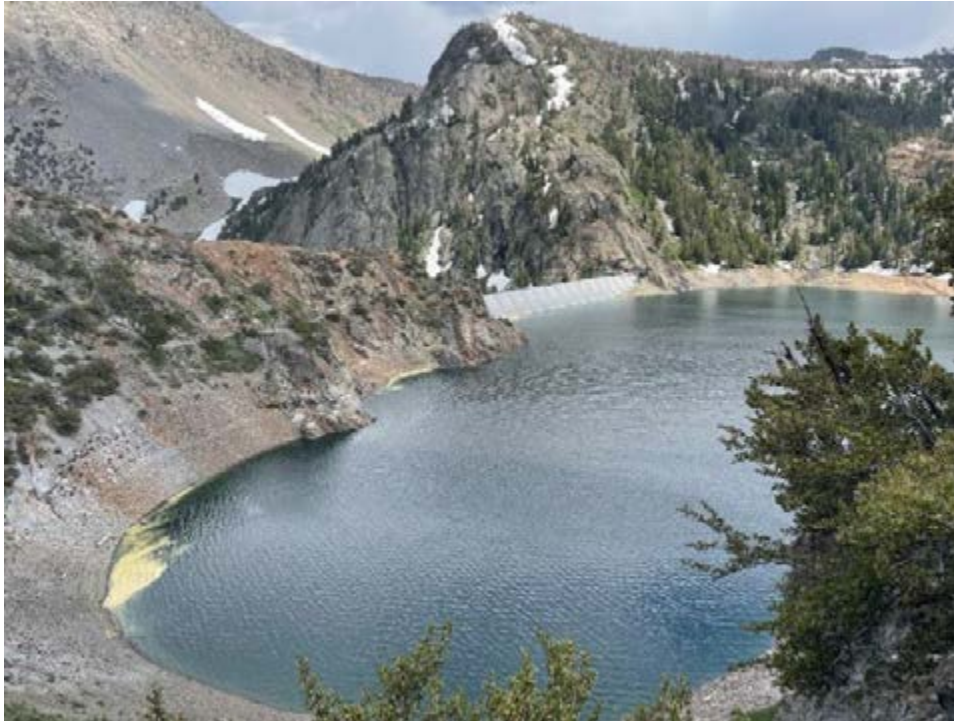
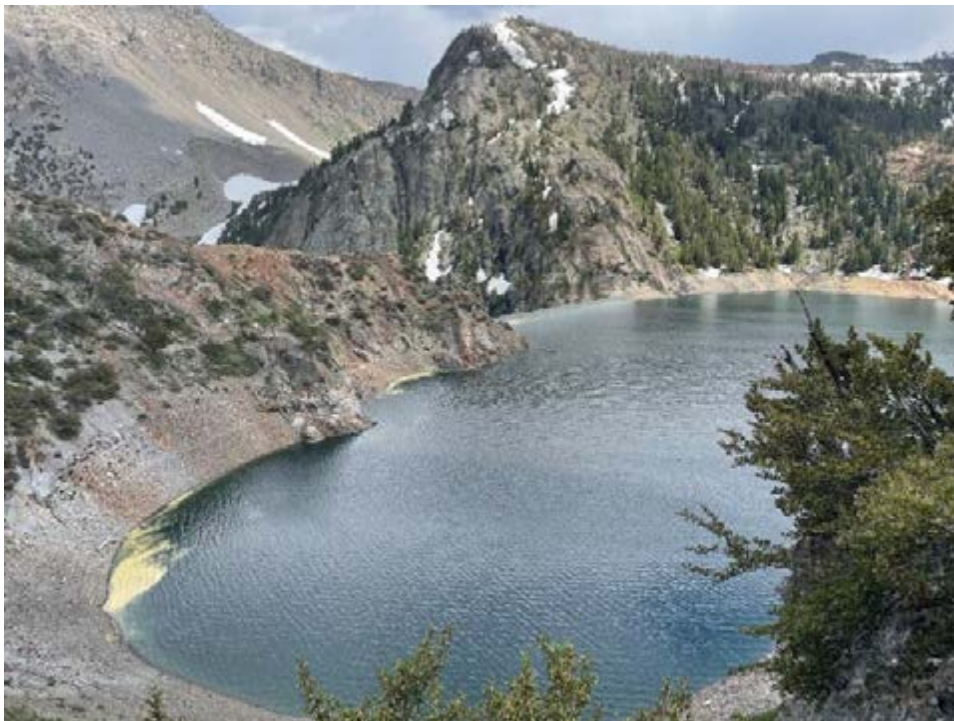
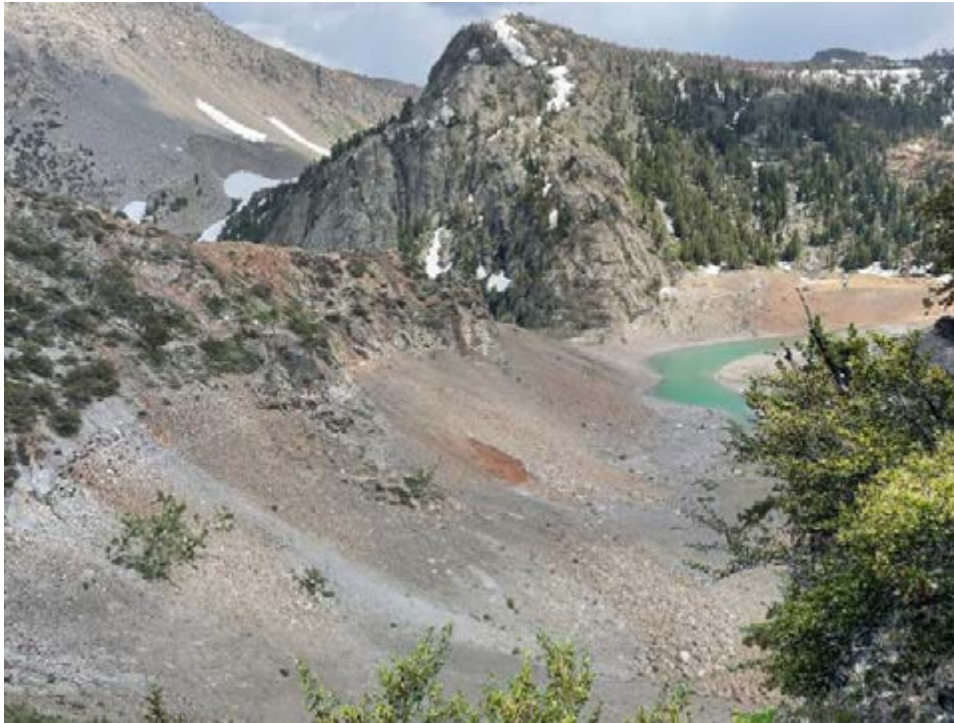
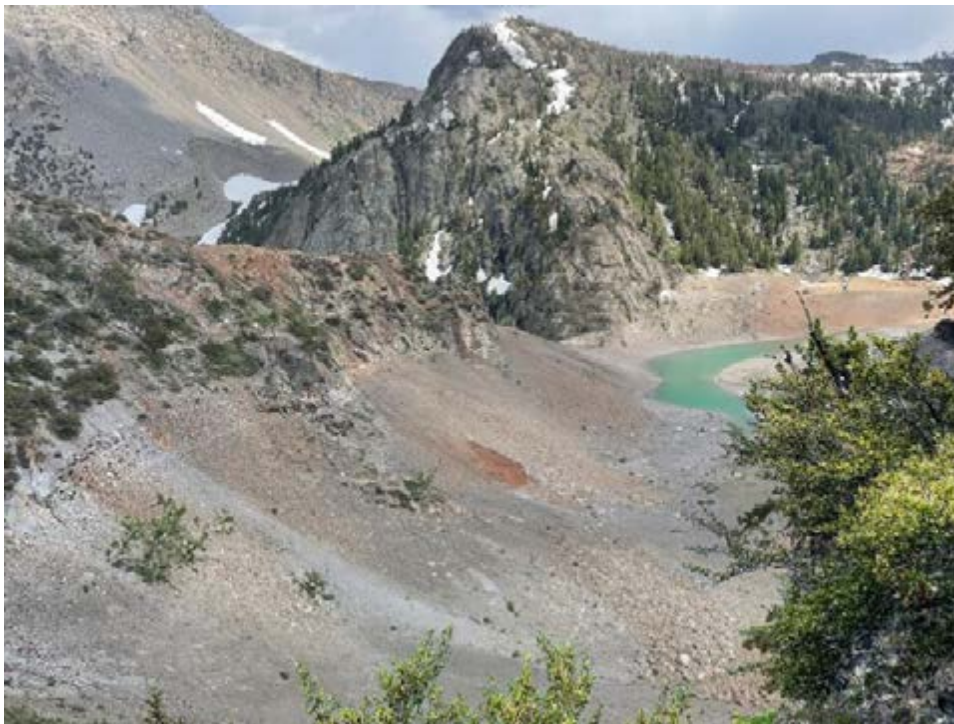
GEM DAM - KOP 8

Original

Simulation - Retrofit

Simulation – Partial Removal

Simulation – Full Removal

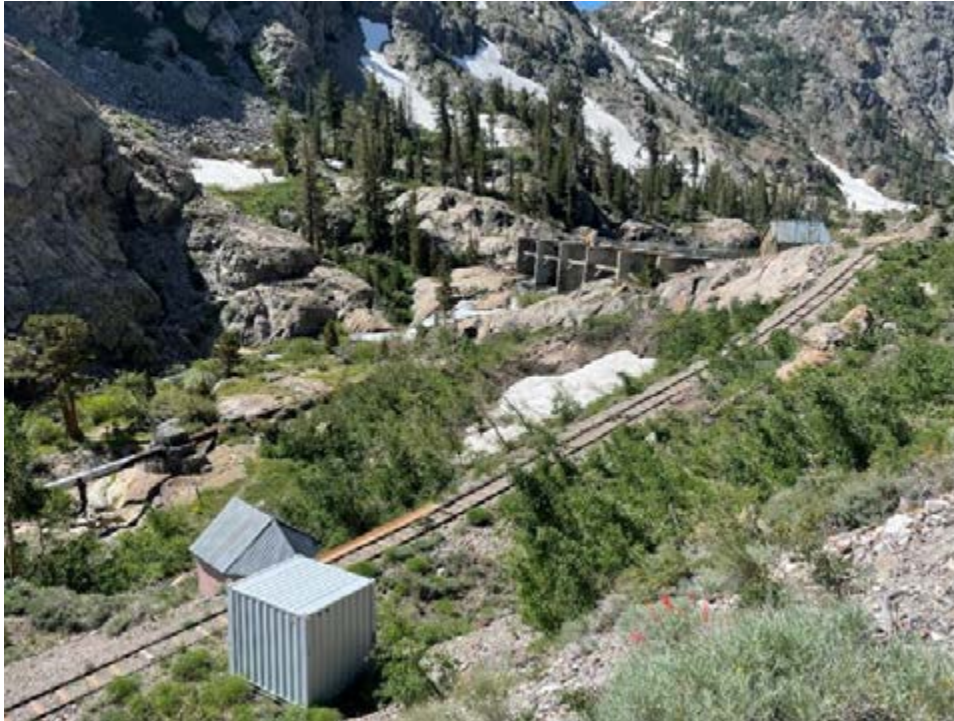
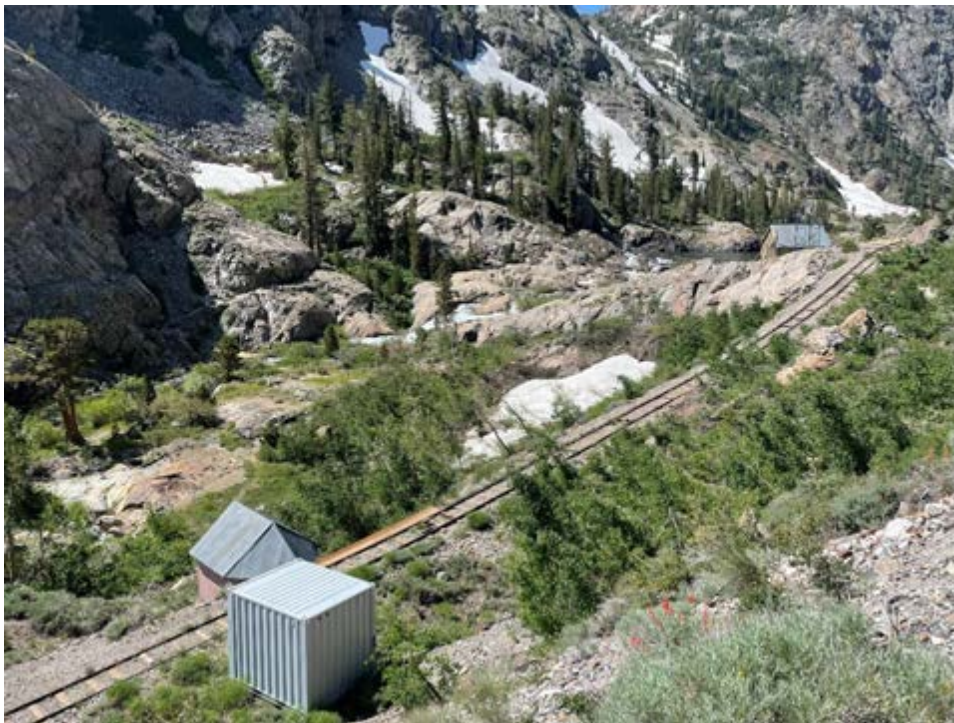
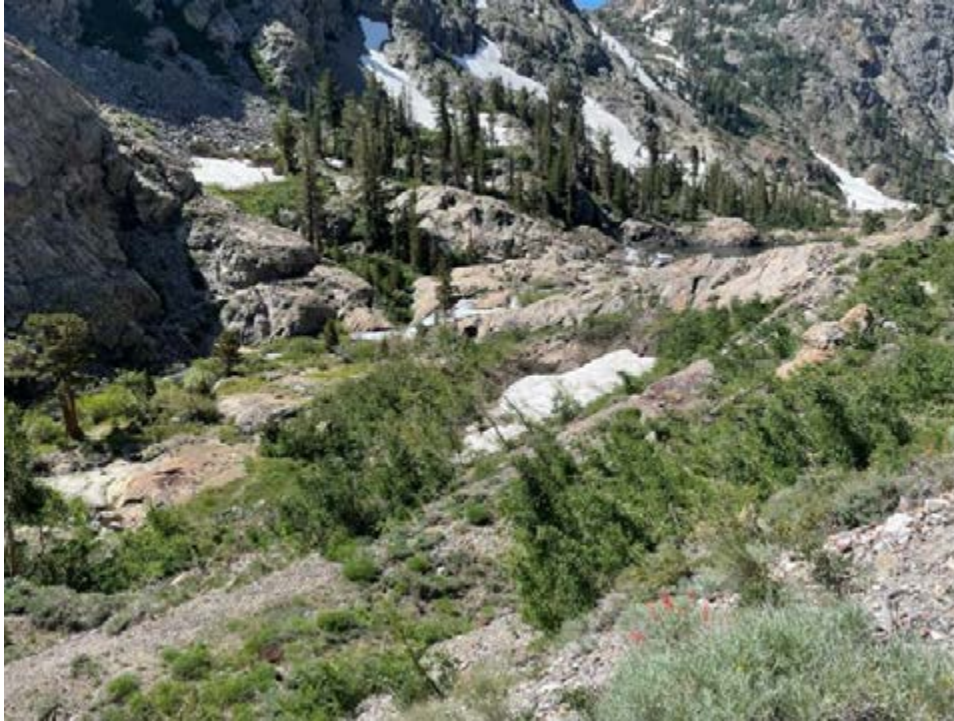
AGNEW DAM – KOP 3

Original

Simulation – Partial Removal

Simulation – Full Removal

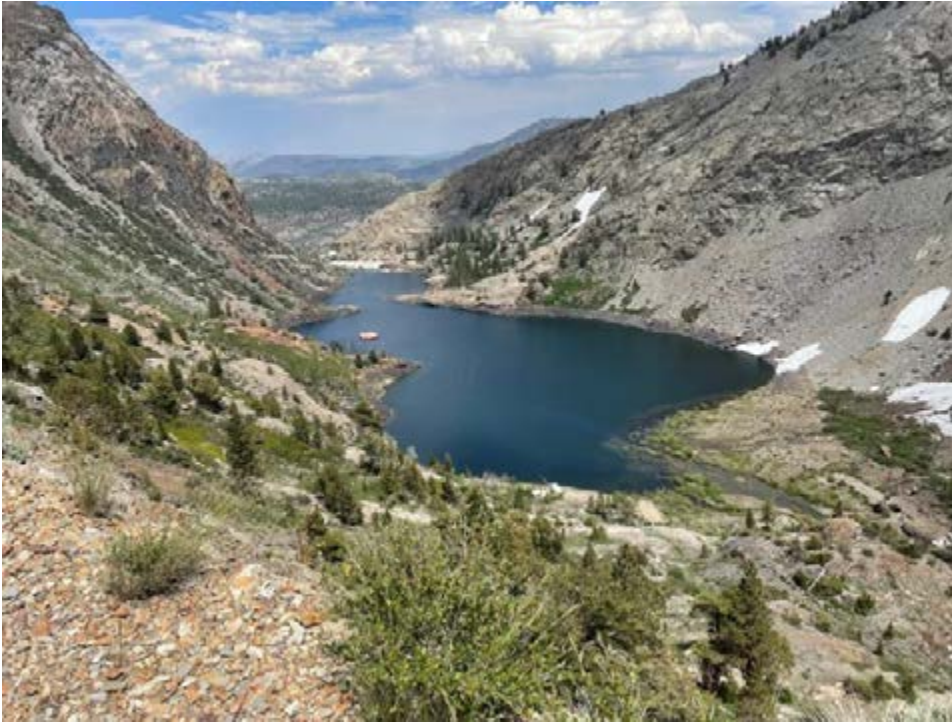
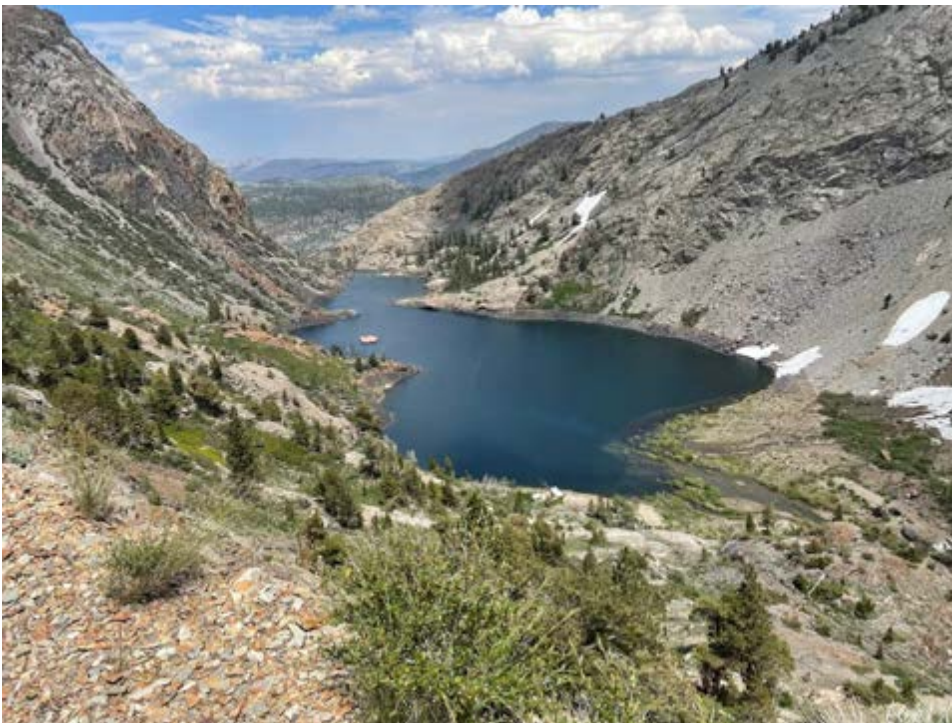
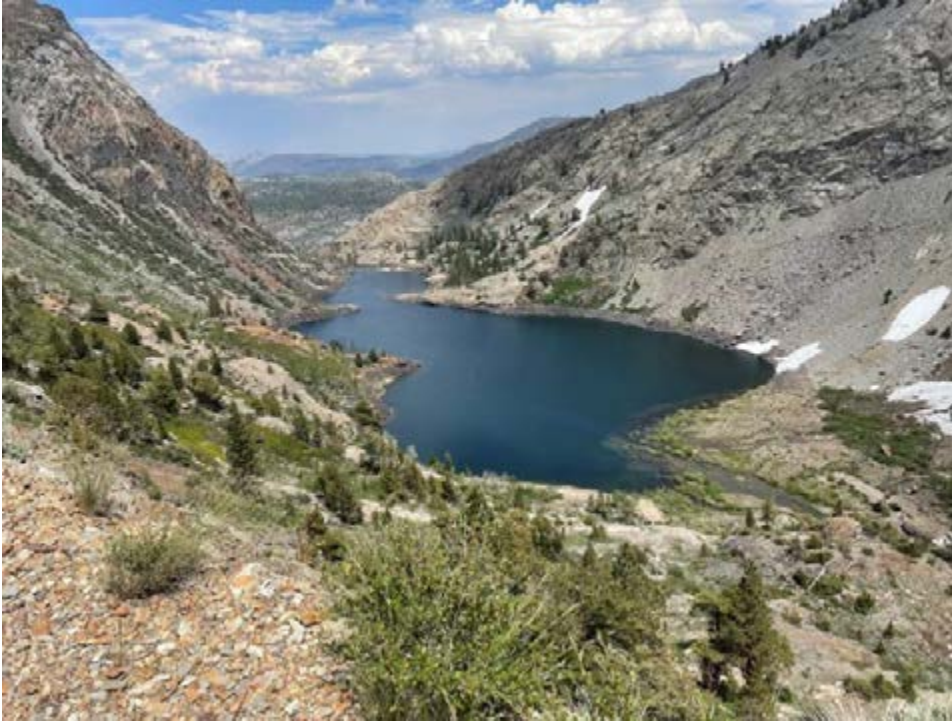
AGNEW DAM – KOP 6

Original

Simulation - Partial Removal

Simulation – Full Removal
